# West Kill Management Unit 16

**Management Unit 16**  
Between Station 16010 and Station 14742

**Management Unit Description**

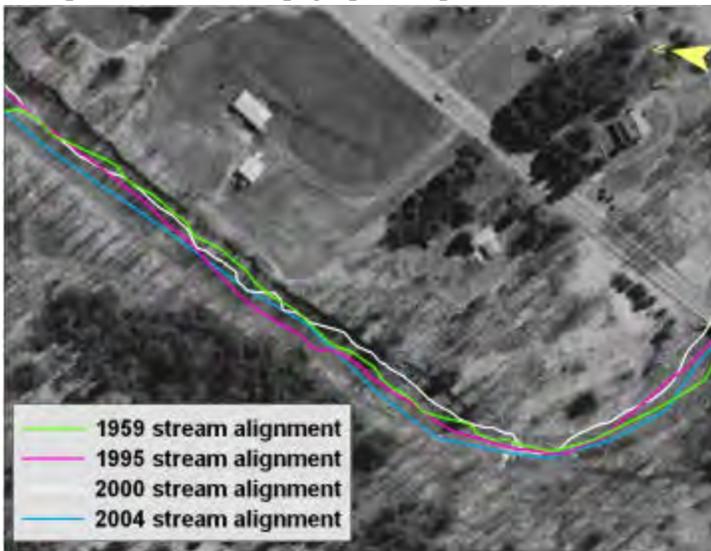
Historic Stream Channel Alignments in MU16

As seen from the historical stream alignments, the channel alignment has remained fairly consistent over the years. The minor differences between the historical alignments are more likely to be artifacts of nuances in the correlation of the photographs than evidence of actual channel migration. Channel migration in this unit is undetectable at this scale of inquiry.

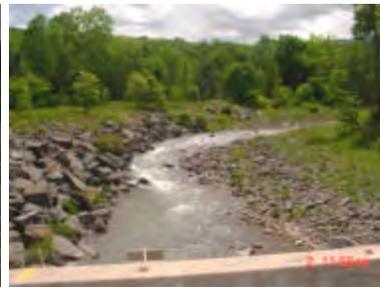
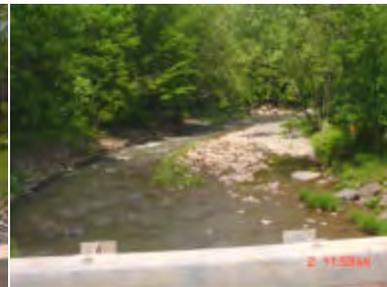
**NYS Route 42 bridge**

NYS Route 42 bridge (Inset D, Fig. 4.16.2) marks the upstream limit of Management Unit 16. The alignment of this bridge is poor, creating a sharp bend to the left as the channel approaches the bridge opening and a sharp bend to the right as the channel departs from the bridge. The sharp bend in combination with poor floodplain drainage through the NYS route 42 road fill results in backwater and aggradation upstream. Recommendations at this site include modification of the stream approach to the bridge, and installation of flood plain drains under NYS Route 42.

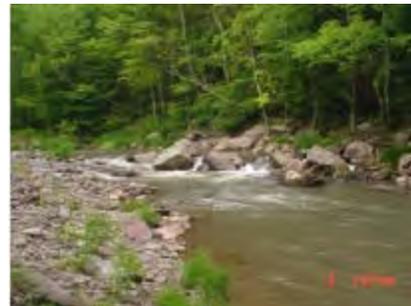
**Rip-rap, left**

Rip-rap (Inset G, Fig. 4.16.2) is installed along 237 ft. of the left bank, starting immediately downstream of the tributary. The treatment is extremely old, and appears to be made

of native stone collected from adjacent uplands. A gravel road lies on the terrace beyond the rip-rap.

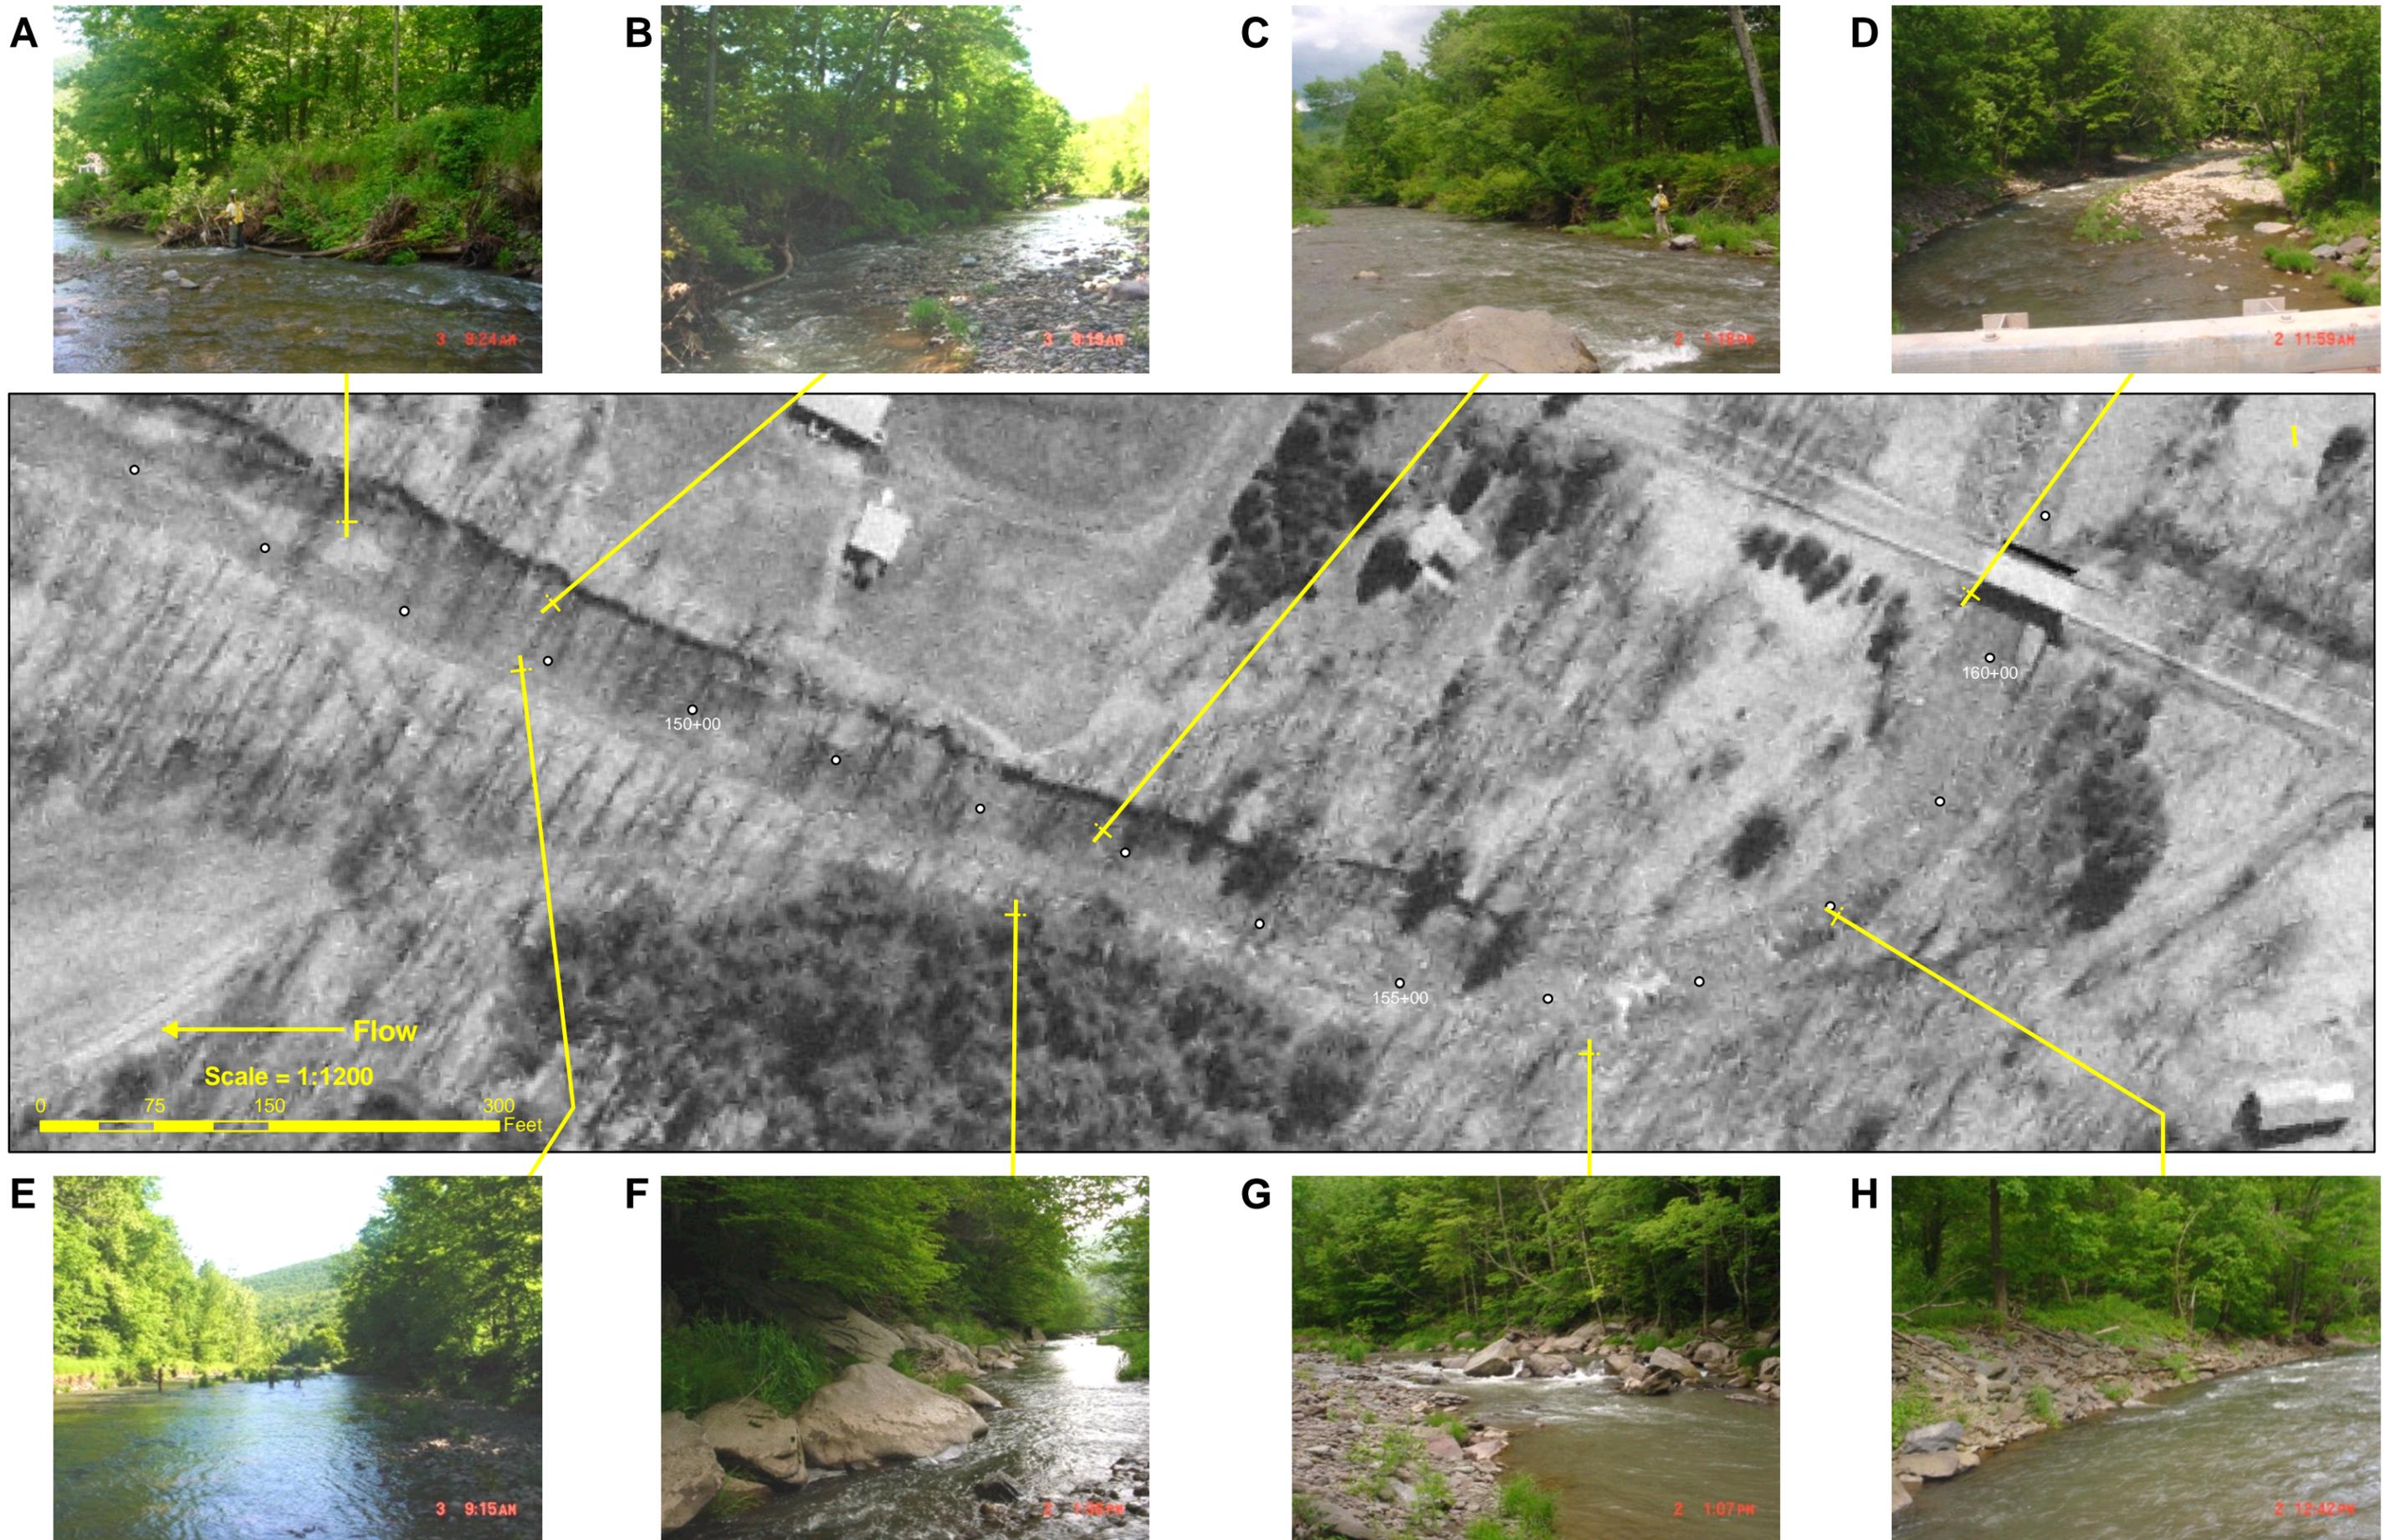
Figure 4.16.2 Management Unit 16 - 2004 aerial photography

Bank erosion (Inset C, Fig. 4.16.2) begins on the right bank near Station 15425, extending 416 ft. downstream. Dense shrubby vegetation obscures the near-vertical bank face. Woody vegetation on the terrace is undercut, and becoming entrained as debris load. The riparian buffer beyond the erosion consists of a narrow strip of shrub and herbaceous vegetation, giving way to lawn just a few feet from the top of the bank. Erosion of the right bank has been

Rip-rap (Inset F, Fig.4.16.2) has again been installed to protect 208 ft. of the left bank at the toe of the embankment of the gravel road. The rip-rap is very old, but in good condition.

Aggradation (Inset E, Fig. 4.16.2) is apparent downstream of the eroded right bank. The aggradation results in cutting at the left and right banks, entraining small amounts of debris. The aggradation is likely to be associated with excess sediment load supplied by the eroding bank. In stream plantings of ecologically appropriate shrub and herbaceous species is recommended for this site, in combination with reduction of local sediment inputs, to promote development of a narrower, deeper bankfull channel with the capacity to convey the delivered sediment.

As the channel becomes more connected with the terraces at the left and right, erosion compromises 227 ft. of the right bank. Woody vegetation is being undermined and falling into the stream from the top of the terrace, resulting in another debris jam (Inset A, Fig. 4.16.2) formed at the downstream end of the erosion.

(BEMS Station 16-15177). In a prioritization of twenty-one BEMS sites throughout the West Kill watershed (see Section 3.3, Watershed Inventory and Assessment), this site ranked Low Priority. Vegetative toe treatments are recommended for this site to improve bank stability and reduce sediment yield resulting in aggradation downstream. Riparian buffer enhancement is recommended for the lawn area at the top of the terrace. The risk to bank stability can be minimized by maintaining mature trees along the stream margin, including a critical buffer zone extending approximately 75 ft. from the centerline of the stream (Fig. 4.16.4).
