West Kill Management Unit 18

Stream Feature Statistics

Management Unit 18
Between Station 9304 and Station 7402

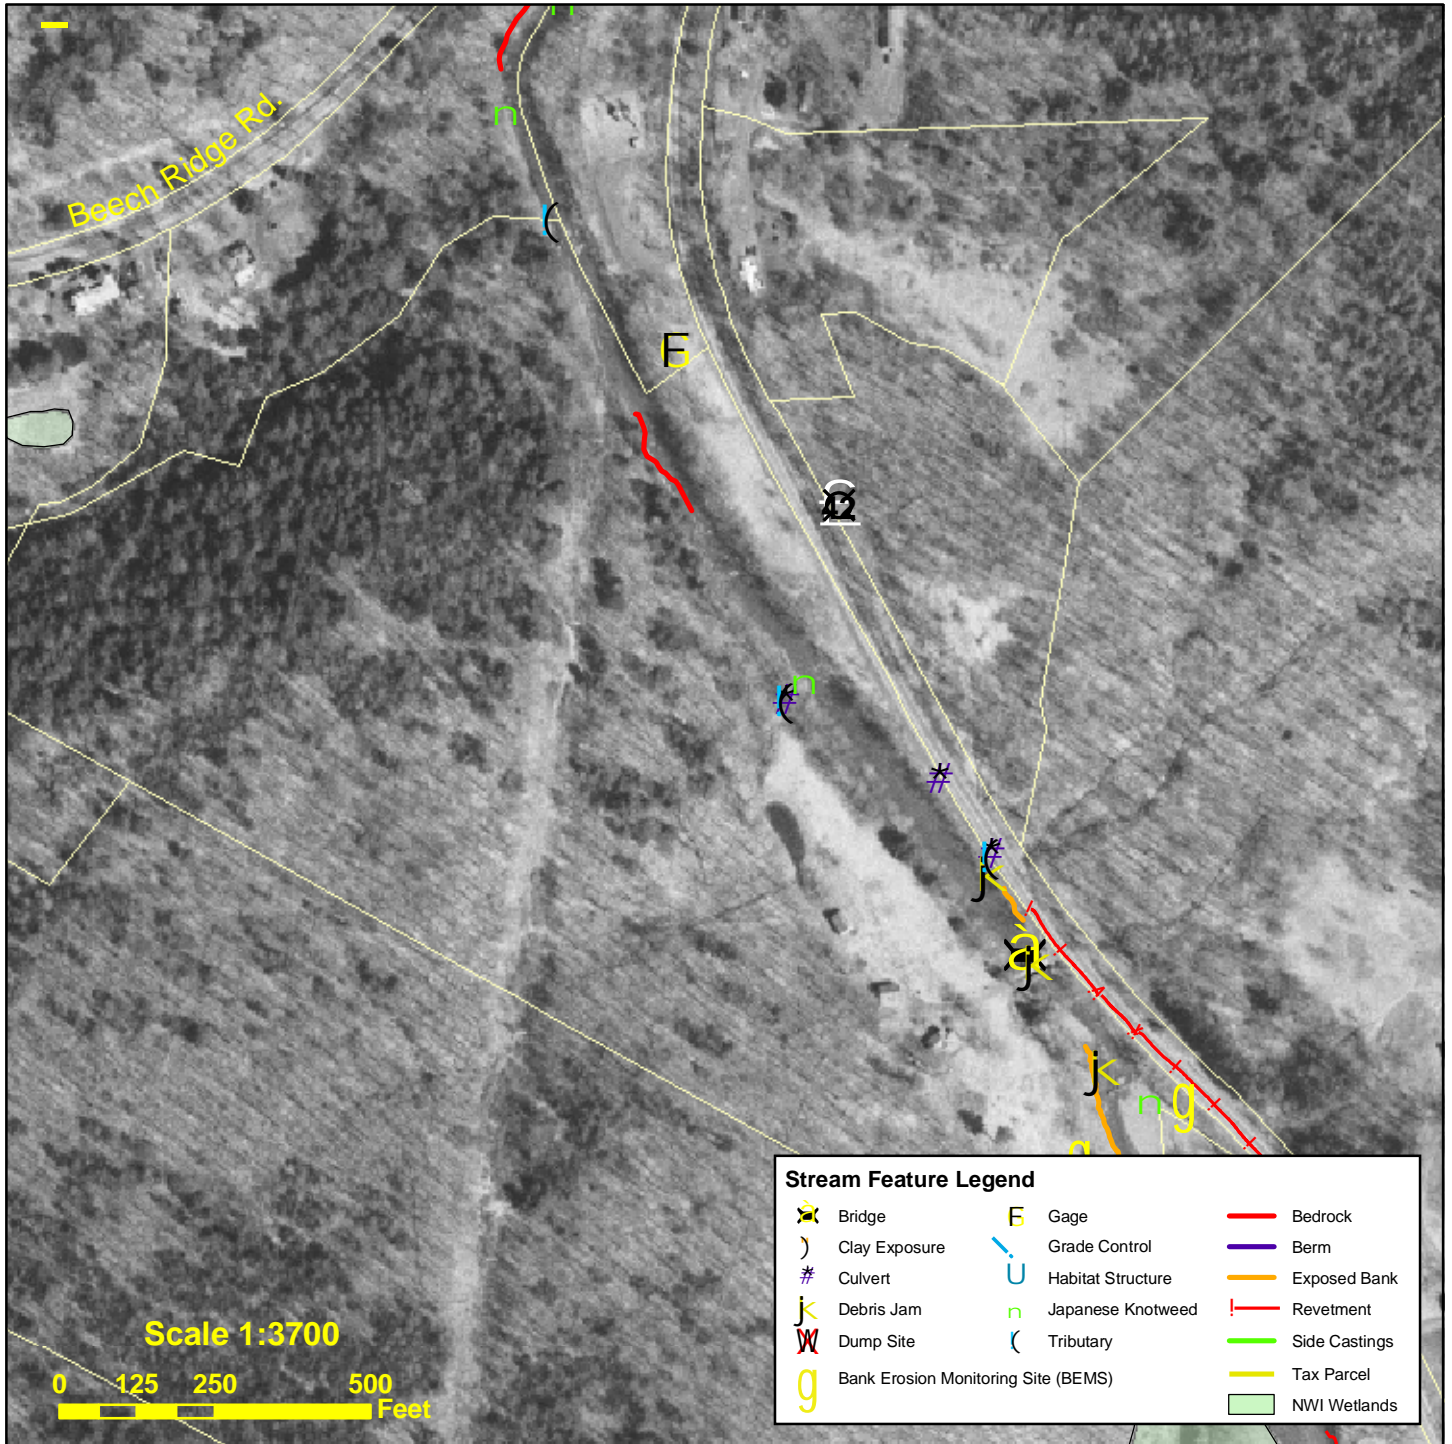
Figure 4.18.1 2004 aerial photography with stream feature inventory and tax parcels

- 7% of stream length is experiencing erosion
- 16% of stream length has been stabilized
- 3.2 acres of inadequate vegetation within the 300 ft. buffer
- 0 ft. of stream is within 50 ft. of the road
- 0 houses located within the 100-year floodplain boundary

The 2004 stream feature inventory revealed that 7% (138 ft.) of the stream exhibited signs of active erosion along 1902 ft. of total channel length (Fig. 4.18.1). Revetment has been installed on 16% (1902 ft.) of the stream. No berms were identified in this management unit at the time of the stream feature inventory.

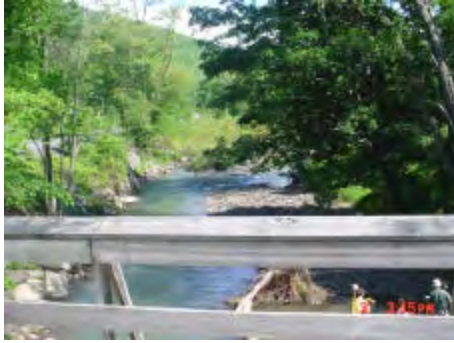
Lady's Bridge, looking upstream

Proceeding downstream, more large woody debris has collected, creating an obstruction at all flows directly upstream of the bridge (Inset H, Fig. 4.18.2). These trees, which are likely to accumulate additional material if not removed, represent a potential hazard to the bridge. They are also contributing to significant abutment scour. Removal of this debris is recommended, and the

extent of scour of the abutments should be evaluated.

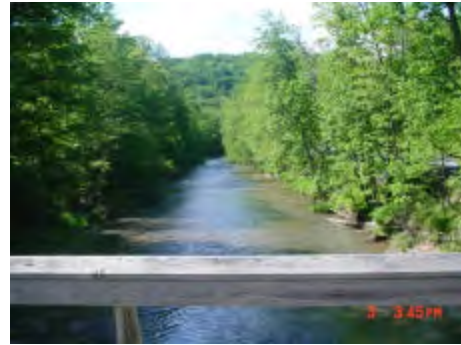
Lady's Bridge, looking downstream

Downstream of the bridge, the channel appears overwide, perhaps a consequence of channel grading, but apparently stable, despite some aggradation resulting in minor erosion at the base of the road embankment, right (see Insets G and C, Fig.

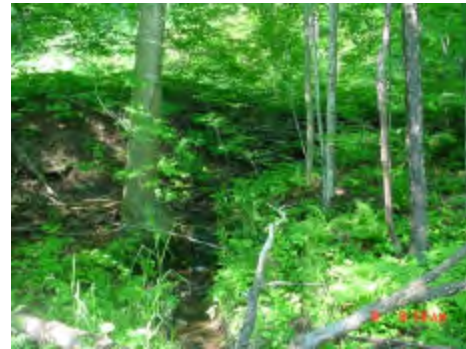
Culvert, left

Downstream a second culvert carries road drainage from across the highway, and is perched without outfall protection. The mowed field on the left transitions to a mature forest buffer.

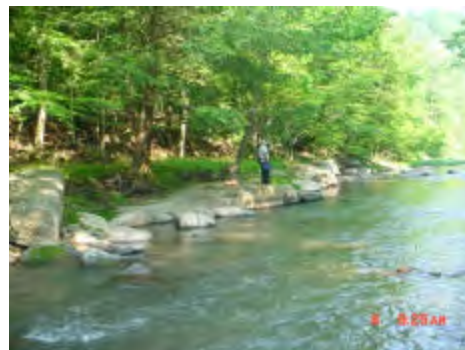
Bed Rock

As the floodplain continues to broaden on the right bank, entrenchment moderates, marking the transition (around Station 8300) to a B3c streamtype. Channel slope increases to 1.29%, dominant channel material remains cobble, but entrenchment reduces as the channel is reconnected with its floodplain. Proceeding downstream, a bedrock outcropping on the left bank, and probably extending across the bed, provides lateral and perhaps grade control (Inset E, Fig. 4.18.2). The site may have once served as a

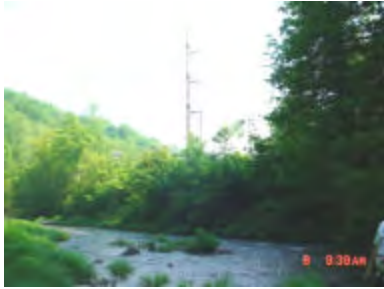
Utility right-of-way

A power-line right-of-way crosses the channel obliquely, heading toward the step-down station in the floodplain on the right.

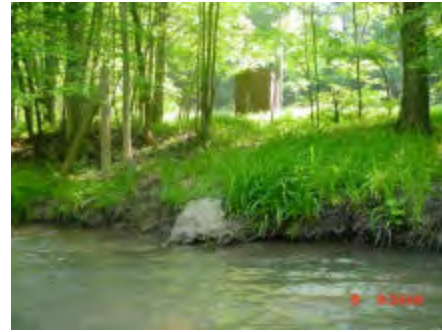
USGS gauging station, right

Downstream and on the right, a USGS gauging station (#01349810) has been established (Inset B, Fig. 4.18.2), providing continuous real-time stage measurements, and with a staff plate and crest stage recorder. A monumented cross-section at Station 7774 documents the B3c stream type.
