West Kill Management Unit 19

Management Unit 19

Between Station 7402 and Station 4778

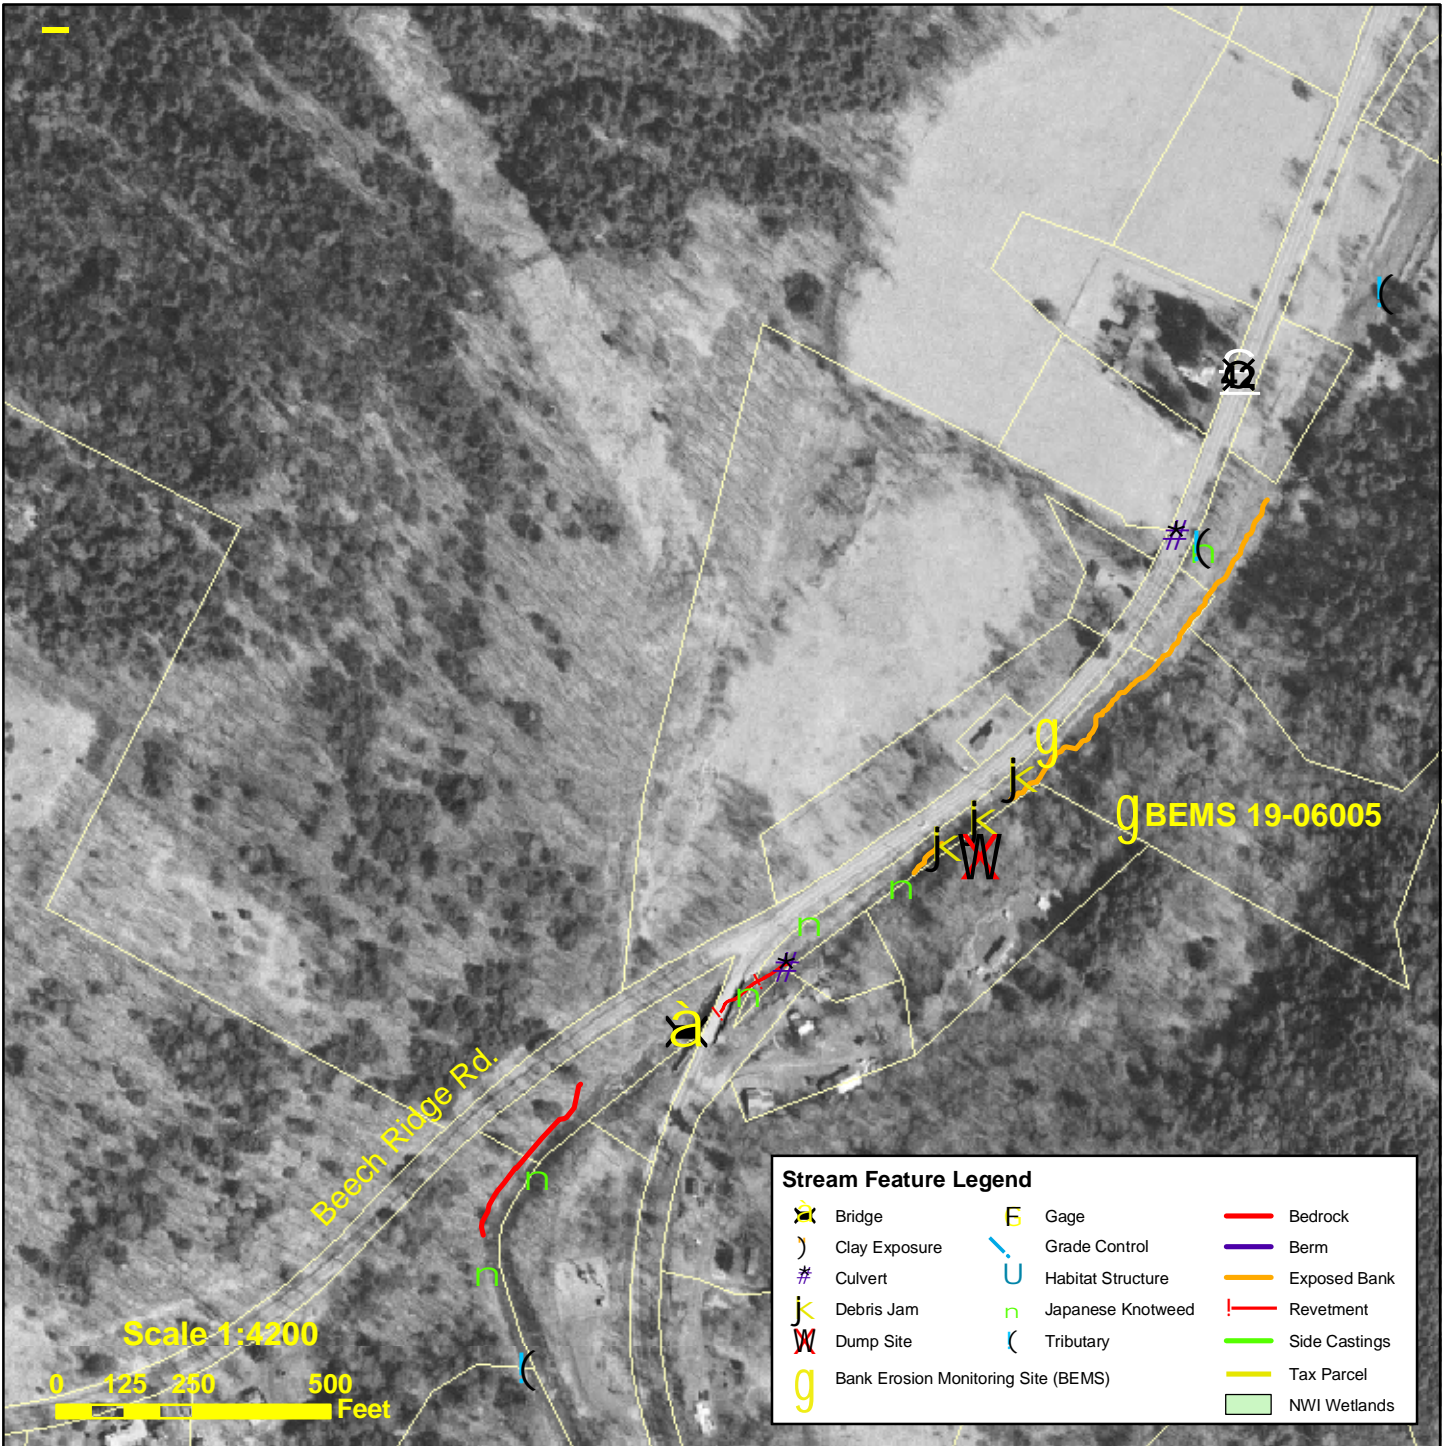
Figure 4.19.1 2004 aerial photography with stream feature inventory and tax parcels

The 2004 stream feature inventory revealed that 32% (849 ft.) of the stream exhibited signs of active erosion along 2,624 ft. of total channel length (Fig. 1). Revetment has been installed on 6% (161 ft.) of the stream. No berms were identified in this management unit at the time of the stream feature inventory.

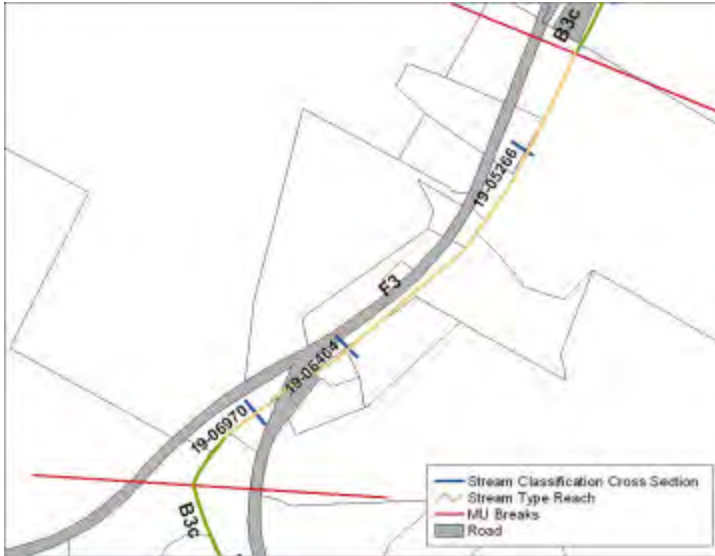
Cross-sections and Rosgen stream type classification in MU19

Three monumented cross-sections (Stations 6970, 6464, and 5266) document 2,624 ft. of F3 stream type, which encompasses this entire management unit. The channel slope decreases upstream to downstream, from to 1.83% at a monumented cross-section just downstream of the culvert outfall that carries drainage from Beech Ridge Road, to 0.85% near the downstream end of the unit. The dominant bed material remains cobble throughout the entire unit.

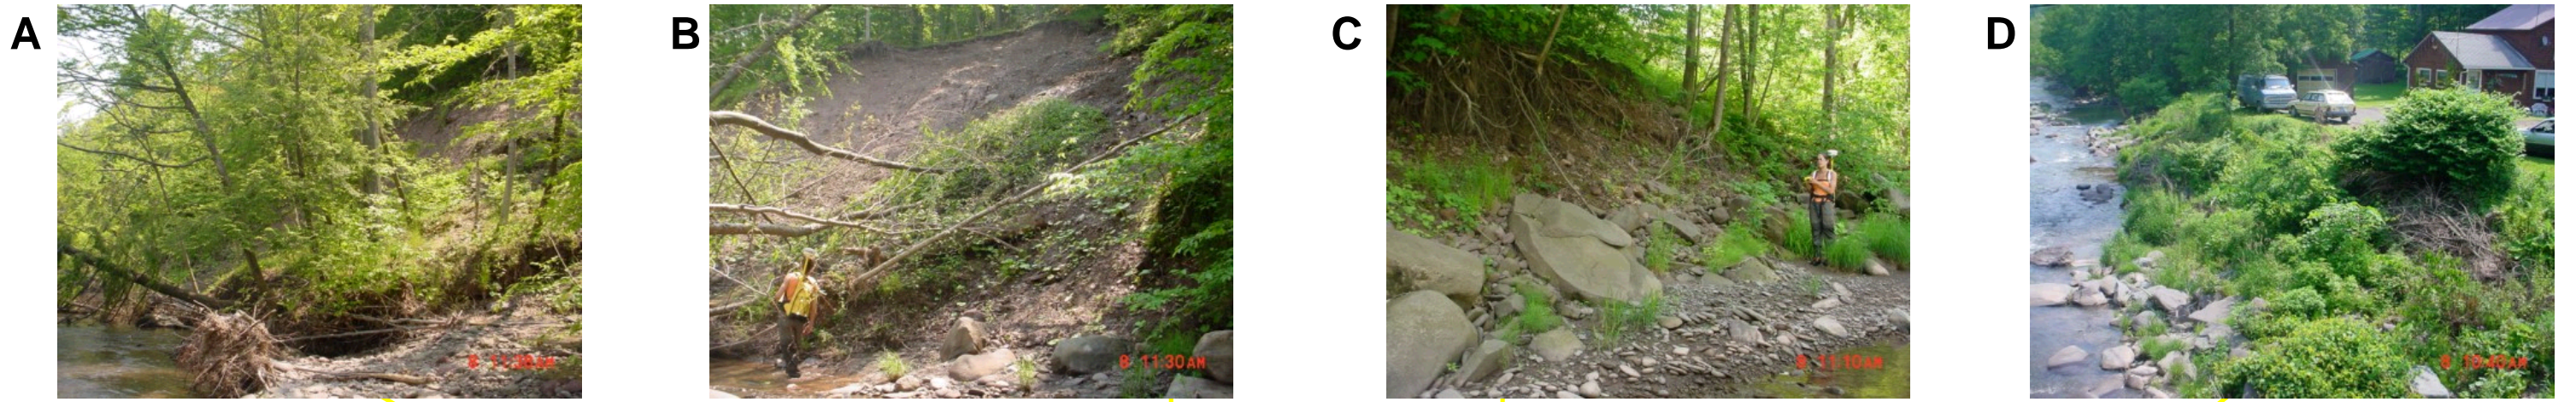
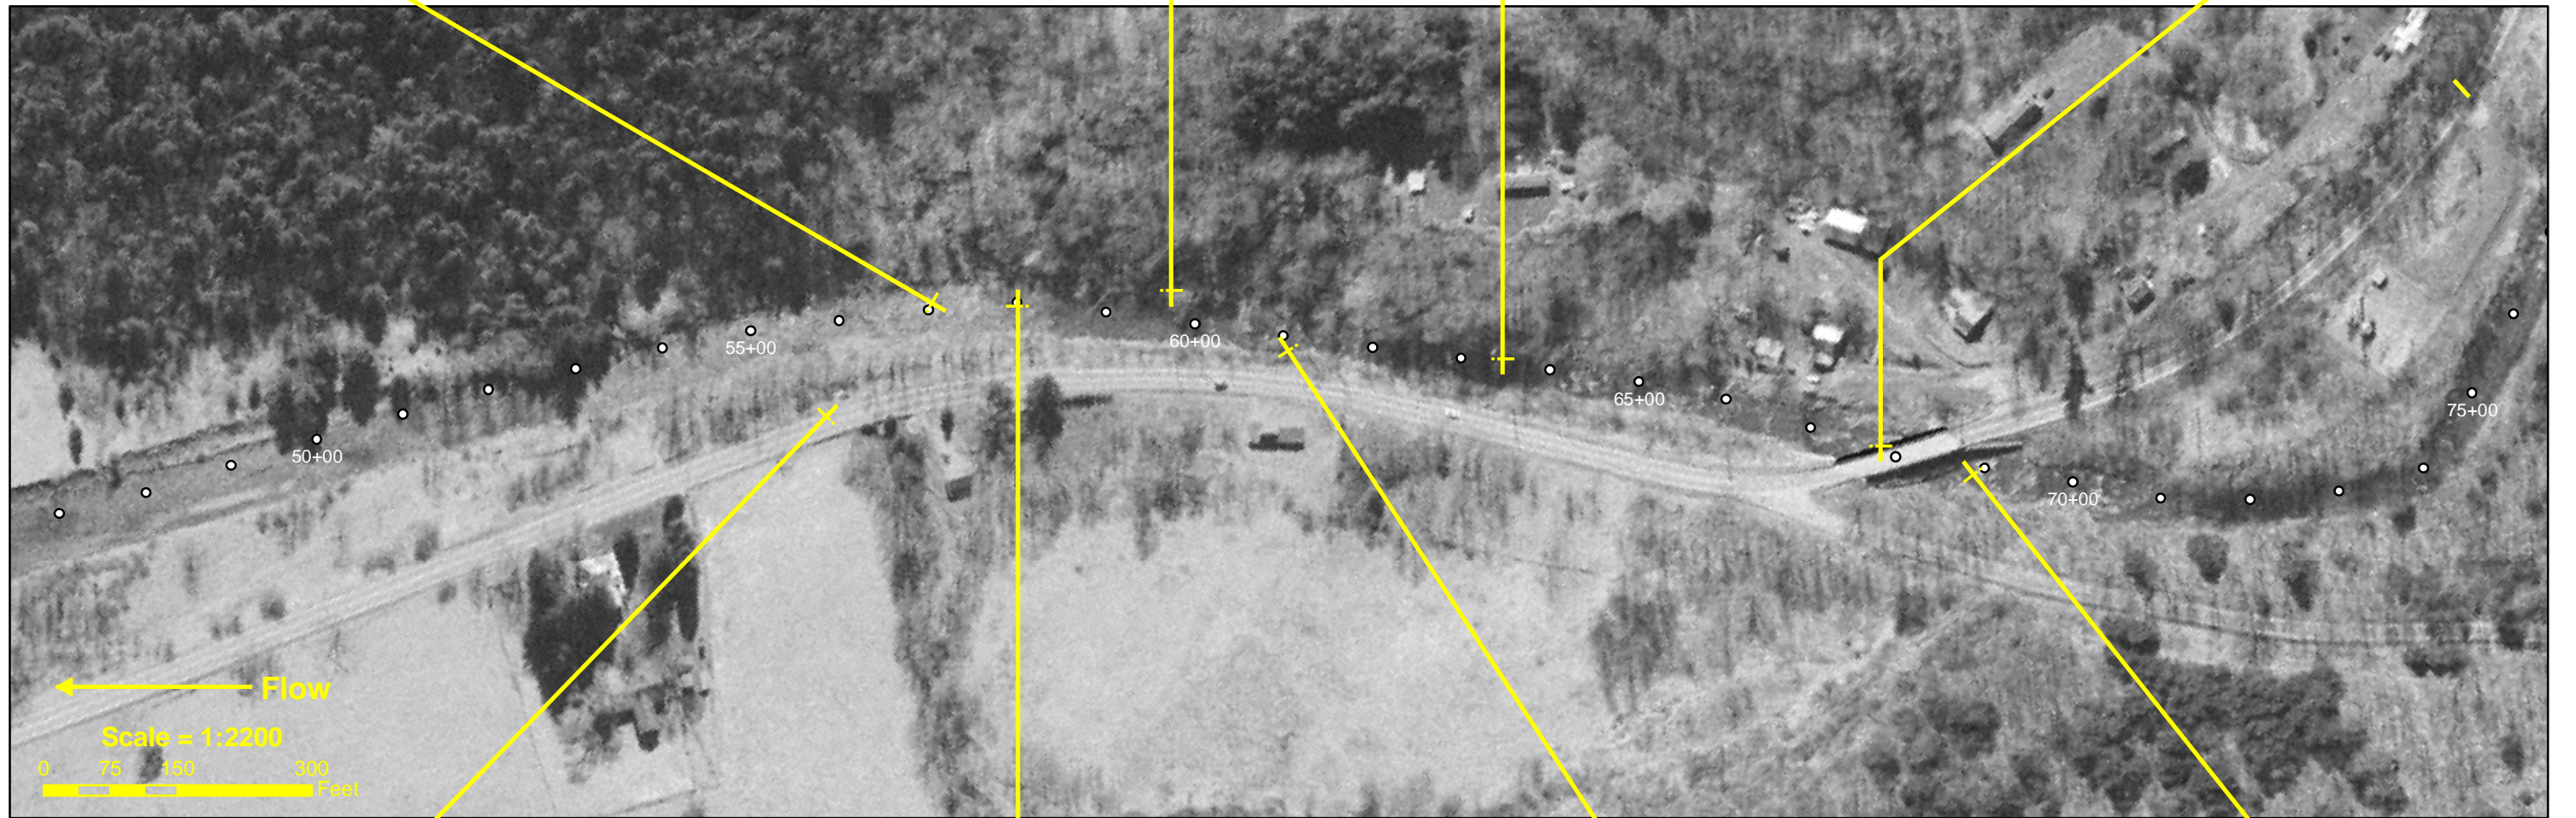
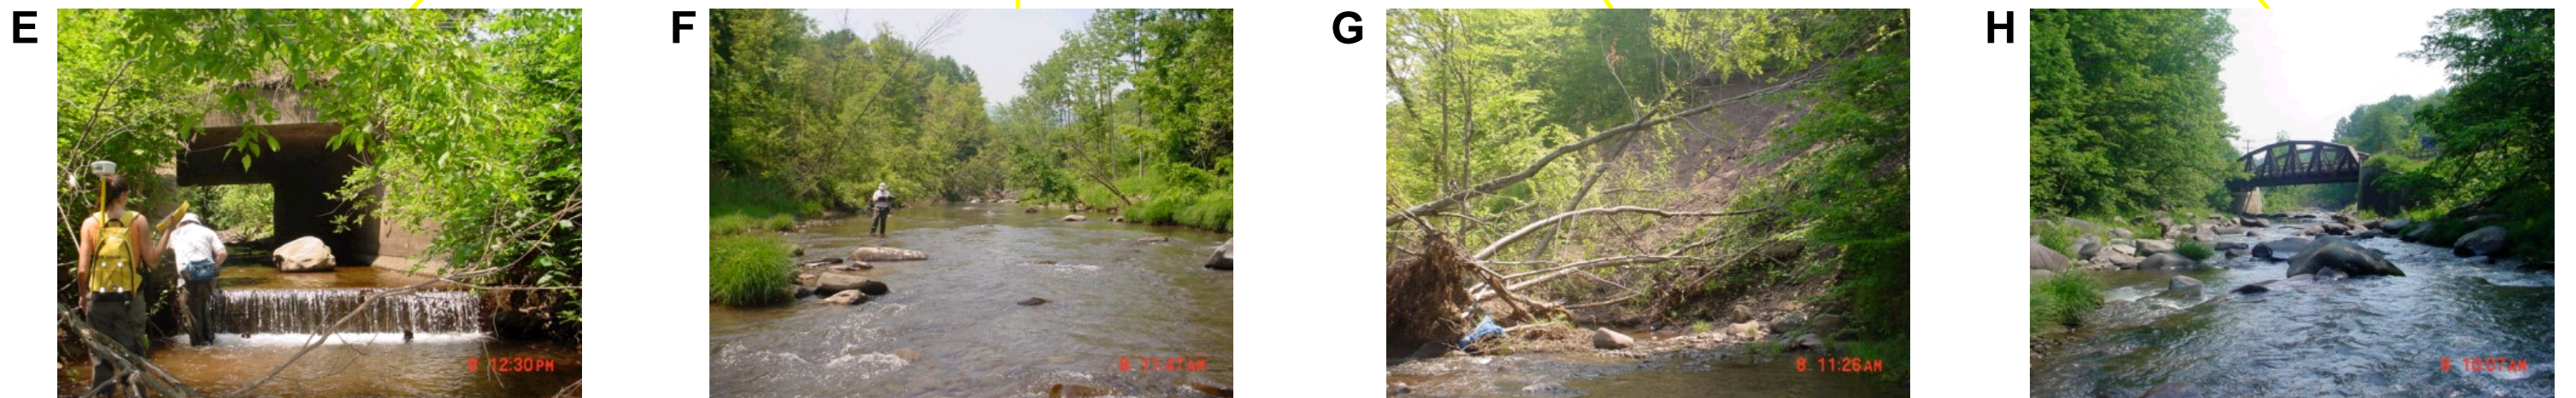
Figure 4.19.2 Management Unit 19 - 2004 aerial photography

The channel bed is armored with abundant boulders upstream, under and downstream of the NYS Route 42 bridge (#10252000) (see Inset H, Fig. 4.19.2). The abutments and concrete wingwalls are in good condition and despite the skewed angle of the crossing, the span appears sufficient to pass flood flows with little obstruction. There is some evidence of scour on the left and right abutments, and recent addition of dumped rip-rap scour protection on the right. This is the first evidence of possible channel incision in MU19.

Downstream of the bridge on the right, a residence sits adjacent to the channel on a terrace that confines the channel on the right (see Inset D, Figure 4.19.2). The lawn is mown to the edge of the bank. The terrace bank is covered with a mixture of disturbed herbaceous vegetation and dumped revetment comprised of rock riprap and construction debris. The owner of the residence reports channel incision.

downstream, aggradation of the bed was observed, likely the result of flow obstruction by a major debris jam comprised of abundant large woody material -- trees and rootballs -- introduced into the stream from large failing banks just downstream (See Insets C, G and B, Figure 4.19.2).

ranked High Priority, and in fact, is the highest priority site in the watershed. The *thalweg*, or deepest part of the stream channel flows up against the failing hillslope, which is being undermined by toe erosion, leaving large sections of the stream bank unvegetated. The hillslope, which has multiple scarps, is stratified, with numerous sand lenses exposed by the erosion through which groundwater piping was observed. These exposed *lodgement till* soils have a high silt and clay content, contributing sediment through both *wet and dry ravel* and yielding a significant suspended sediment and bed load during high flows. Clay inputs into a stream are a serious water quality concern because they increase *turbidity*, degrade fish habitat, and can act as a carrier for other pollutants and pathogens.

The conditions at this site present low potential for self-recovery. Full restoration of the site is recommended, necessarily preceded by a geotechnical assessment of the hillslope failure mechanisms. The restoration would likely involve installation of rock vanes to direct stream flows away from the banks, stabilization of at least the lower portion of the bank, and revegetation of the bank face. Because the instability problems at this site are related to sediment transport discontinuities
