# West Kill Management Unit 20

**Management Unit 20**  
Between Station 4778 and Station 2317

This management unit begins approximately 750 ft. downstream of the confluence of Roarback Brook, continuing approximately 2,461 ft., ending approximately 700 ft. upstream of the NYS Route 42 Bridge. The drainage area ranges from 30.7 mi<sup>2</sup> at the top of the management unit to 31.1 mi<sup>2</sup> at the bottom of the unit. The valley slope is 0.83%.

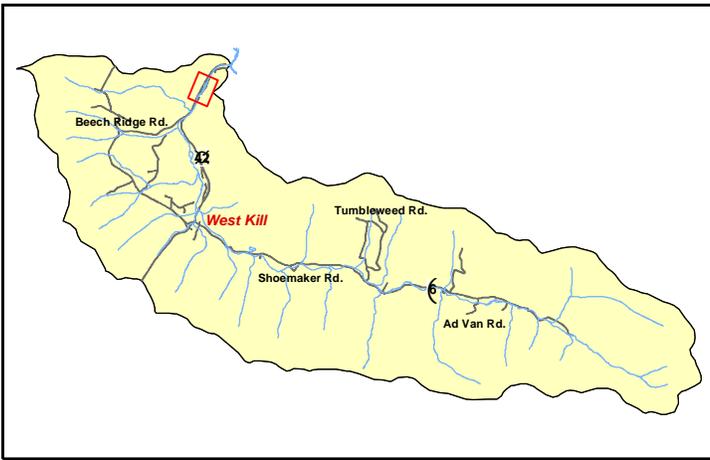
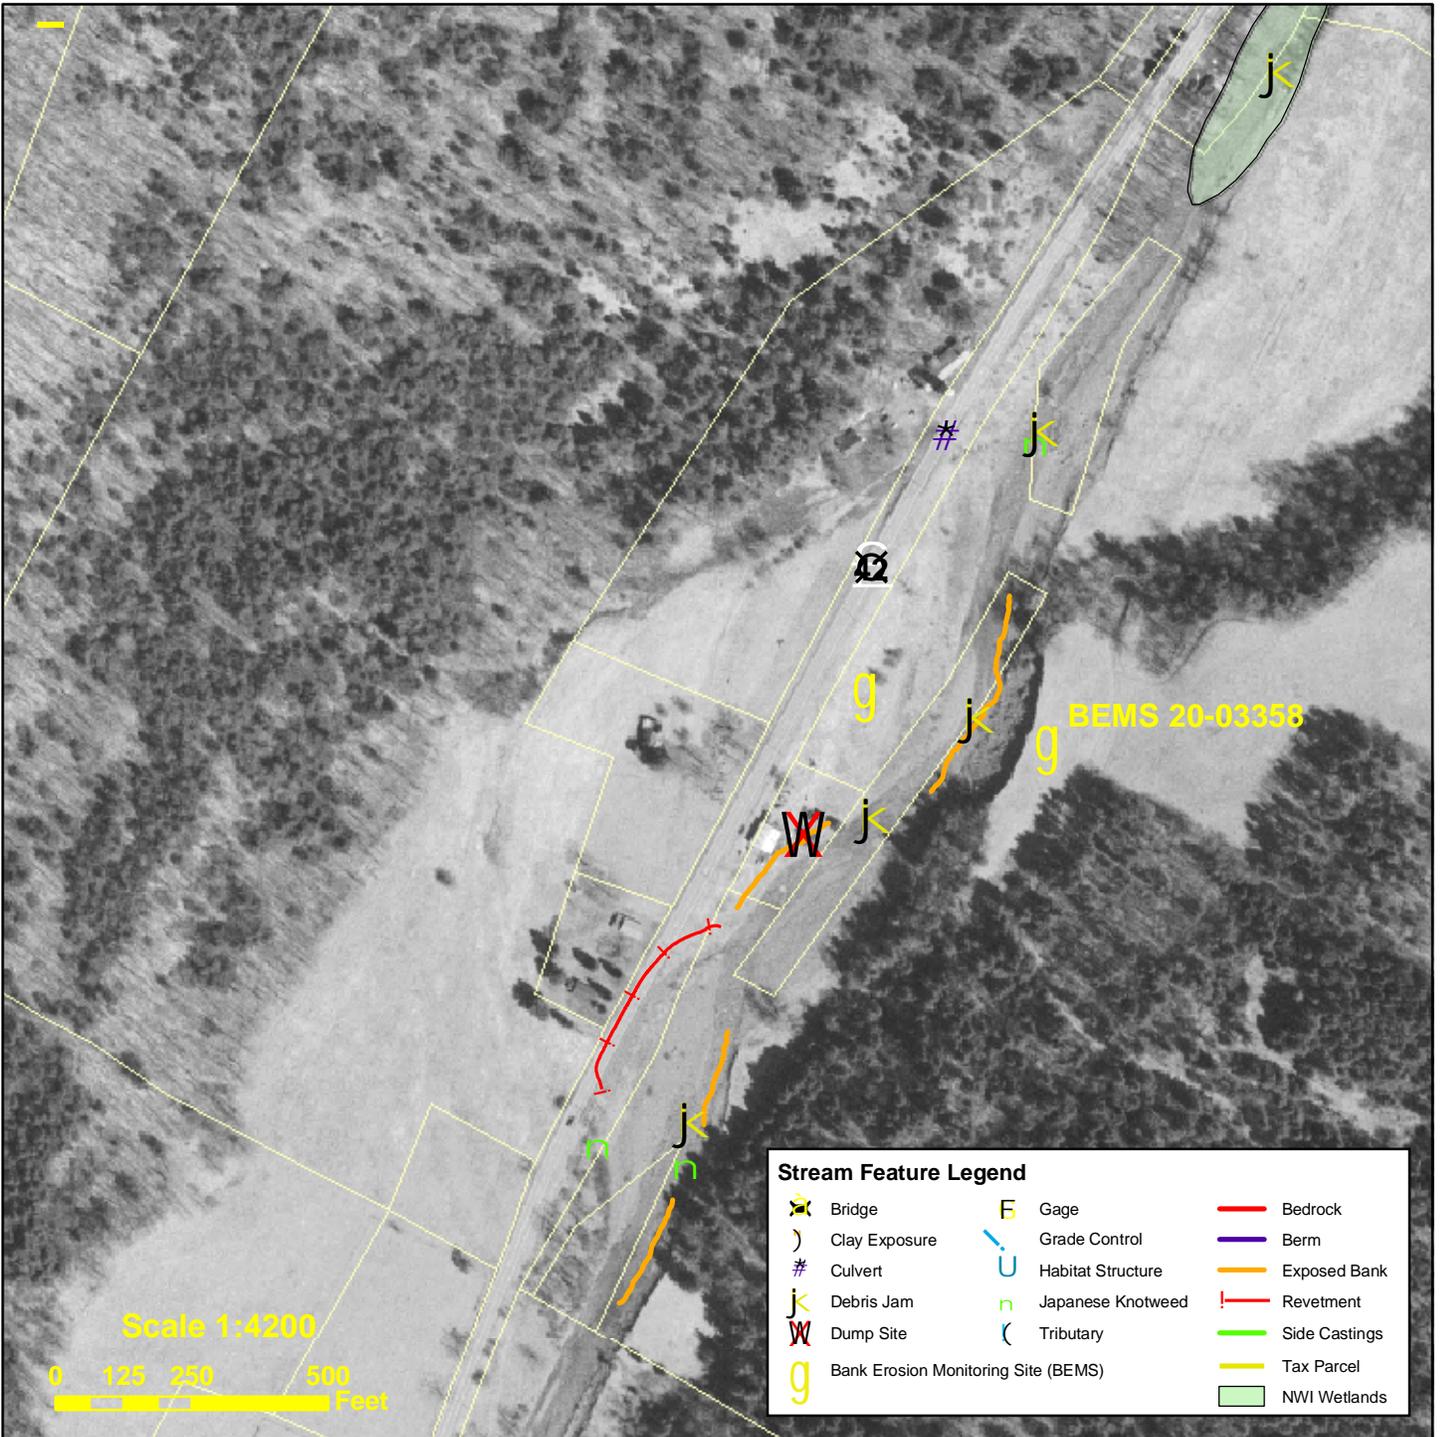
Figure 4.20.1 2004 aerial photography with stream feature inventory and tax parcels

43% of stream length is experiencing erosion  
 17% of stream length has been stabilized  
 20.9 acres of inadequate vegetation within the 300 ft. buffer  
 227 ft. of stream is within 50 ft. of the road  
 1 house located within the 100-year floodplain boundary

The 2004 stream feature inventory revealed that 43% (1055 ft.) of the stream exhibited signs of active erosion along 2461 ft. of total channel length (Fig. 4.20.1). Revetment has been installed on 17% (406 ft.) of the stream. No berms were identified in this management unit at the time of the stream feature inventory.

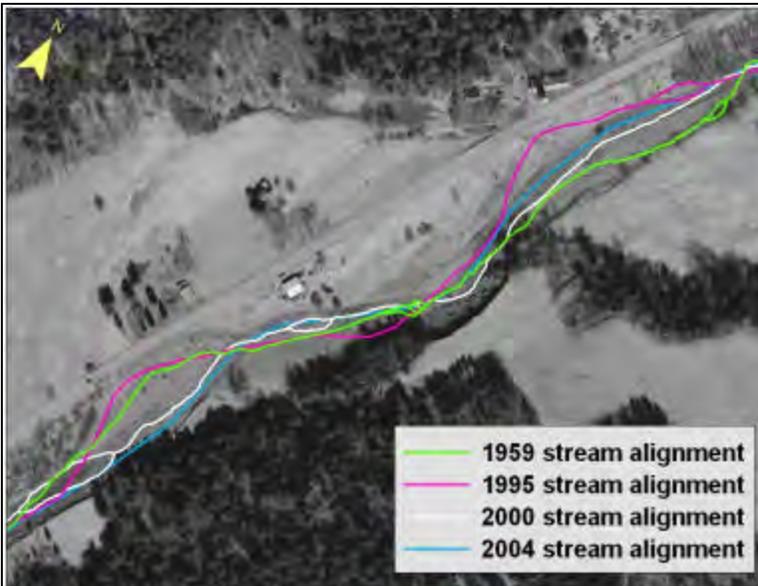
Historic Stream Channel Alignments in MU20

As seen from the historical stream alignments, the channel alignment has changed significantly over the years.

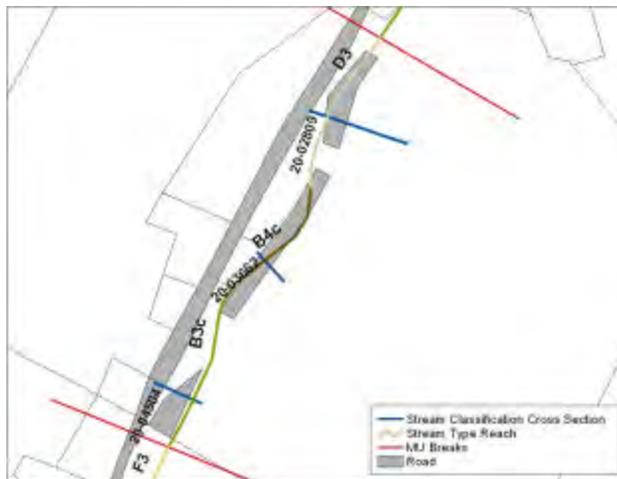
Cross-sections and Rosgen stream types in MU20

Management Unit #20 begins with a 828 ft. reach of B3c stream type, as documented by a monumented cross-section at Station 4504. The channel is moderately *entrenched*, or somewhat confined within the stream banks during high flood events. The bankfull channel width is nearly double that of the reach upstream, channel slope is a very flat 0.4 % and the bed material is dominated by cobble, but with abundant gravel.

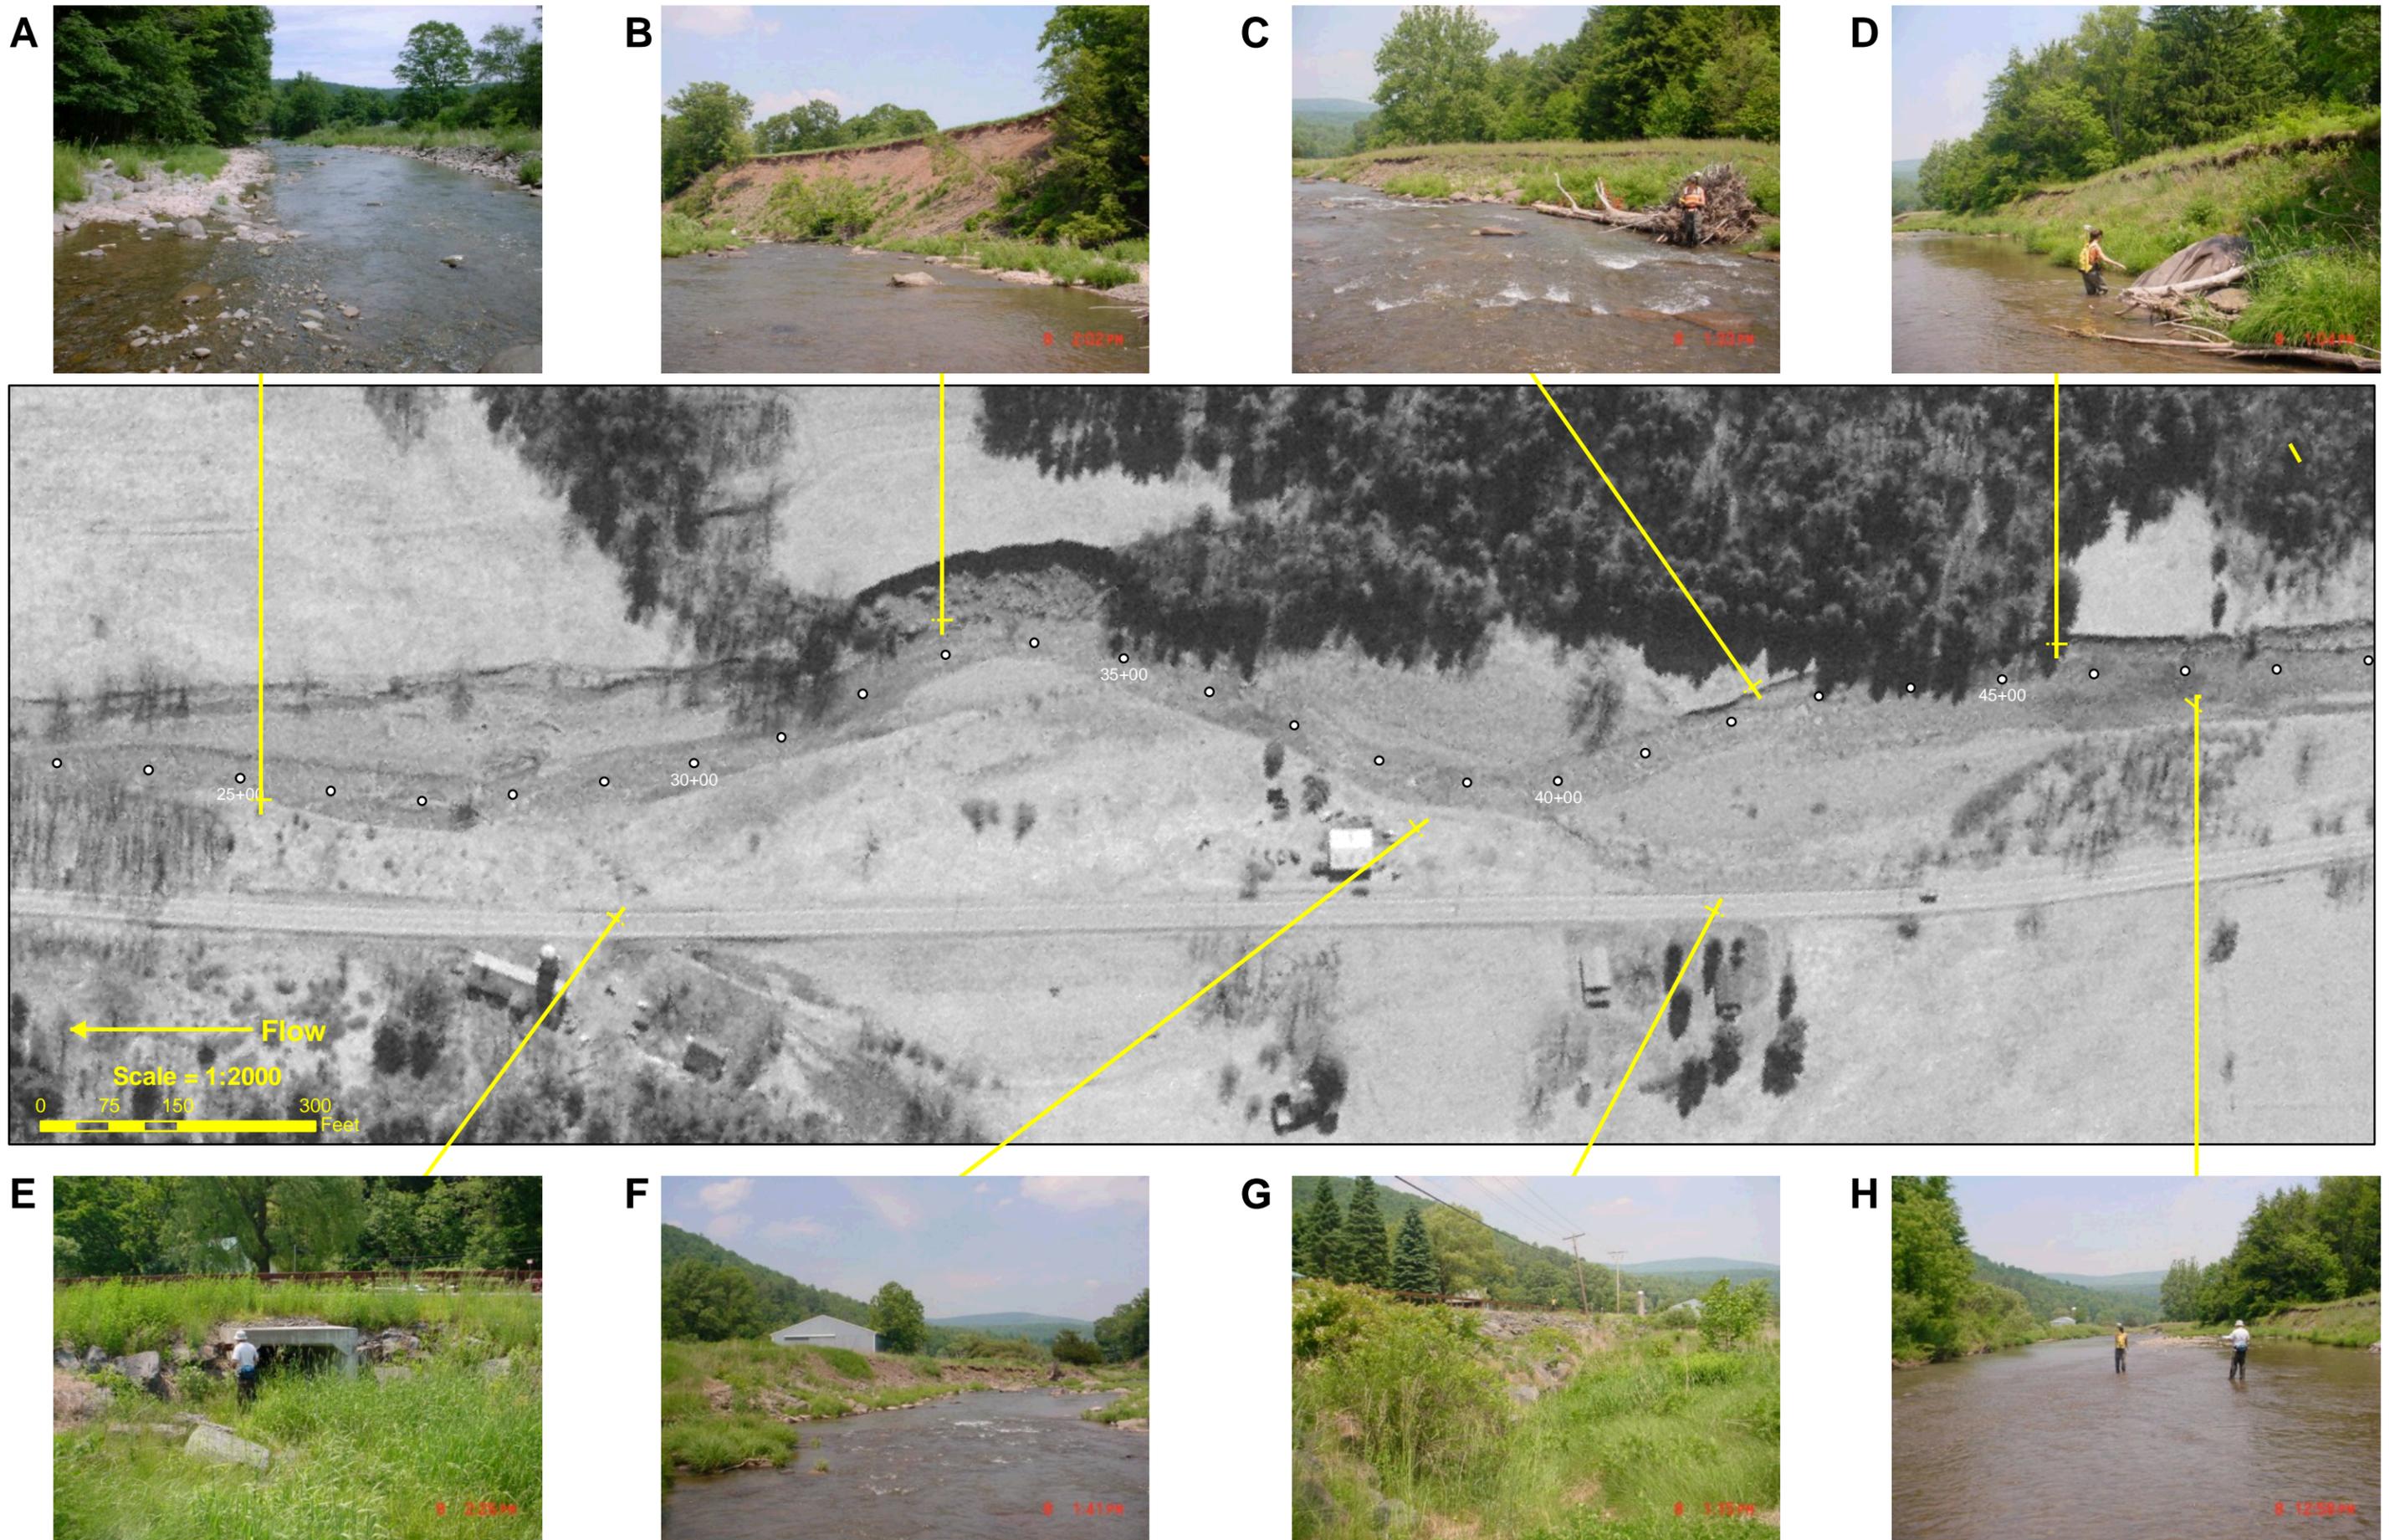
Figure 4.20.2 Management Unit 20 - 2004 aerial photography

As the valley opens up and the extreme entrenchment that characterized the previous management unit moderates, higher flows develop excessive access to the floodplain (see Inset H, Fig. 4.20.2). Overwide channels lose their ability to transport the stream's *bedload*. Under these conditions streams often *aggrade*, or rise in stream bed elevation due to the excessive deposition, as is seen here. As a result of this aggradation, the bankfull width of the channel doubles here, producing potential thermal impacts on

These aggradational conditions and poor riparian vegetation have led to erosion of 219 ft. of the alluvial terrace on the right through toe scour. Although there was some evidence of revegetation of the bank face, initial development of a point bar on the left indicates that the site may be trending to a more sinuous morphology (see Inset D, Fig. 4.20.2) in response to the aggradational conditions.

Across the channel, approximately 100 ft. of point bar and floodplain currently separate the active channel from the NYS Route 42 road embankment (Inset G, Fig. 4.20.2), which is protected by 406 ft. of dumped rip rap, in good condition. While a narrow band of the floodplain adjacent to the rip-rap is now well-vegetated, historic aerial photography indicates that the channel flowed against the road here before the 1996 flood.

As the channel crosses over to flow against the alluvial terrace on the left, another 240 ft. length of erosion, again caused by toe scour, has exposed a formerly buried dumpsite in the floodplain (see Inset F, Fig. 4.20.2). The refuse appears to be old farm machinery and garbage, and should be removed.

As the channel flows up against the glacial terrace on the right bank (Inset B, Fig. 4.20.2) a high, 415 ft. section of erosion has been monumented as a Bank Erosion Monitoring Site (BEMS Station 20-3358). In a prioritization of twenty-one BEMS sites throughout the West Kill watershed (see Section 3.3, Watershed Inventory and Assessment), this site was ranked High Priority. The *thalweg*, or deepest part of the stream channel flows up against the high hillslope, which is stratified with multiple sand and silt layers, and is being undermined by toe

erosion, leaving most of the stream bank unvegetated. The exposed *lodgement till* soils have a high silt and clay content, contributing sediment through both *wet and dry ravel* and yielding a significant suspended sediment load during high flows. Clay inputs into a stream are a serious water quality concern because they increase *turbidity*, degrade fish habitat, and can act as a carrier for other pollutants and pathogens. Large mature trees continue to be introduced into the channel at the toe of the slope, as the failure enlarges upstream and downstream. The amount of sediment introduced here – including a substantial volume of fine gravel– as well as the obstruction caused by the woody debris, has produced aggradation at the downstream end of the failure, inducing lateral flow.

Full restoration is recommended for this site. This would likely involve establishment of a well-vegetated bench on the right with rock vanes to direct stream flows away from the bank, regrading and then revegetation of the bank face, and establishment of channel geometry throughout the unit to more effectively convey the sediment load.
