# West Kill Management Unit 21

## Stream Feature Statistics

## Management Unit 21

Between Station 2317 and Station 0

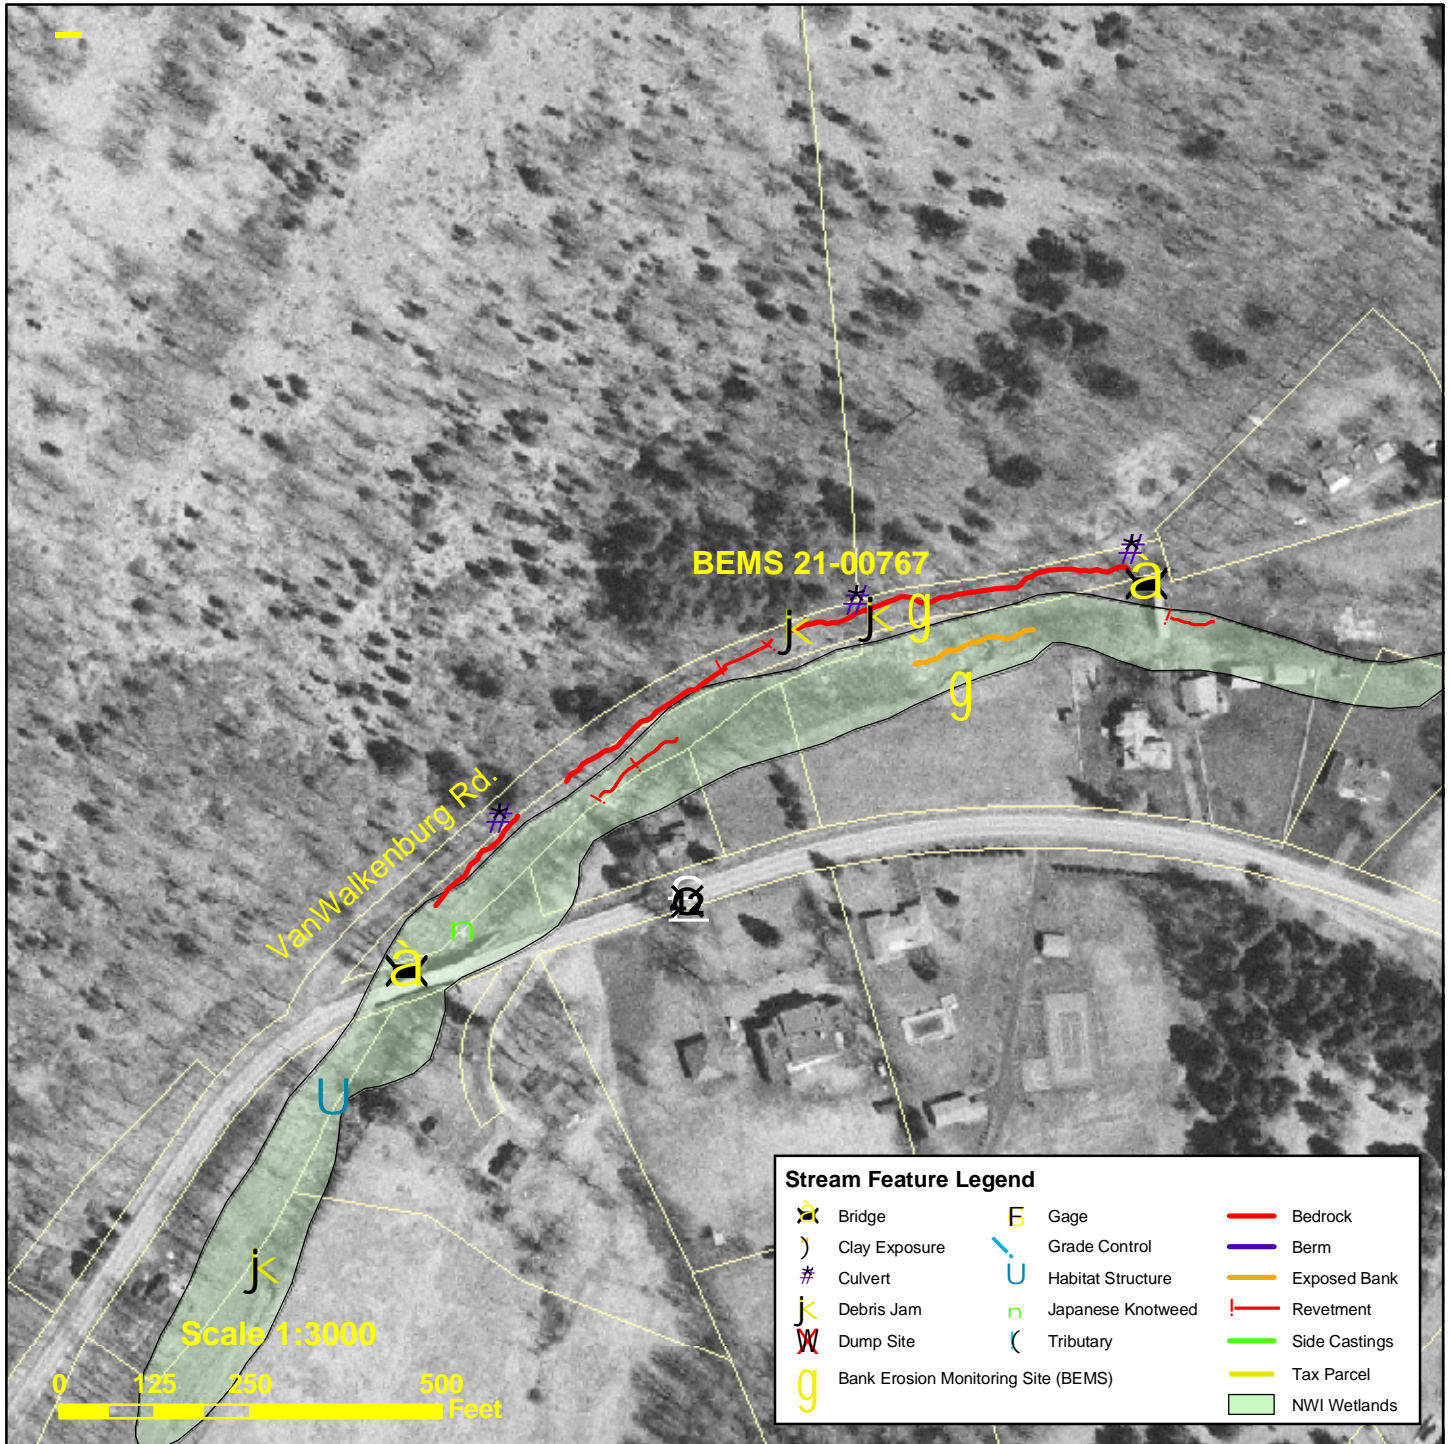
Figure 4.21.1 2004 aerial photography with stream feature inventory and tax parcels

The 2004 stream feature inventory revealed that 7% (168 ft.) of the stream exhibited signs of active erosion along 2317 ft. of total channel length (Fig. 4.21.1). Revetment has been installed on 12% (271 ft.) of the stream. No berms were identified in this management unit at the time of the stream feature inventory.

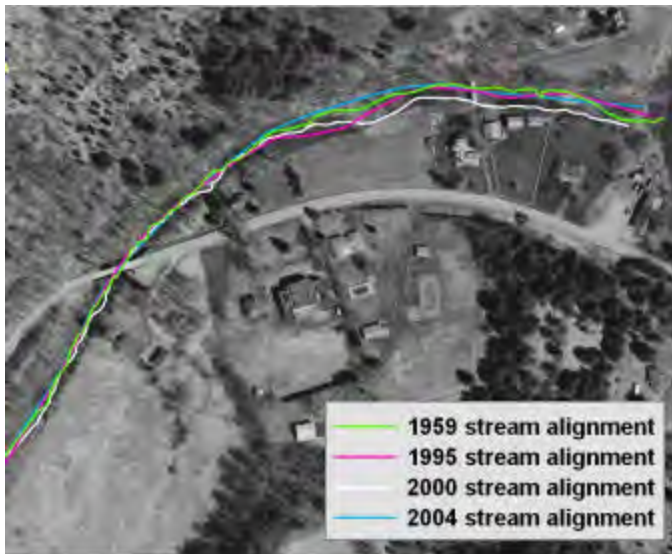
Historic Stream Channel Alignments in MU21

As seen from the historical stream alignments, the channel alignment has not changed significantly over the years.

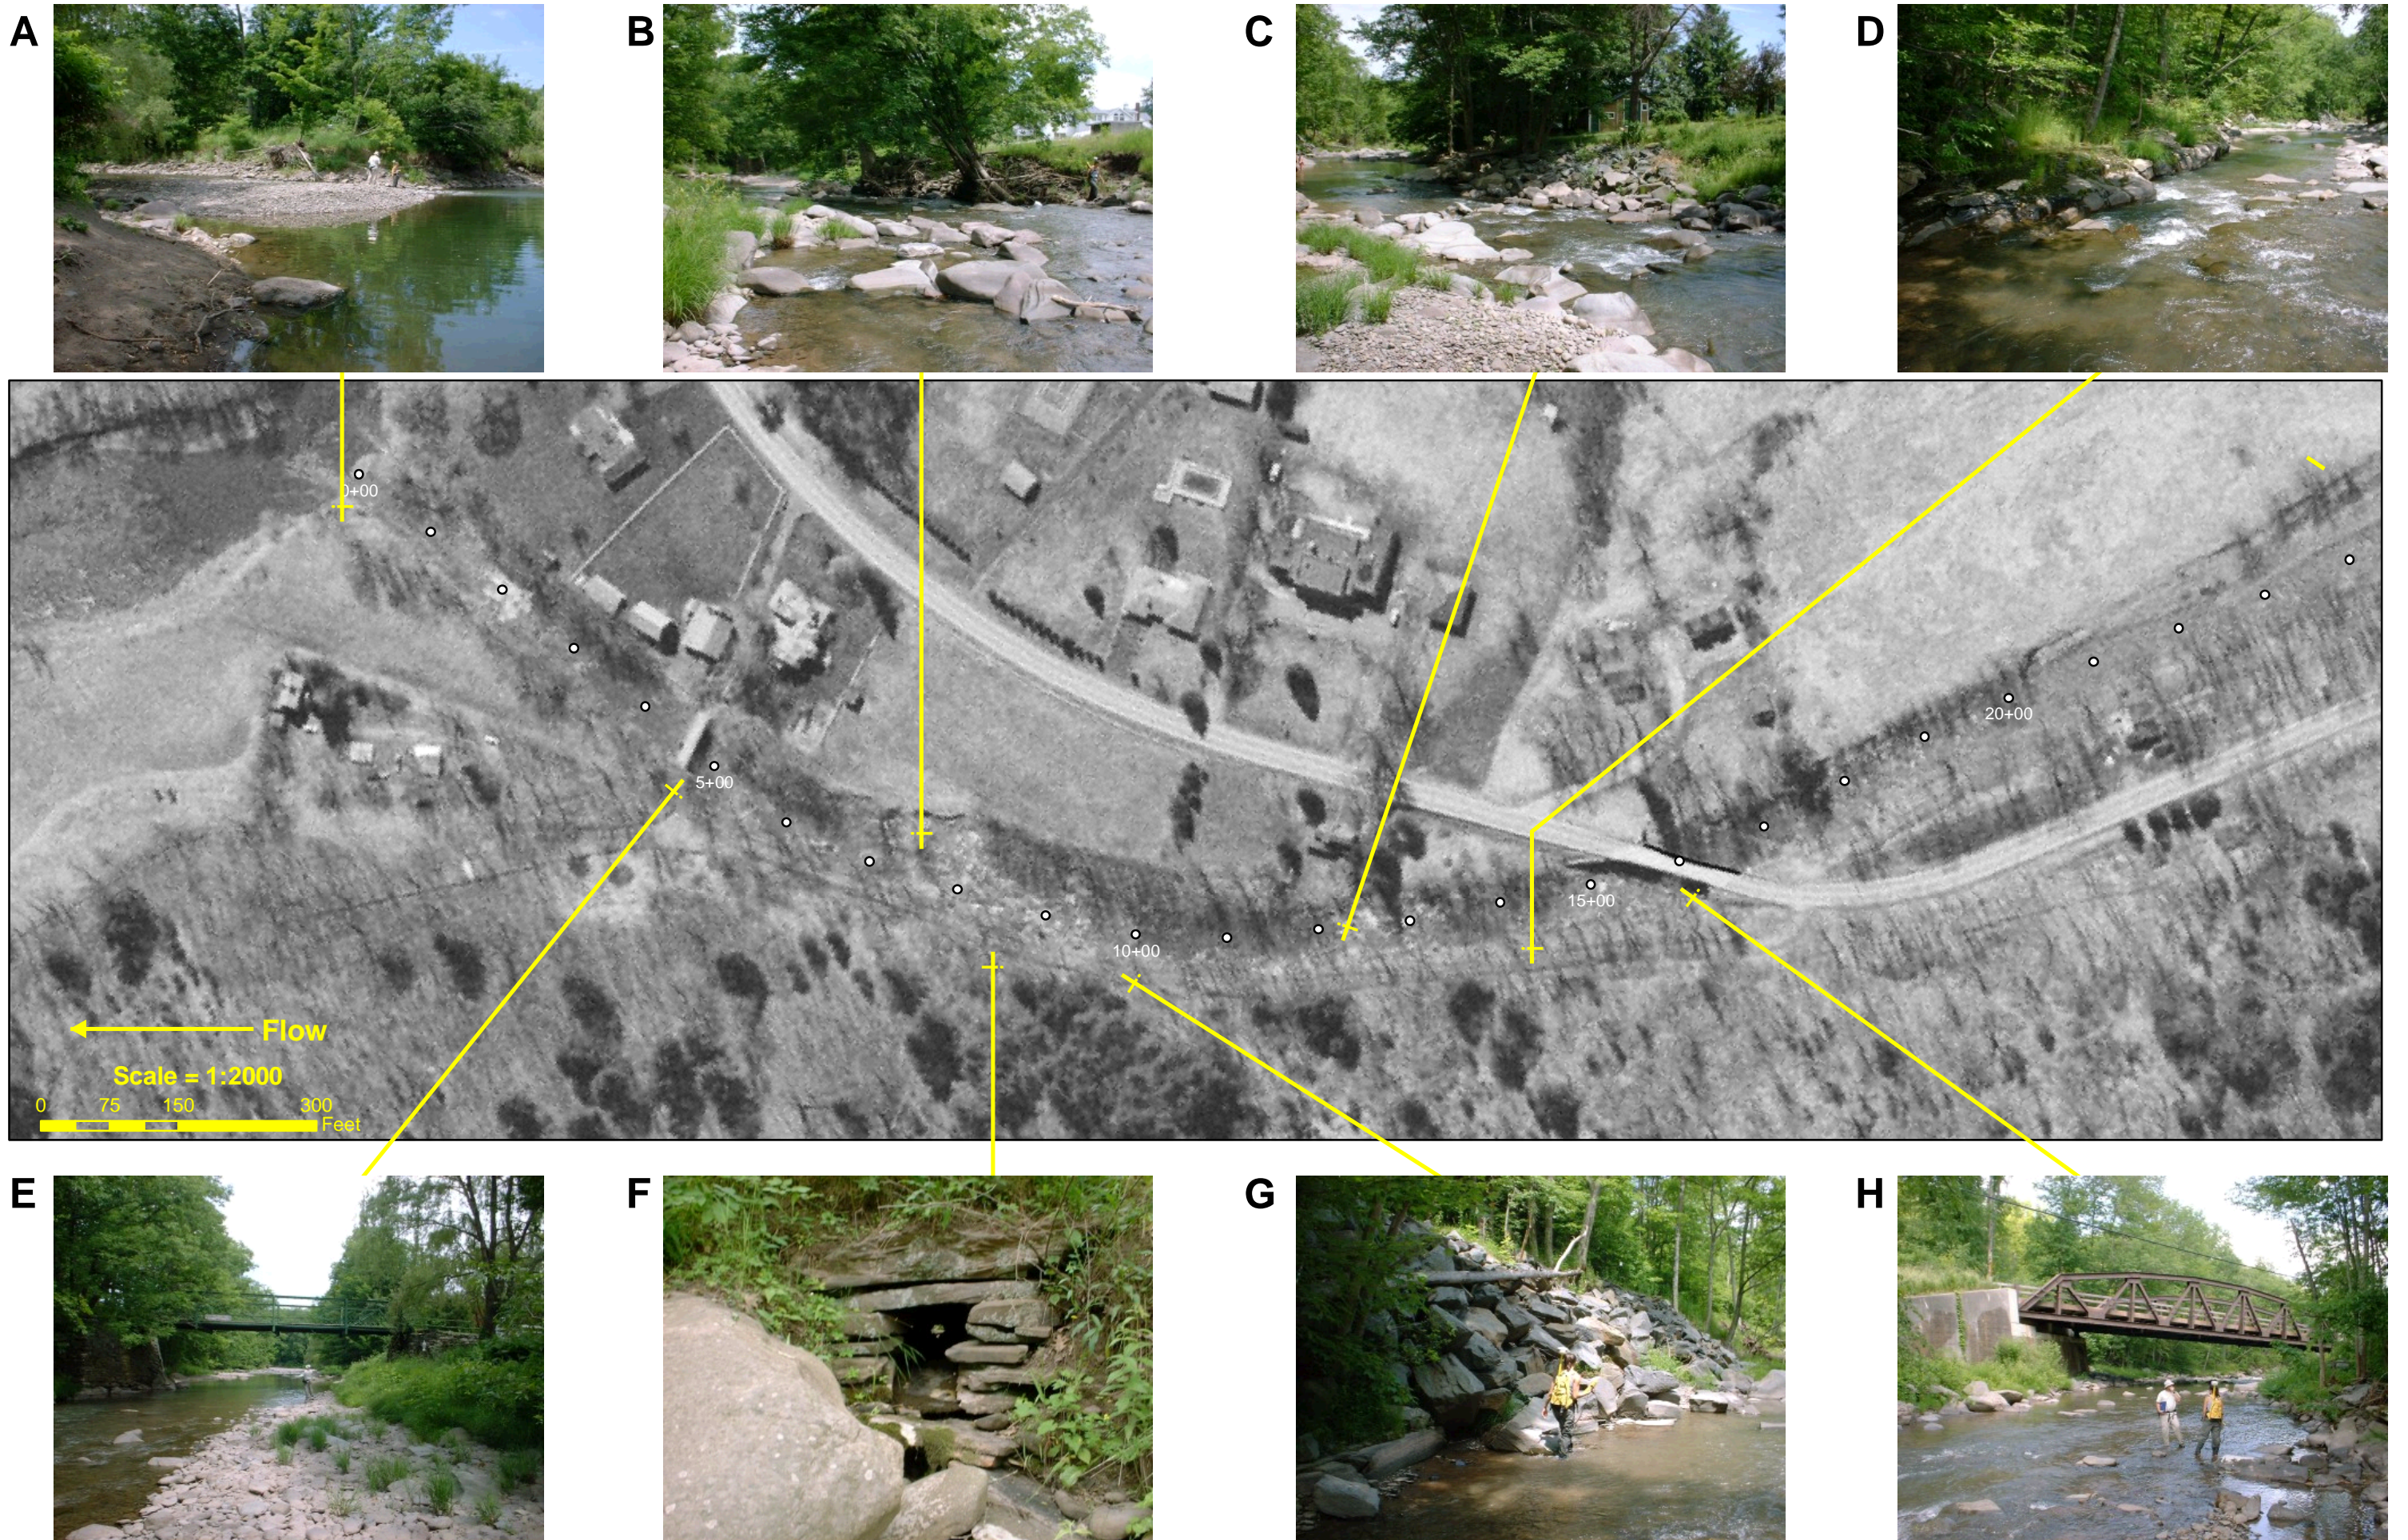
Figure 4.21.2 Management Unit 21 - 2004 aerial photography

Approaching the NYS Route 42 bridge, which crosses the stream at an oblique angle, the channel material becomes finer, and the entrenchment increases (Inset H, Fig.4.21.2).

Downstream of the bridge, the channel is turned abruptly by the valley wall. Stacked rock on the left ties the abutment into a bedrock ledge exposed on the bank and left half of the bed (Inset D, Fig. 4.21.2). This bedrock controls the grade to some degree both upstream and downstream in the

Across the channel, 135 ft. of rip-rap protects a low bank with a residential lawn beyond it, mowed to the edge of the stream (see Inset C, Fig. 4.21.2). The rip-rap also serves as outfall protection for a drainage swale that carries stormwater runoff from across the highway. In addition to exposed bedrock on the left channel bed and bank, abundant large native boulders throughout the channel mitigate bed scour.

dominated by cobble, but due to the protection provided by abundant boulders and bedrock, the erosional power of large flows is displaced onto the streambanks. On the left, the dirt road embankment has washed out, and a 76 ft. section of dumped rip-rap was recently installed (Inset G, Fig. 4.21.2). The toe of this rip-rap has begun to fail, threatening the installation. Recommendations here include stabilization of the toe of the slope. If bedrock prevents the keying-in of the base of the rip-rap below the channel grade, then stacking rock revetment at least up to bankfull elevation is recommended. This will also reduce both the embankment slope and the narrowing of the channel.

An old, hand-stacked rock culvert carries upslope stormwater drainage under the dirt road and, slightly perched, outfalls onto stacked outfall protection on the dirt road embankment (Inset F, Fig.4.21.2).

Opposite and downstream of the debris jam on the left, a 168 ft. section of the bank is eroding at the edge of a mowed field at Bay Bridge Farm (Inset B, Fig. 4.21.2). At the upstream end of the erosion, the bank is well-vegetated with young trees, but the base of the slope begins to show signs of scour around Station 850. As the mature vegetation transitions to open field adjacent to the stream, erosion of the right bank has been monumented as a Bank Erosion Monitoring Site (BEMS 21-00767).

Assisted Self-recovery is recommended for this site. Minor changes in the bed and bank could significantly shift erosive forces off the bank and eliminate the headcut. The toe of the bank should be protected with larger rock and a low bench should be established with plantings of sedge and willows. The bank and a buffer in the field adjacent to the stream should be replanted with ecologically appropriate trees and shrubs.
