**Project Design Report
R.A. Hill Stables Demonstration Project
West Kill Creek**

**December 31, 2006
Prepared by Mark Vian¹ and Joel Dubois²**

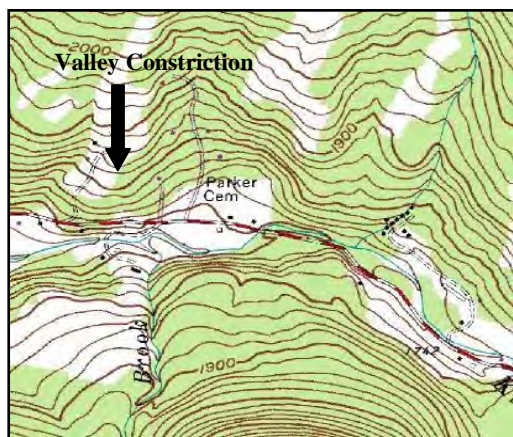
Excerpt of 1980 USGS topographic map

Several characteristics of the site contribute to chronic stream function problems. The bridge crossing to the stable complex on the terrace, left, is located at a pinch point in the valley morphology, and the bridge abutments further confine high flows. Both the left bank here upstream of the bridge, and the bed under the bridge, are exposed bedrock. The high right bank and left terrace just downstream of the bridge, however, are comprised largely of glacial till. Scour downstream of the bridge chronically erodes both banks.

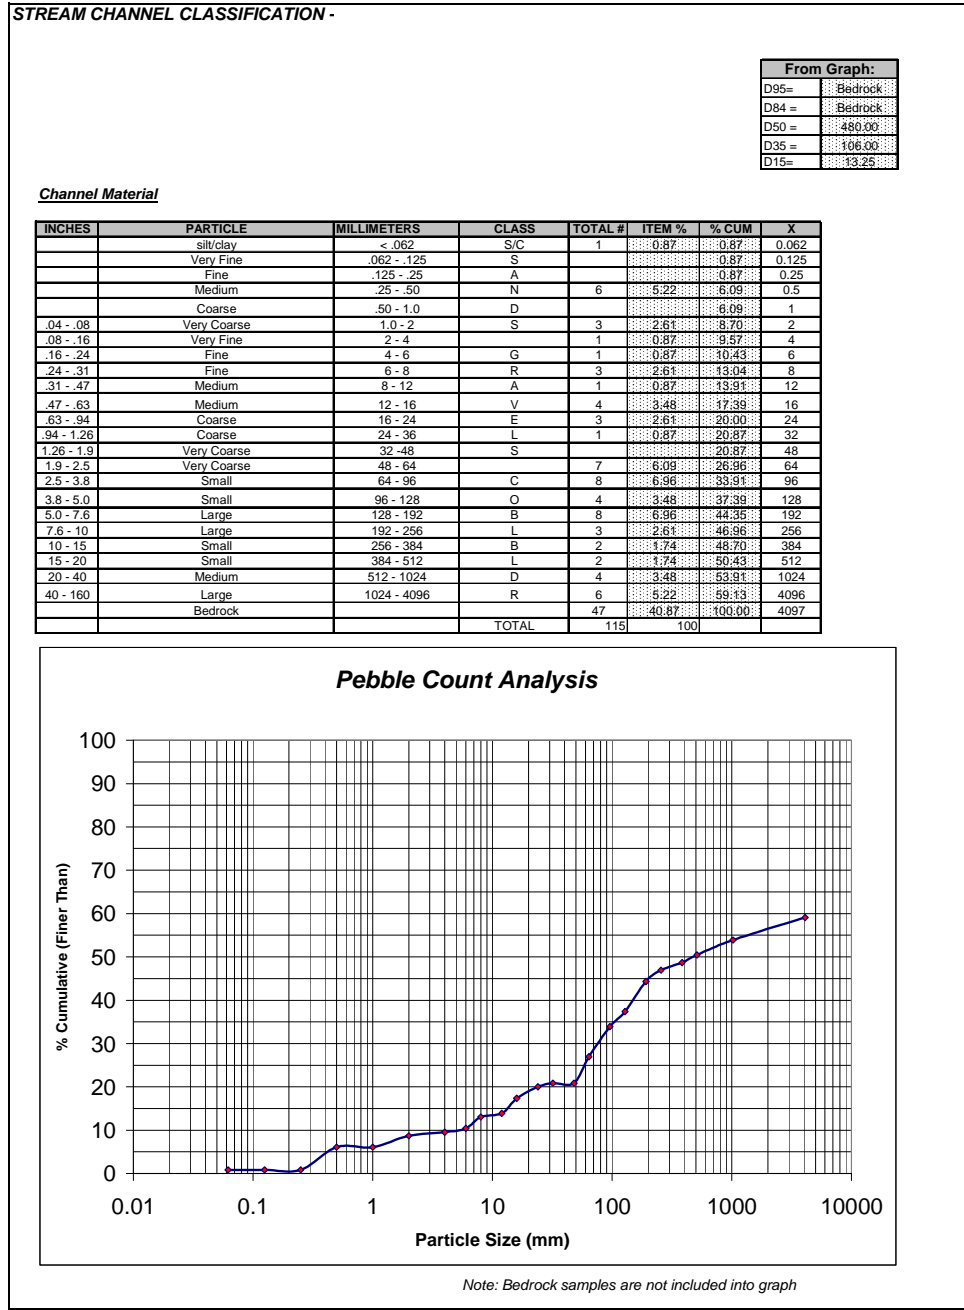
Bed material characterization, classification XS10-20, at the project site, prior to construction.

The statistics presented in the table above the chart for XS10-20 include the bedrock sampled during the pebble count. In the entrainment analysis below, we use the statistics for only the mobile portion of the bed material. Thus the D84 of the mobile portion is approximately the D50 (480mm) of the full count, and the D50 of the mobile portion is approximately the D30 (74mm) of the total count.
