# Neversink River East Branch

## MANAGEMENT UNIT 10

EAST BRANCH MANAGEMENT UNIT 10  
BETWEEN STATION 40080 AND STATION 34900

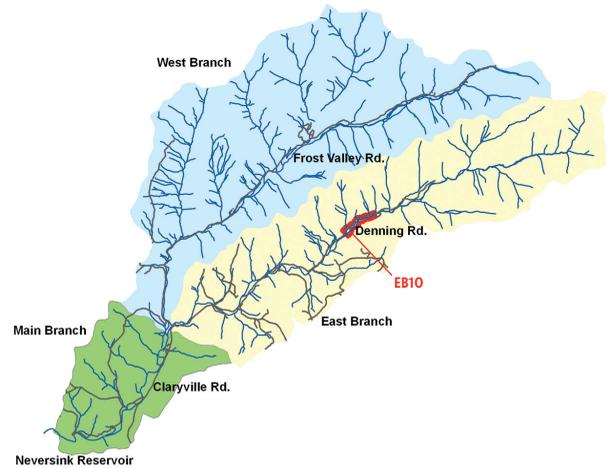
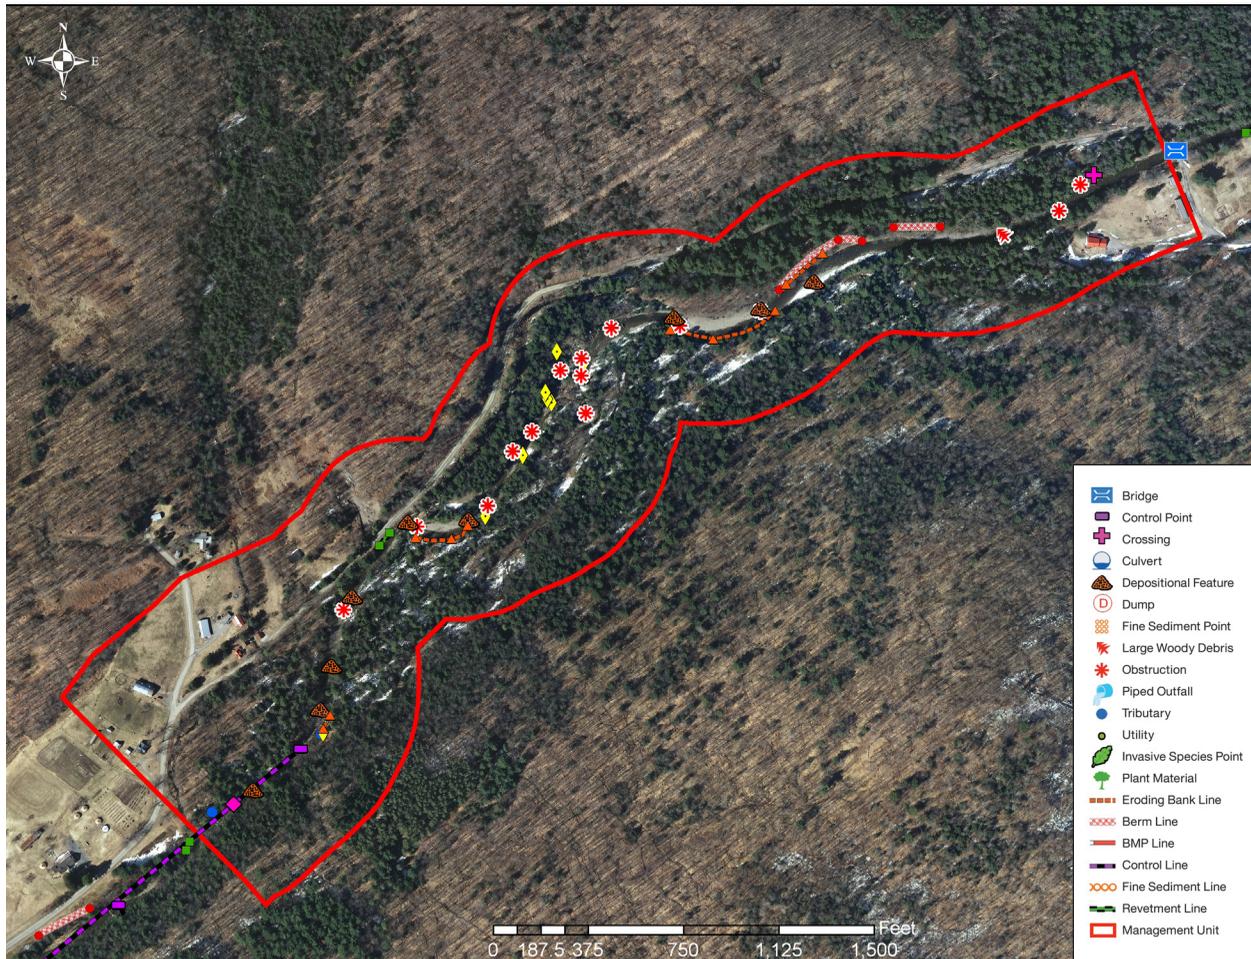
Stream Feature Inventory 2010 (Figure 1)

- 9 % of stream length is experiencing erosion
- 0.62 % of stream length has been stabilized
- 17.21 acres of inadequate vegetation within the riparian buffer
- 250 feet of the stream length is within 50 ft. of the road
- One structure is located within the 100-year floodplain boundary
