Neversink River East Branch

MANAGEMENT UNIT 11

EAST BRANCH MANAGEMENT UNIT 11
BETWEEN STATION 42200 AND STATION 40110

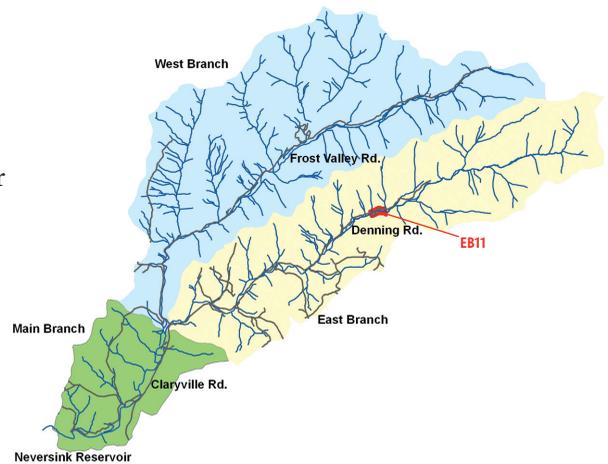
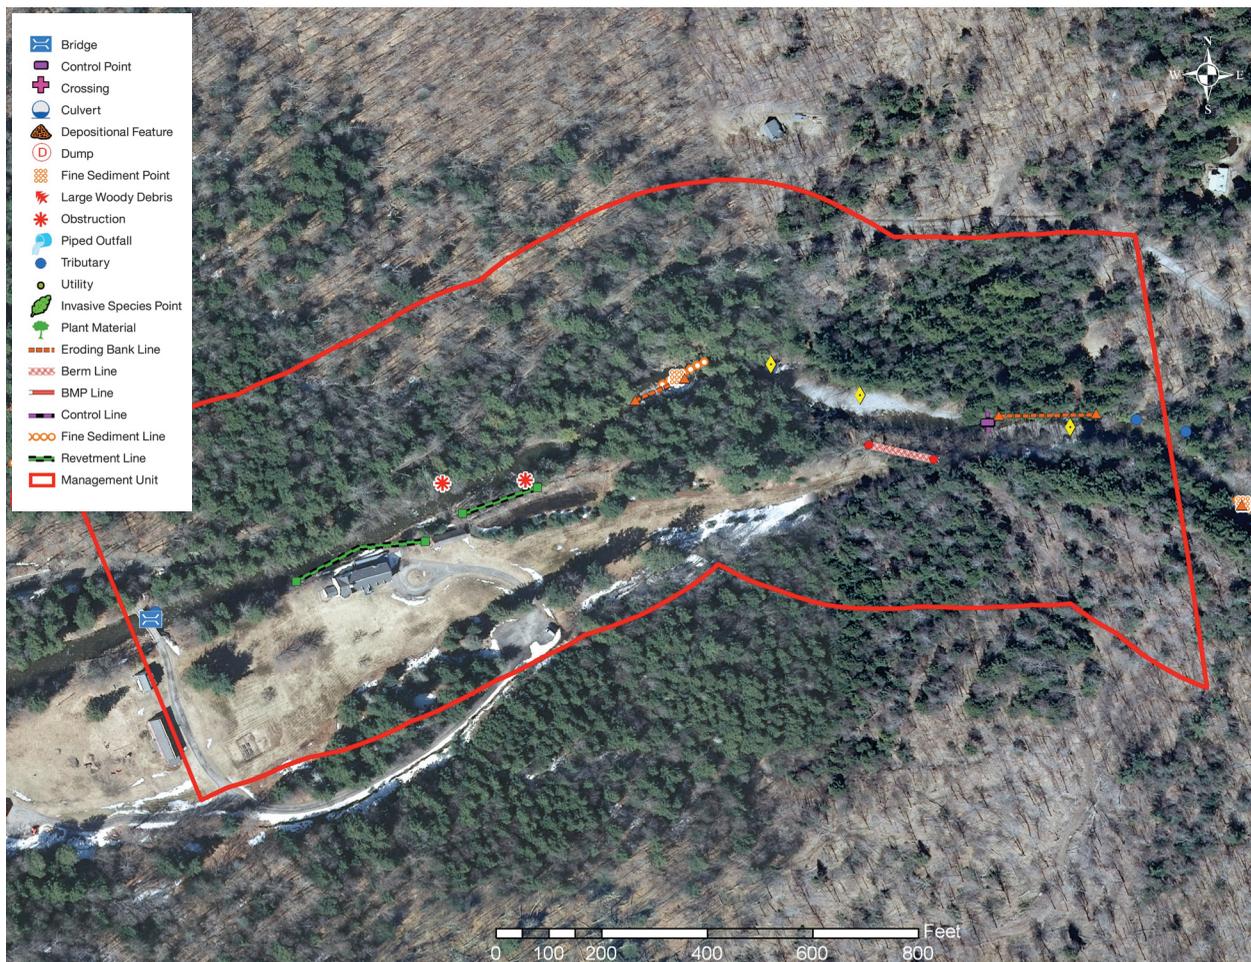
Stream Feature Inventory 2010 (Figure 1)

- 7 % of stream length is experiencing erosion
- 9.63 % of stream length has been stabilized
- 7.28 acres of inadequate vegetation within the 100 ft. buffer
- None of the stream length is within 50 ft. of the road
- Two structures are located within the 100-year floodplain boundary

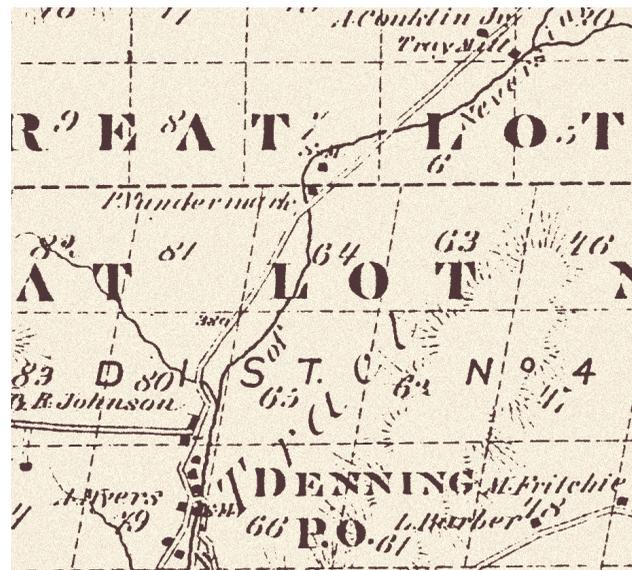
Excerpt from 1875 Beers Map (Figure 2)

The 1875 Beers Atlas of this area indicates that by that time, the stream had been harnessed for manufacturing, primarily saw mills, woodworking shops and tanneries (Figure 2). Raceways were built in the floodplains to divert water to ponds for use as needed. Floodplains were profoundly altered in the process, as these watercourses also became areas of preferential channelized flow when floodwaters inundated the floodplains. When woody debris jams blocked the primary channels, these raceways sometimes eroded out to become major secondary channels, or even took over the full flow to become a new primary watercourse.
