Neversink River East Branch

MANAGEMENT UNIT 13

EAST BRANCH MANAGEMENT UNIT 13
BETWEEN STATION 46900 AND STATION 50100

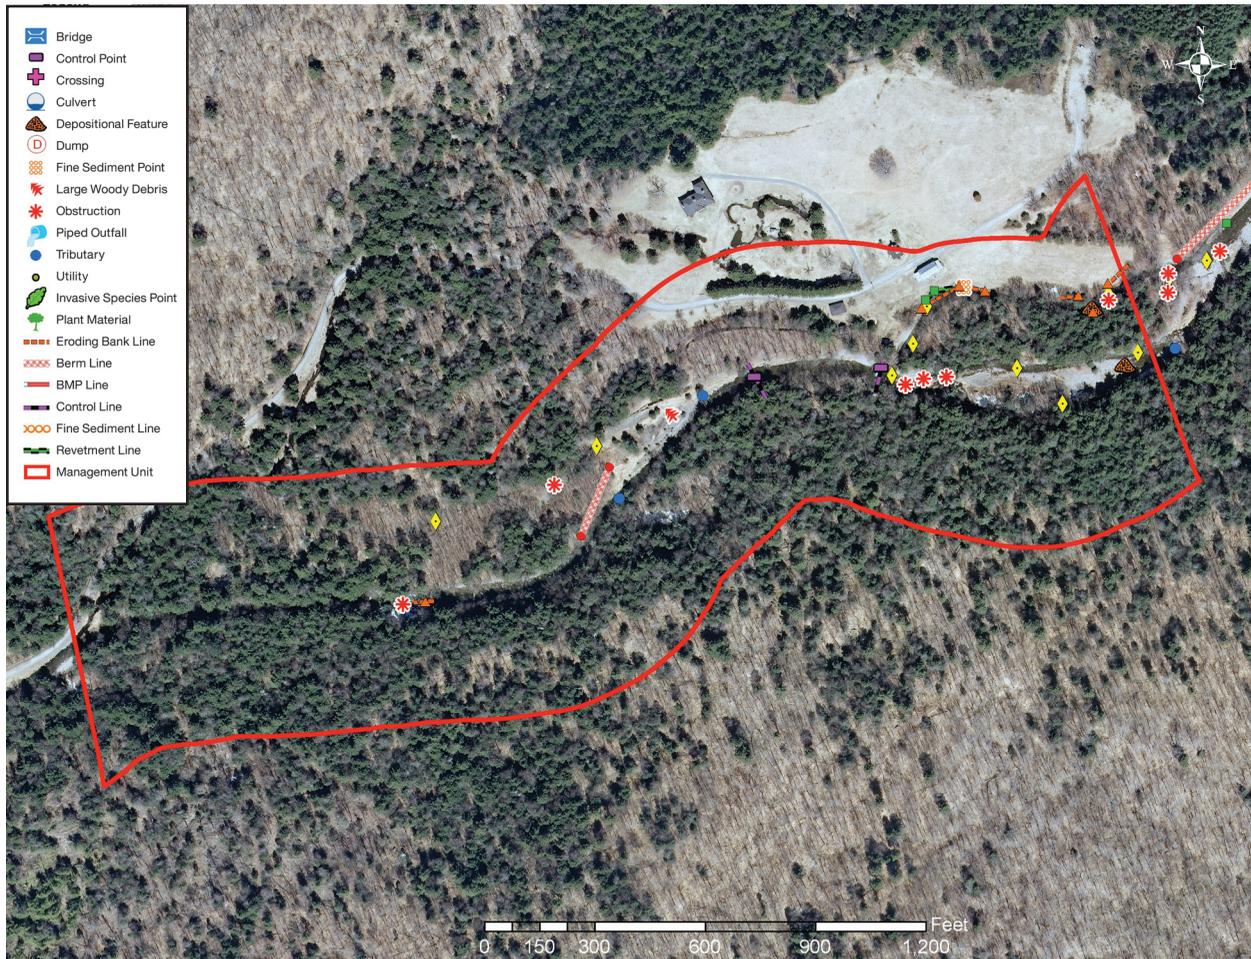
Stream Feature Inventory 2010 (Figure 1)

- 6 % of stream length is experiencing erosion
- 1.63 % of stream length has been stabilized
- 7.23 acres of inadequate vegetation within the riparian buffer
- None of stream is within 50 ft. of the road
- No houses are located within the 100-year floodplain boundary

Intervention Level	<p>Assisted restoration of the bank erosion site between Station 46900 and Station 46850. (BEMS NEB13_46800) (continues from EBMU14)</p> <p>Assisted restoration of the bank erosion site between Station 46790 and Station 46750. (BEMS NEB13_46700)</p> <p>Assisted restoration of the bank erosion site between Station 46500 and Station 46310. (BEMS NEB13_46300)</p> <p>Passive restoration of the bank erosion site between Station 44630 and Station 44590. (BEMS NEB13_44500)</p>
Stream Morphology	<p>Assess sediment deposition resulting from the accumulation of large woody debris supplied by the watershed upstream.</p> <p>Conduct baseline survey of channel morphology.</p>
Riparian Vegetation	None.
Infrastructure	None.
Aquatic Habitat	Fish population and habitat survey.
Flood Related Threats	None.
Water Quality	None.
Further Assessment	Long-term monitoring of erosion sites.

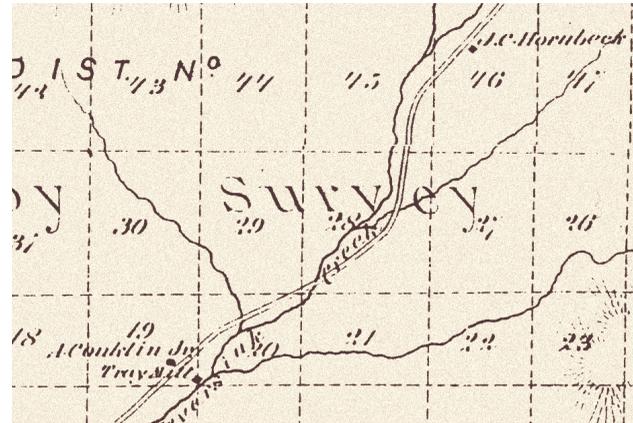
Excerpt from 1875 Beers Map (Figure 2)

The 1875 Beers Atlas of this area indicates that by that time, the stream had been harnessed for manufacturing, primarily saw mills, woodworking shops and tanneries (*Figure 2*).
