Neversink River Main Branch

MANAGEMENT UNIT 10

MAIN BRANCH MANAGEMENT UNIT 10
BETWEEN STATION 1100 AND STATION 100

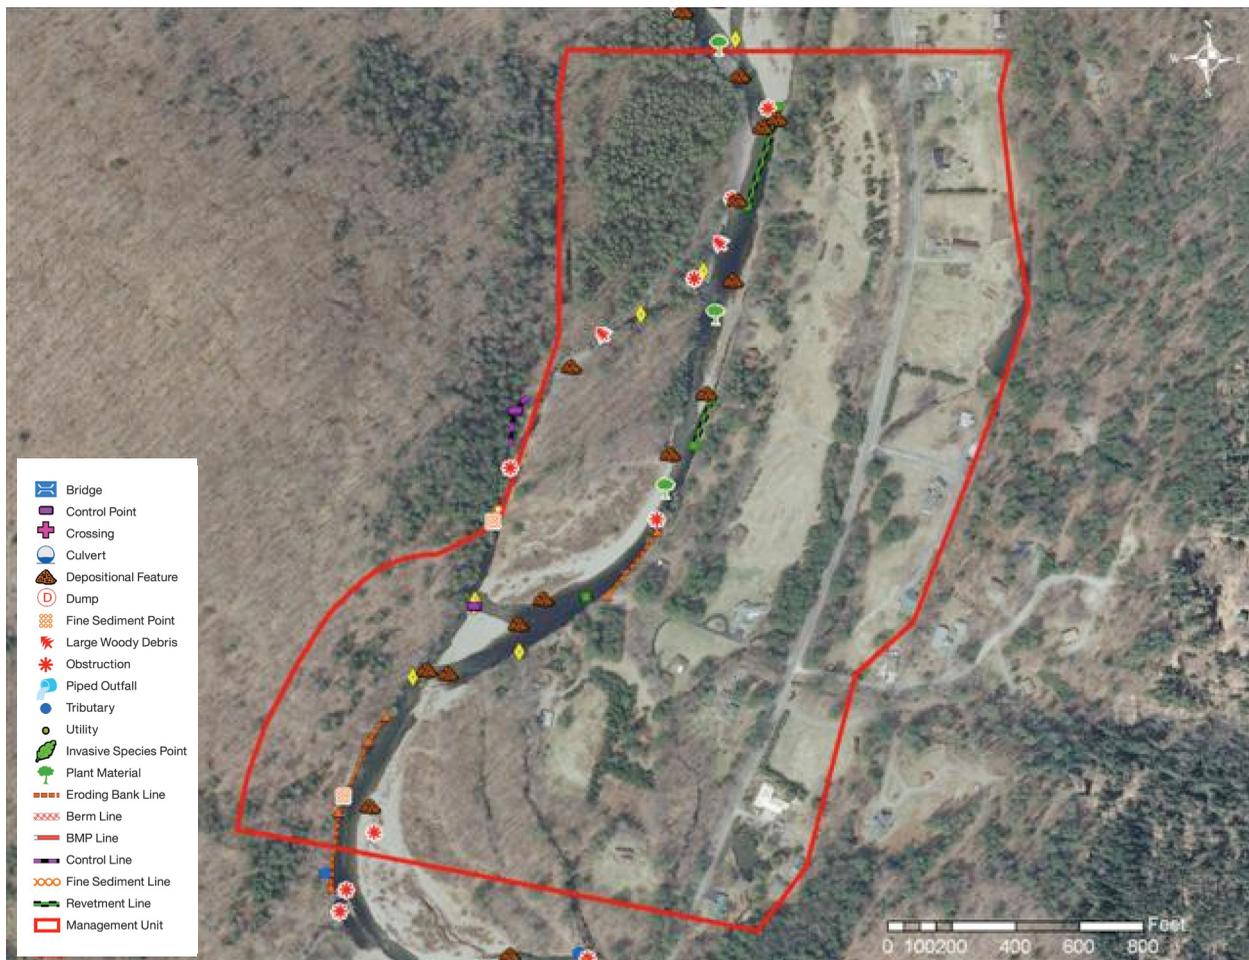
Stream Feature Inventory 2010 (Figure 1)

- 11 % of stream length is experiencing erosion
- 8.42 % of stream length has been stabilized
- 0.15 acres of inadequate vegetation within the 100 ft. buffer
- 0 ft. of stream is within 50 ft. of the road
- 4 structures located within the 100-year floodplain boundary

Intervention Level	Assisted restoration of the bank erosion site between Station 28080 and Station 28020. Passive restoration of the bank erosion between Station 27220 and Station 26680.
Stream Morphology	Protect and maintain sediment storage capacity and floodplain connectivity. Conduct baseline survey of channel morphology.
Riparian Vegetation	Improve riparian buffer from: Station 28900 to Station 28020; 28080 to Station 28020.
Infrastructure	None.
Aquatic Habitat	Fish population and habitat survey.
Flood Related Threats	Flood proofing as appropriate. http://www.fema.gov/library/viewRecord.do?id=1420
Water Quality	Maintain household septic systems.
Further Assessment	Long-term monitoring of erosion sites.
