Neversink River Main Branch

MANAGEMENT UNIT 6

MAIN BRANCH MANAGEMENT UNIT 6
BETWEEN STATION 17200 AND STATION 14800

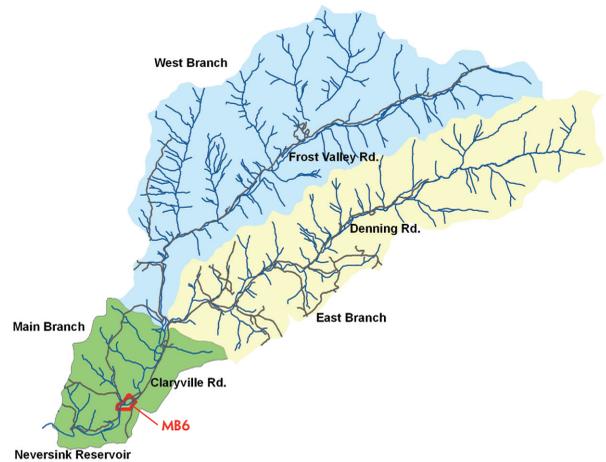
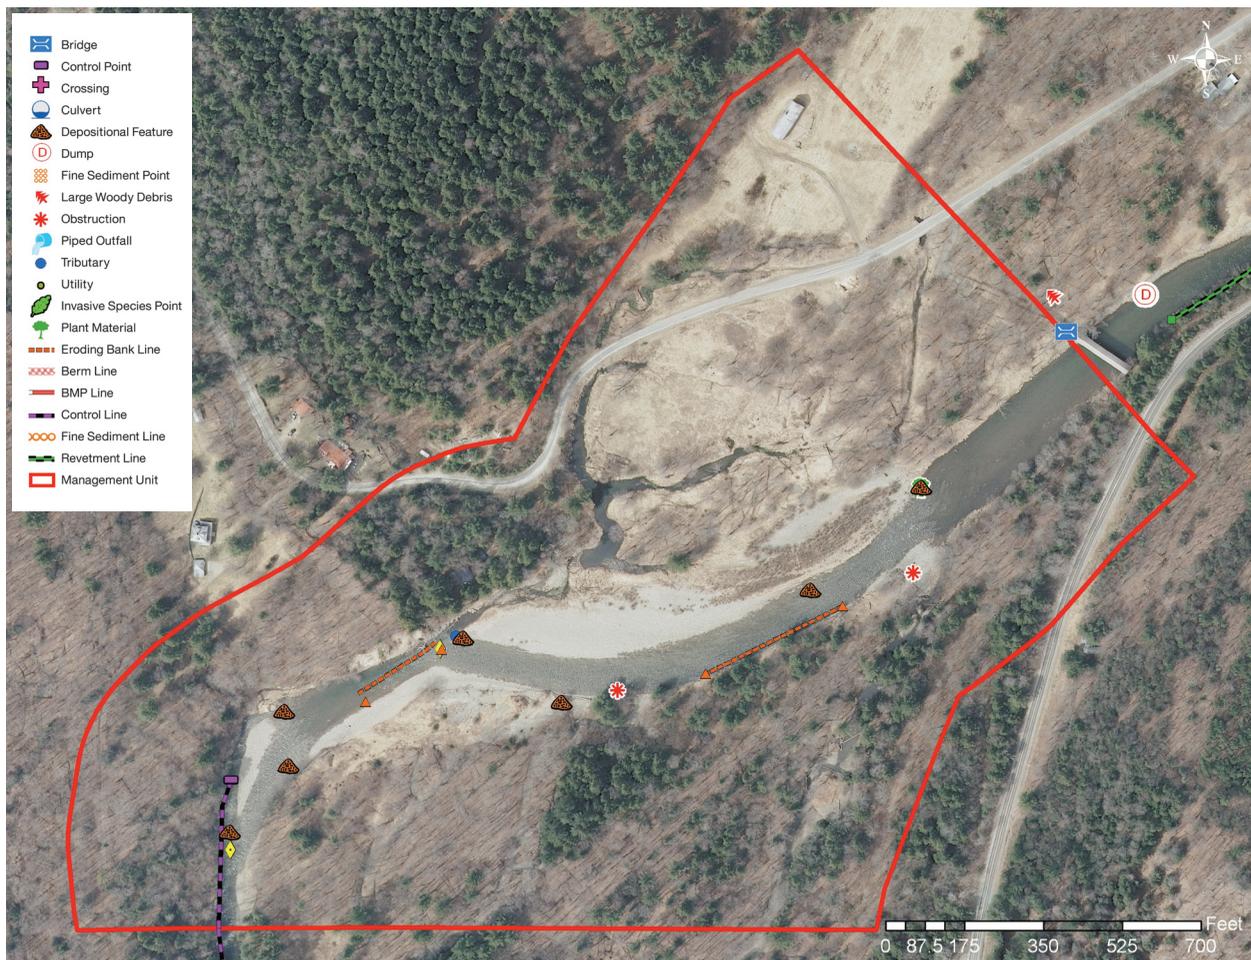
Stream Feature Inventory 2010 (Figure 1)

- 15% of stream length is experiencing erosion
- 16.09% of stream length has been stabilized
- 13.76 acres of inadequate vegetation within the 100 ft. buffer
- None of stream is within 50 ft. of the road
- There are no structures located within the 100-year floodplain boundary

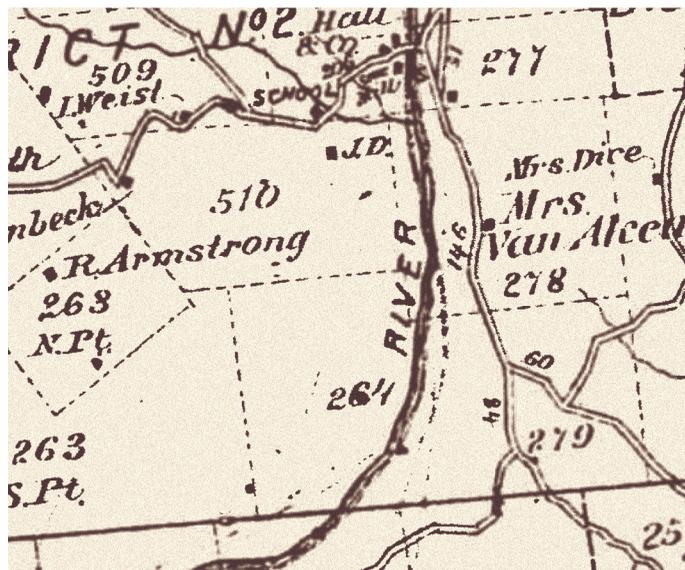
Excerpt from 1875 Beers Map (Figure 2)

The 1875 Beers Atlas of this area indicates that by that time, the stream had been harnessed for manufacturing, primarily saw mills, woodworking shops and tanneries (Figure 2). Raceways were built in the floodplains to divert water to ponds for use as needed. Floodplains were profoundly altered in the process, as these watercourses also became areas of preferential channelized flow when floodwaters inundated the floodplains. When woody debris jams blocked the primary channels, these raceways sometimes eroded out to become major secondary channels, or even took over the full flow to become a new primary watercourse.
