Neversink River West Branch

MANAGEMENT UNIT 10

WEST BRANCH MANAGEMENT UNIT 10
BETWEEN STATION 34300 AND STATION 40000

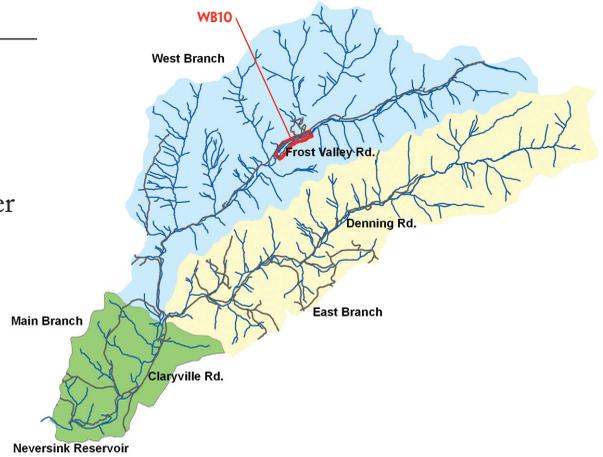
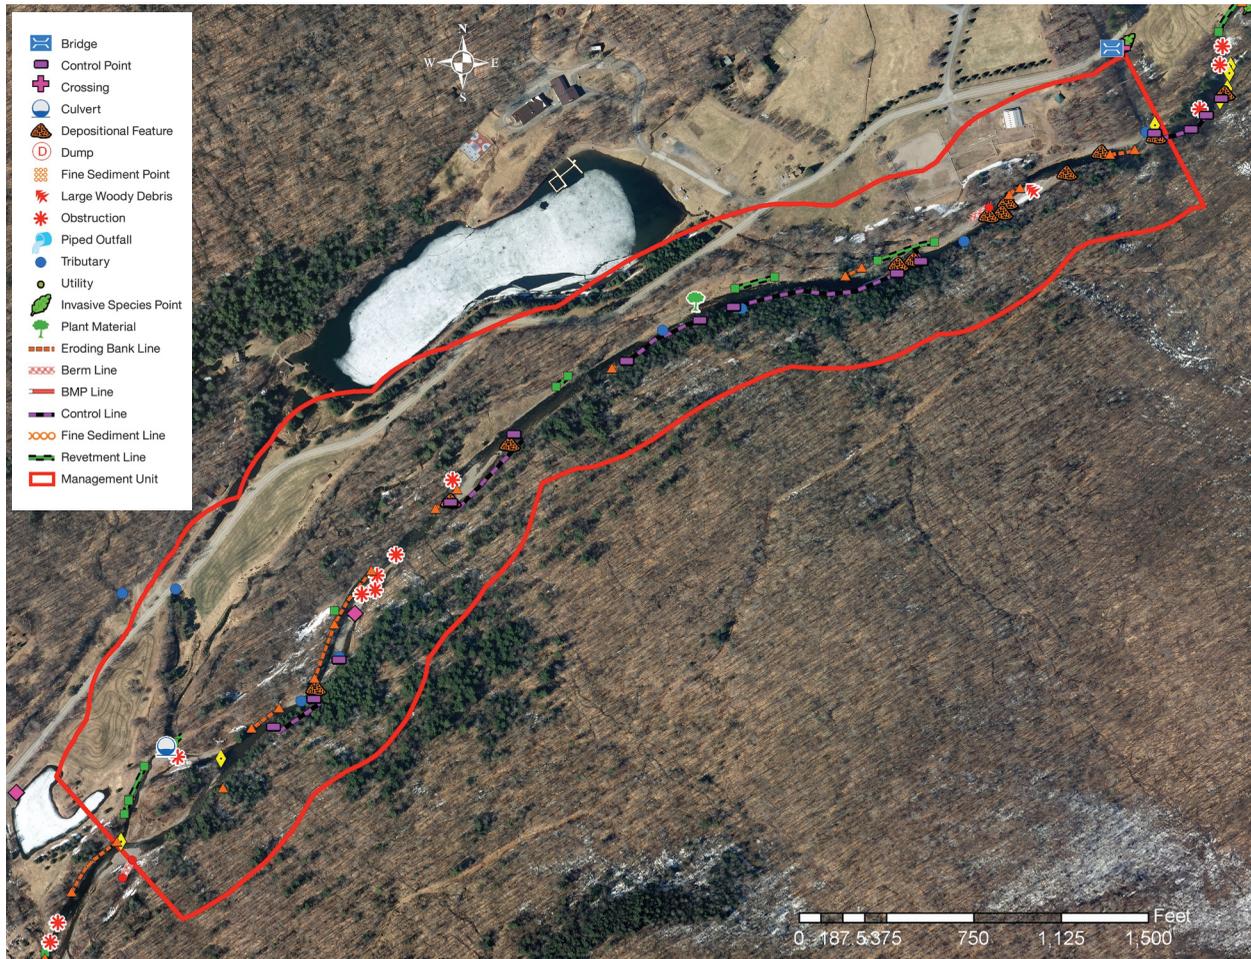
Stream Feature Inventory 2010 (Figure 1)

STREAM FEATURE STATISTICS

- 9.00% of stream length is experiencing erosion
- 7.00% of stream length has been stabilized
- 27.61 acres of inadequate vegetation within the 100 ft. buffer
- None of stream is within 50 ft. of the road
- There are no building structures located in the 100-year floodplain boundary of the West Branch Neversink River.
- There are seven building structures located within the 100-year floodplain boundary of Biscuit Brook

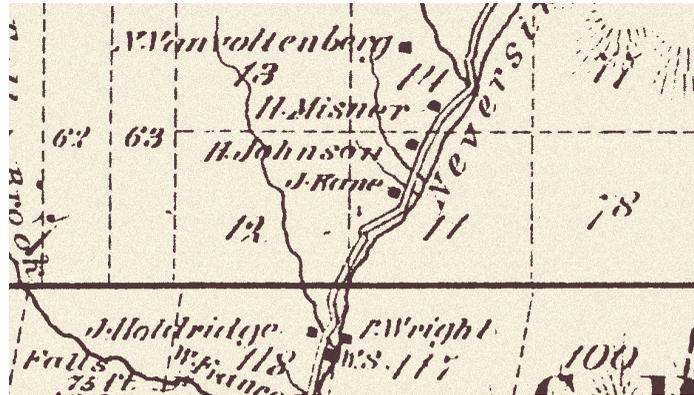
Excerpt from 1875 Beers Map (Figure 2)

The 1875 Beers Atlas of this area indicates that by that time, the stream had been harnessed for manufacturing, primarily saw mills, woodworking shops and tanneries (Figure 2). Raceways were built in the floodplains to divert water to ponds for use as needed. Floodplains were profoundly altered in the process, as these watercourses also became areas of preferential channelized flow when floodwaters inundated the floodplains. When woody debris jams blocked the primary channels, these raceways sometimes eroded out to become major secondary channels, or even took over the full flow to become a new primary watercourse.
