Neversink River West Branch

MANAGEMENT UNIT 2

WEST BRANCH MANAGEMENT UNIT 2
BETWEEN STATION 2200 AND STATION 5700

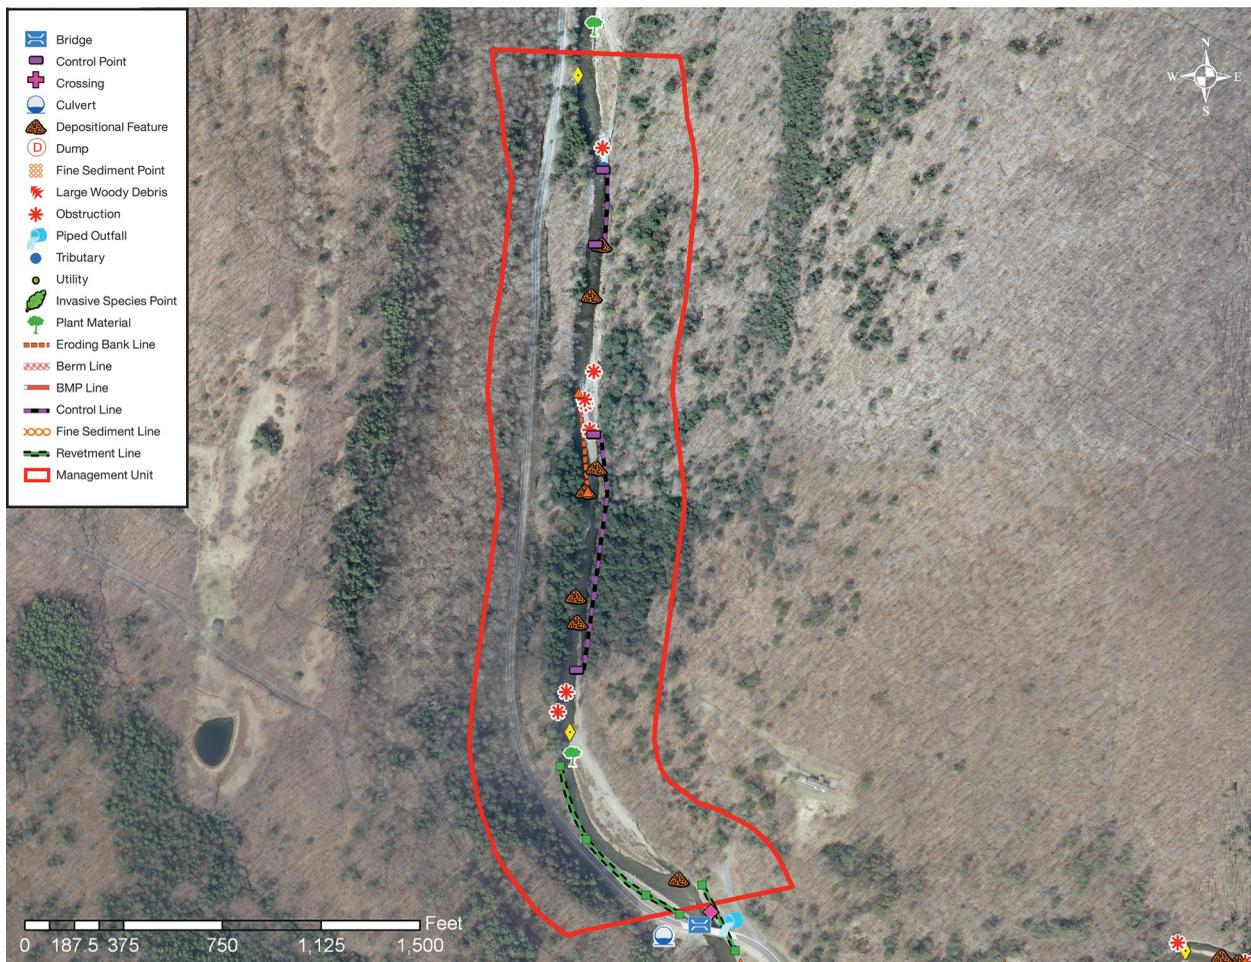
Stream Feature Inventory 2010 (Figure 1)

- 5.00% of stream length is experiencing erosion
- 11.97% of stream length has been stabilized
- 4.86 acres of inadequate vegetation within the 100 ft. buffer
- 600 feet of stream is within 50 ft. of the road
- No structures are located within the 100-year floodplain boundary

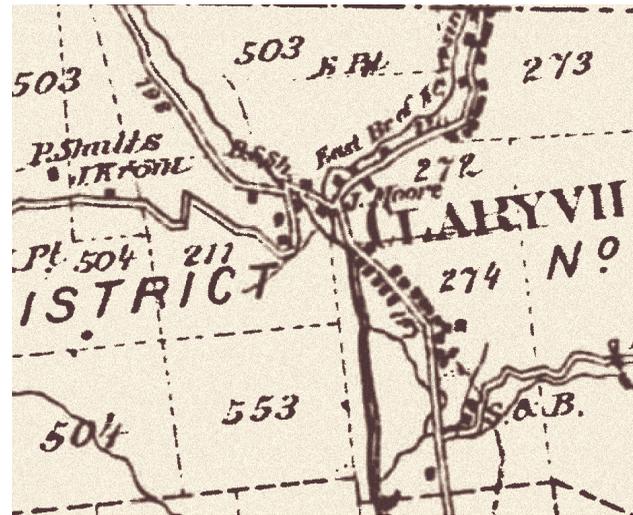
Excerpt from 1875 Beers Map (Figure 2)

The 1875 Beers Atlas of this area indicates that by that time, the stream had been harnessed for manufacturing, primarily saw mills, woodworking shops and tanneries (Figure 2). Raceways were built in the floodplains to divert water to ponds for use as needed. Floodplains were profoundly altered in the process, as these watercourses also became areas of preferential channelized flow when floodwaters inundated the floodplains. When woody debris jams blocked the primary channels, these raceways sometimes eroded out to become major secondary channels, or even took over the full flow to become a new primary watercourse.
