# Neversink River West Branch

## MANAGEMENT UNIT 3

WEST BRANCH MANAGEMENT UNIT 3  
BETWEEN STATION 5700 AND STATION 10300

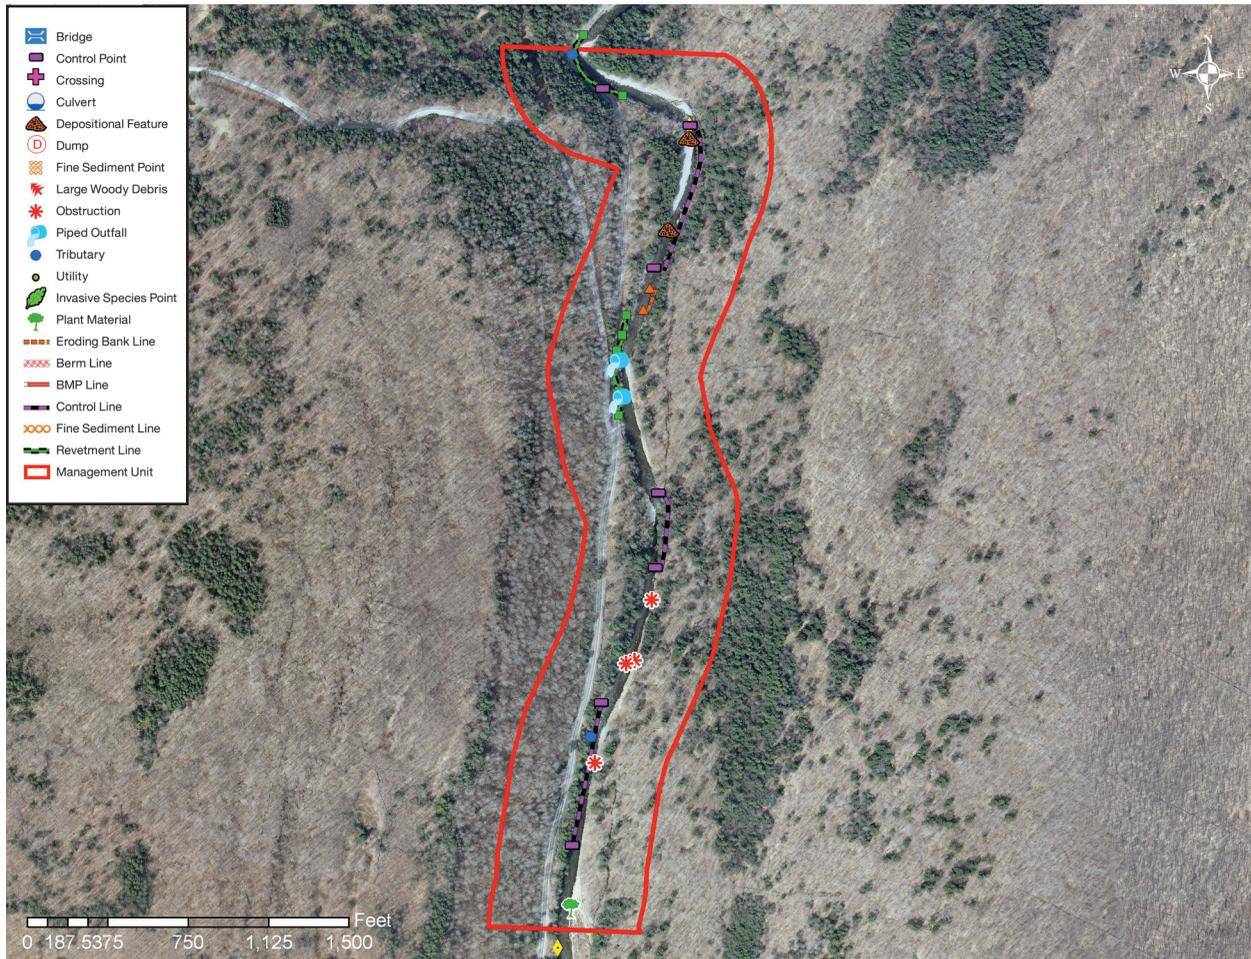
Stream Feature Inventory 2010 (Figure 1)

- 1.00% of stream length is experiencing erosion
- 8.99% of stream length has been stabilized
- 6.15 acres of inadequate vegetation within the 100 ft. buffer
- 400 feet of stream is within 50 ft. of the road
- No building structures are located within the 100-year floodplain boundary

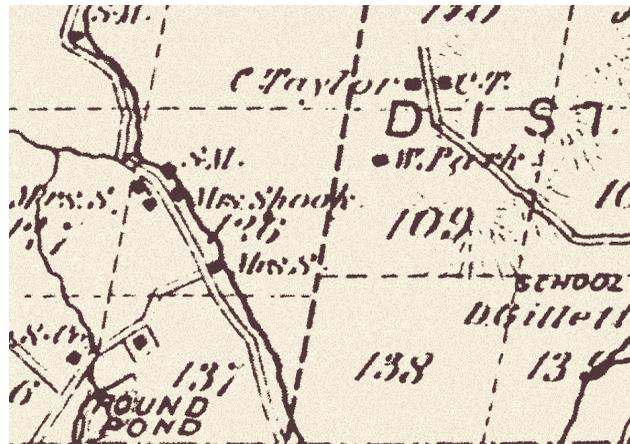
Excerpt from 1875 Beers Map (*Figure 2*)

The 1875 Beers Atlas of this area indicates that by that time, the stream had been harnessed for manufacturing, primarily saw mills, woodworking shops and tanneries (*Figure 2*).
