Neversink River West Branch

MANAGEMENT UNIT 7

WEST BRANCH MANAGEMENT UNIT 7
BETWEEN STATION 25000 AND STATION 27500

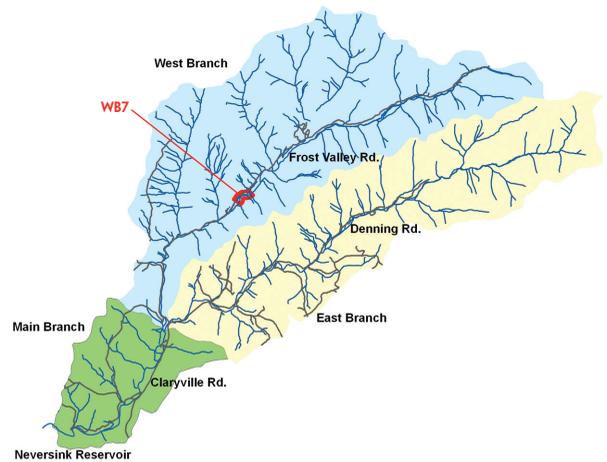
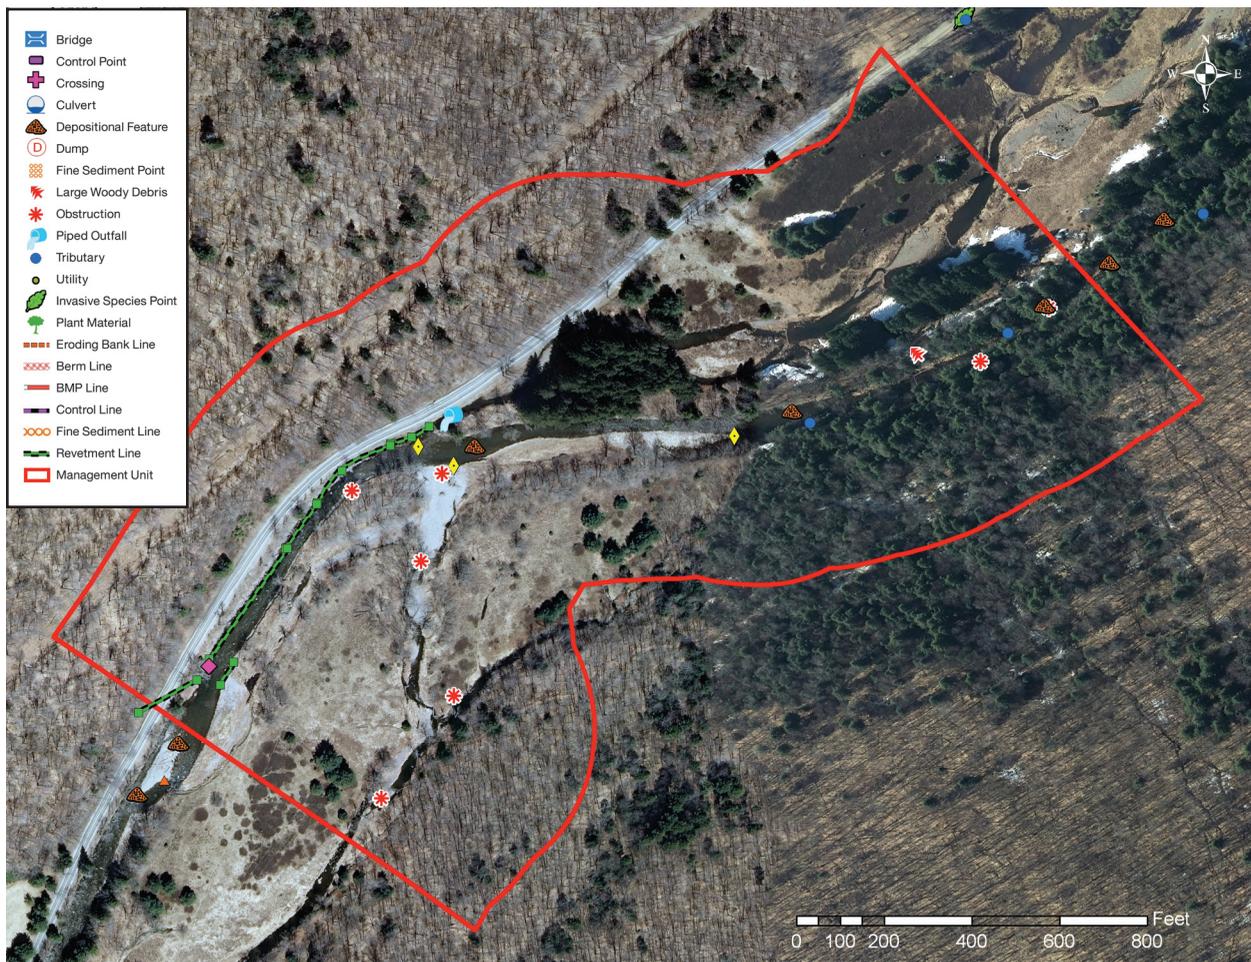
Stream Feature Inventory 2010 (Figure 1)

- 0.00% of stream length is experiencing erosion
- 19.67% of stream length has been stabilized
- 4.74 acres of inadequate vegetation within the 100 ft. buffer
- 900 feet of stream is within 50 ft. of the road
- No structures are located within the 100-year floodplain boundary

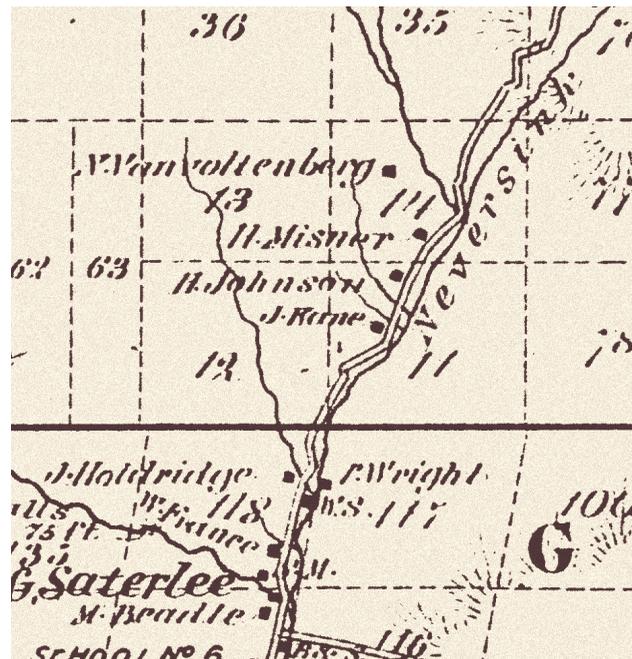
Excerpt from 1875 Beers Map (*Figure 2*)

The 1875 Beers Atlas of this area indicates that by that time, the stream had been harnessed for manufacturing, primarily saw mills, woodworking shops and tanneries (*Figure 2*). Raceways were built in the floodplains to divert water to ponds for use as needed. Floodplains were profoundly altered in the process, as these watercourses also became areas of preferential channelized flow when floodwaters inundated the floodplains. When woody debris jams blocked the primary channels, these raceways sometimes eroded out to become major secondary channels, or even took over the full flow to become a new primary watercourse.
