Broadstreet Hollow Stream Restoration Project

IMPLEMENTATION & MONITORING REPORT

Broadstreet Hollow
Town of Lexington, Greene County, NY

UPDATED
March 2008

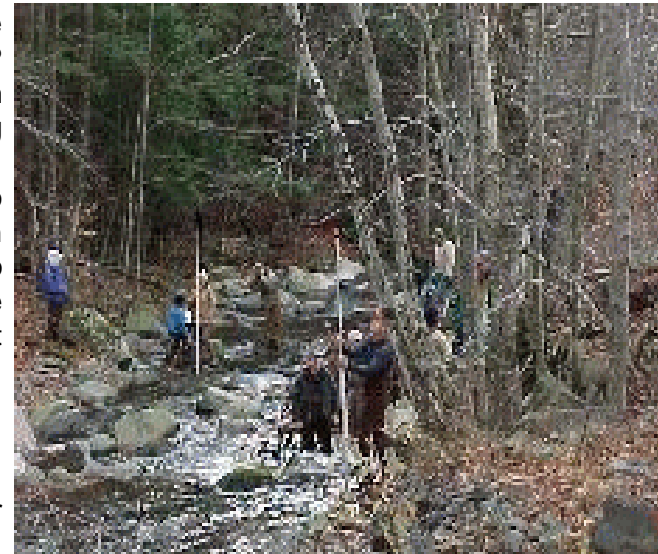
Photo 1. Survey of the reference reach located above project site
