BRANDYWINE RESTORATION PROJECT - BATAVIA KILL -

IMPLEMENTATION & MONITORING REPORT

BRANDYWINE PROJECT - BATAVIA KILL
TOWN OF ASHLAND, GREENE COUNTY, NY

UPDATED
MARCH 2008

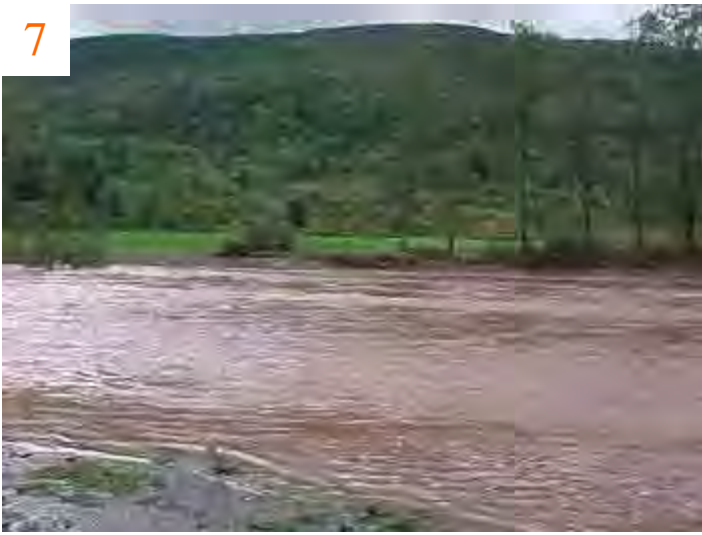
7

Brandywine Stream Restoration Project
Flood Event September 16, 1999

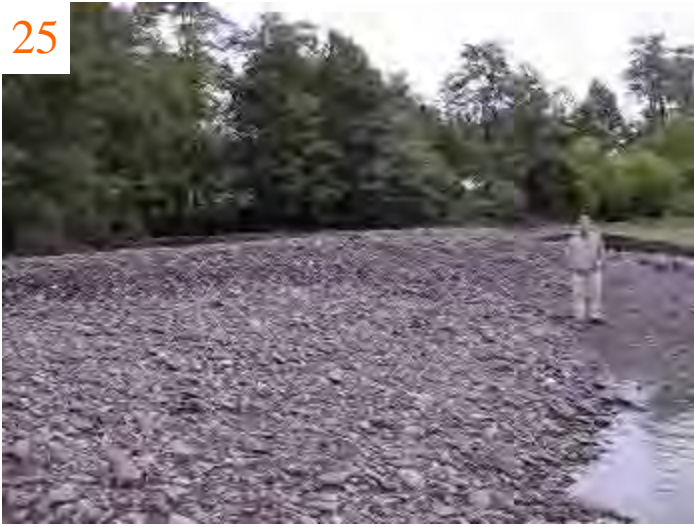
25

Brandywine Stream Restoration Project
Post Flood Damage September 24, 1999

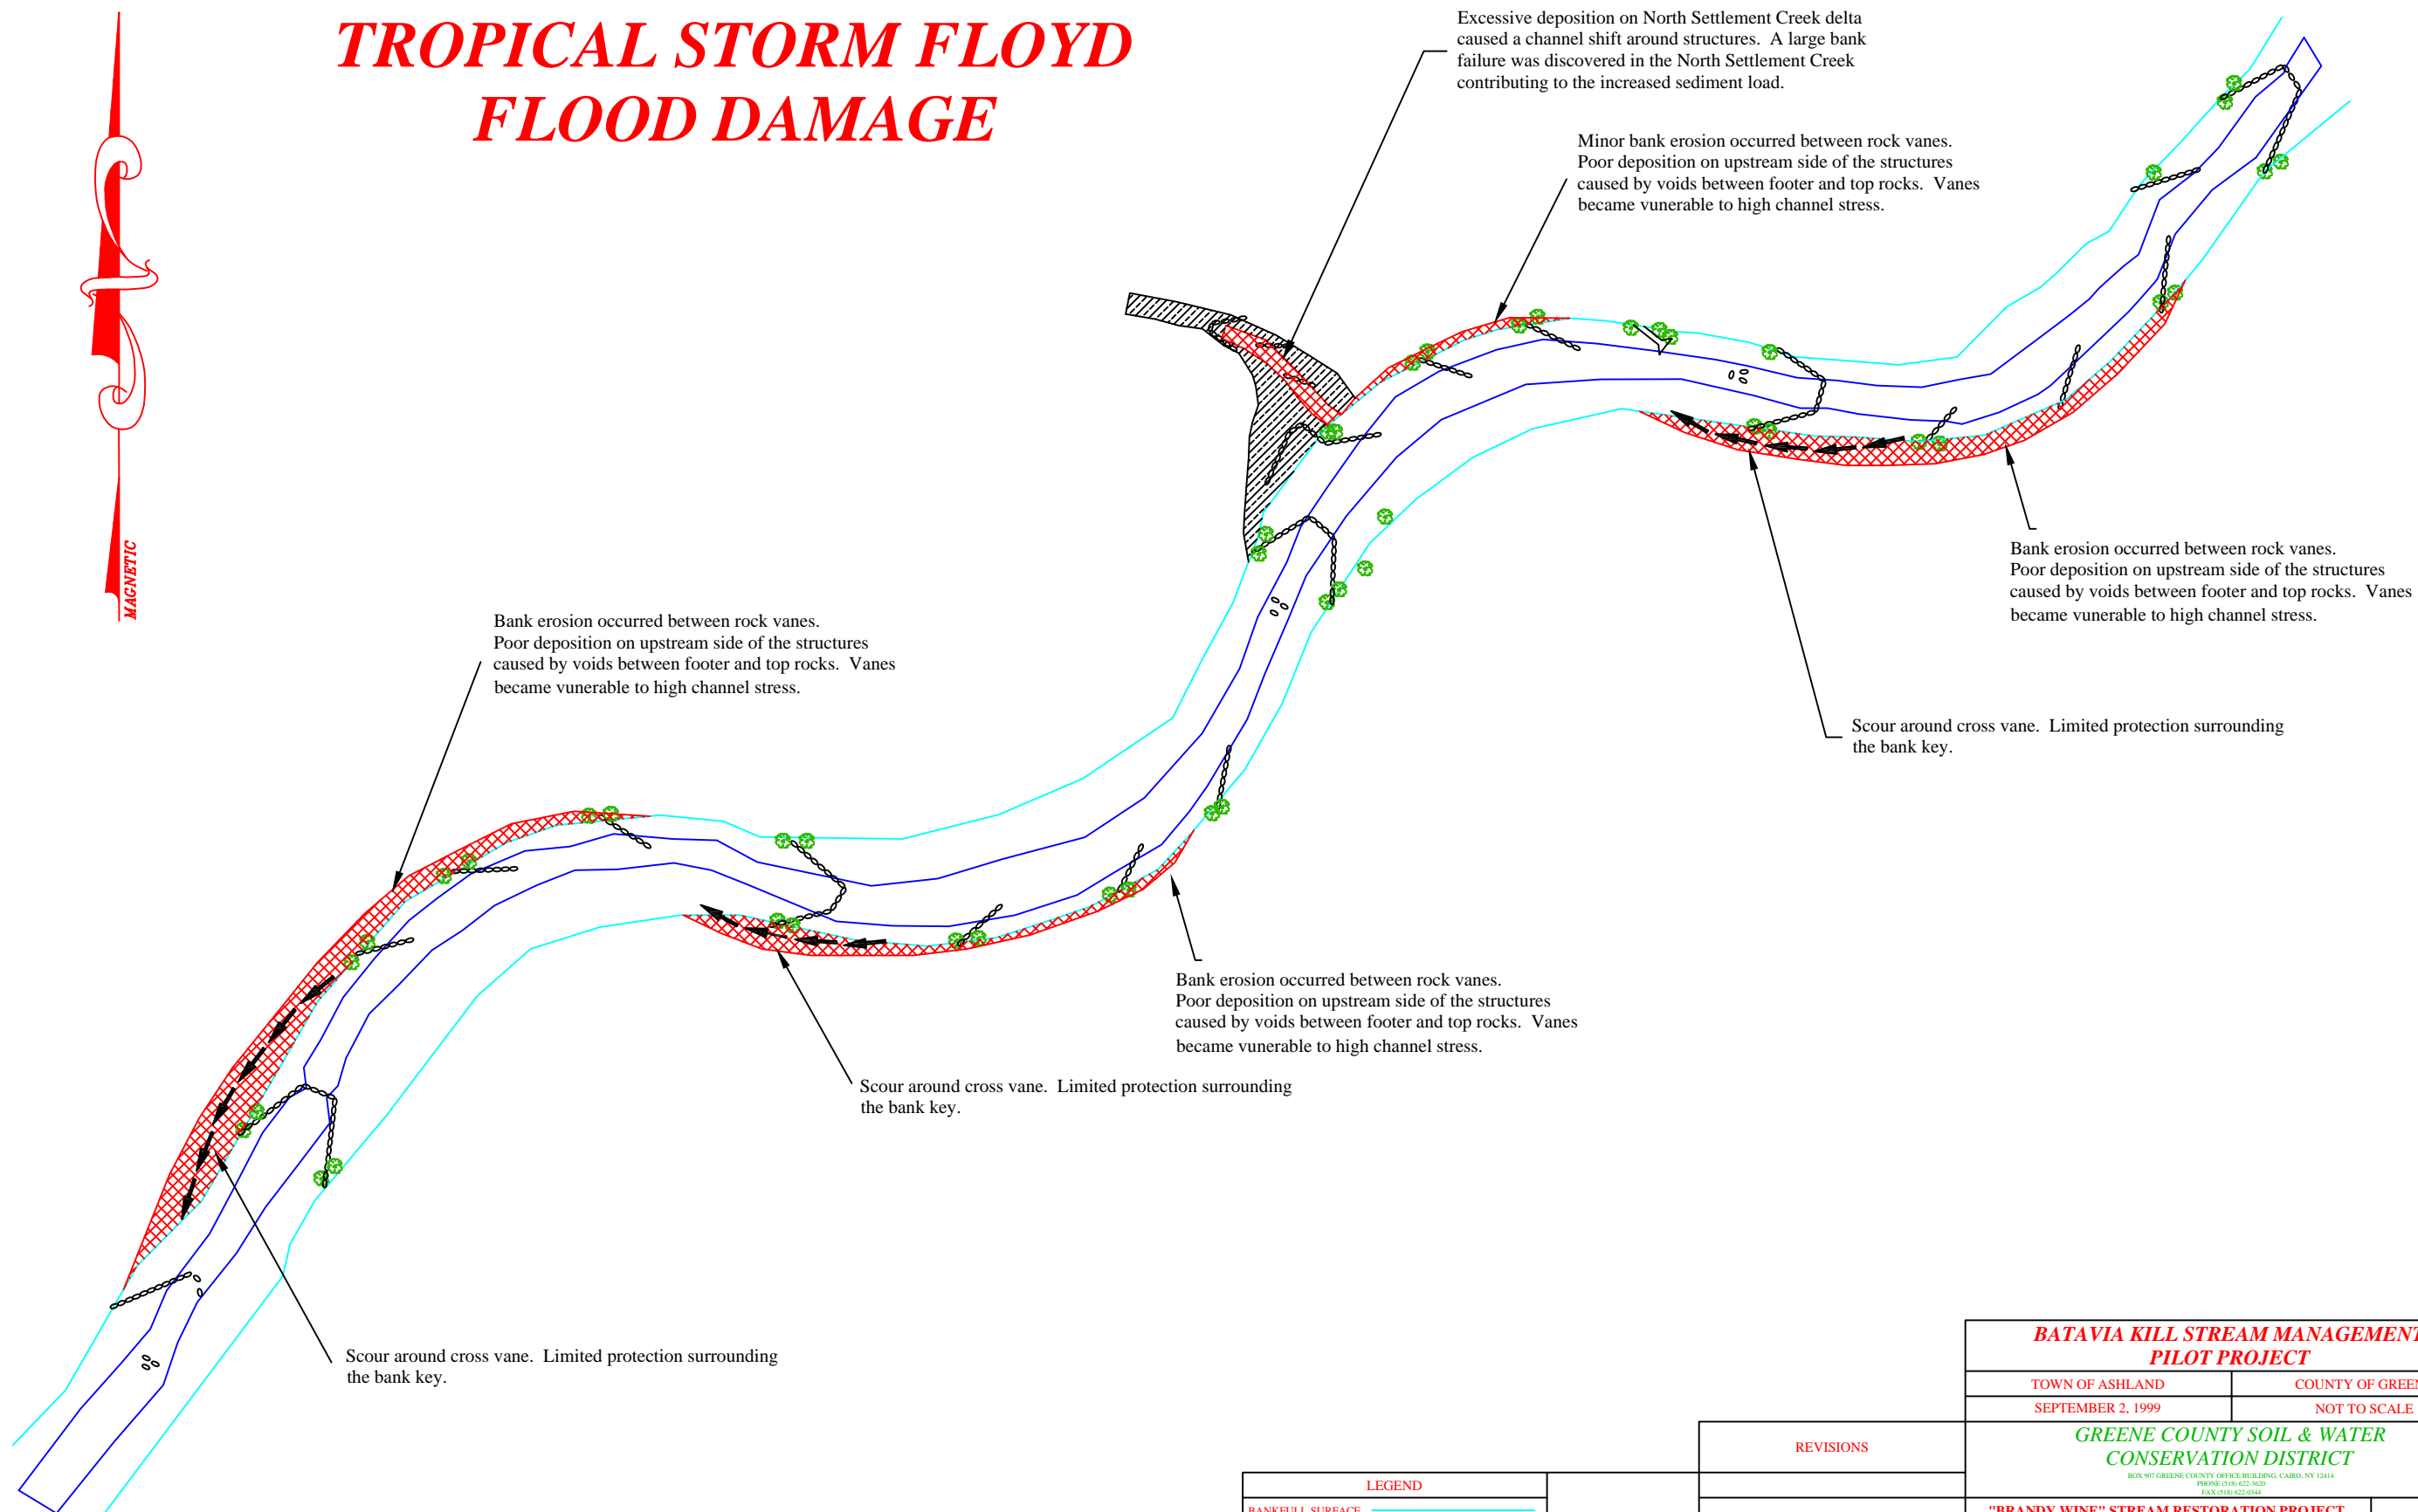
TROPICAL STORM FLOYD FLOOD DAMAGE

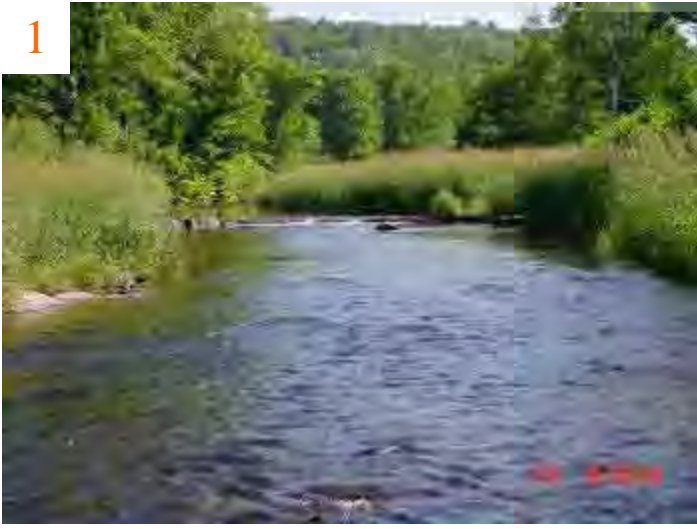
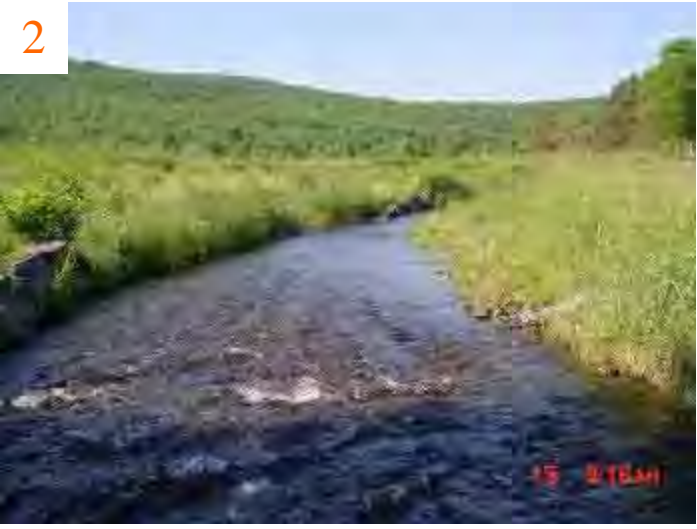
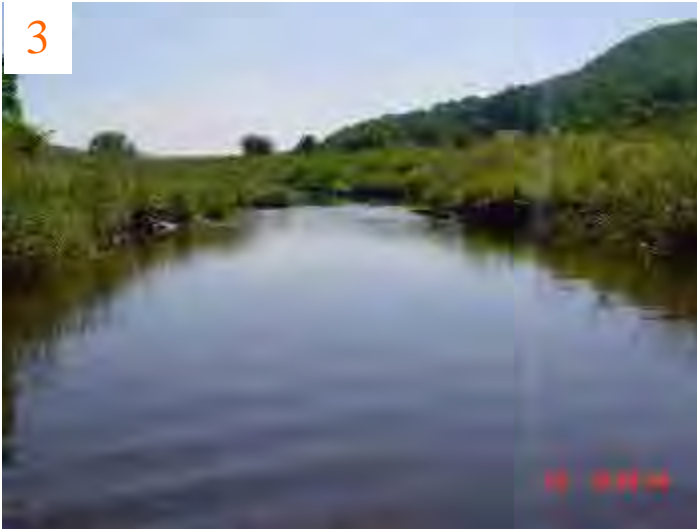
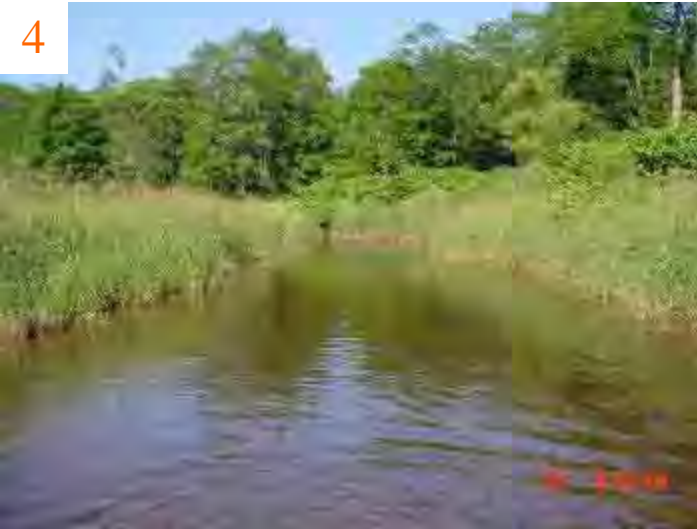
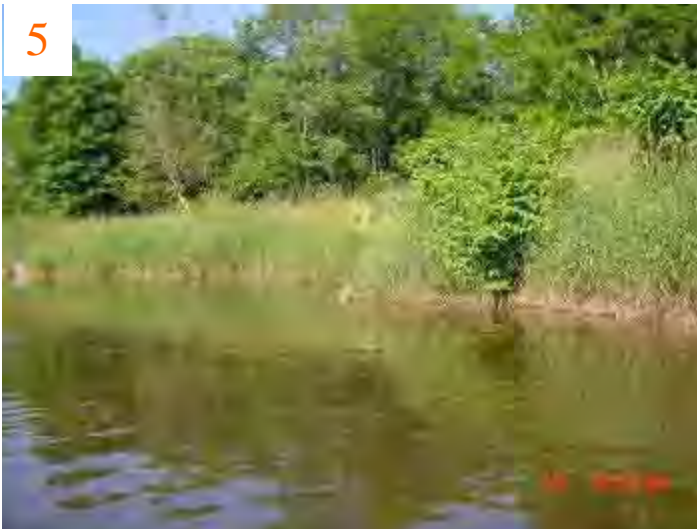
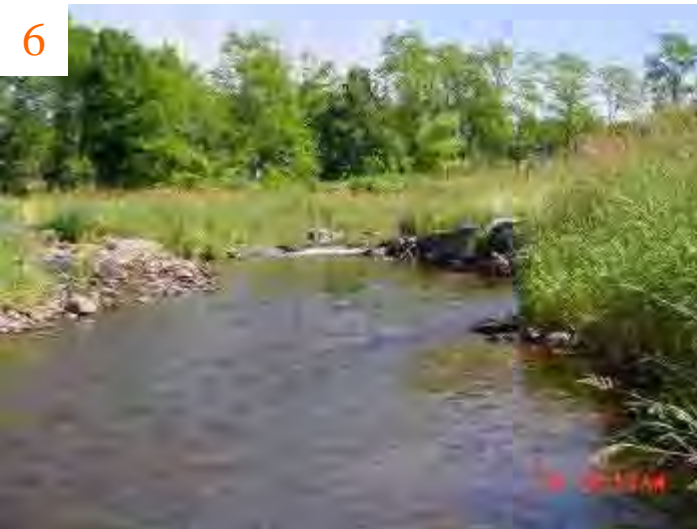
Brandywine Stream Restoration Project
Project Inspection— 2004

Photograph 11: The last cross vane on the project site.

Photograph 12: The bottom of the project site with minor aggradation along the left bank.

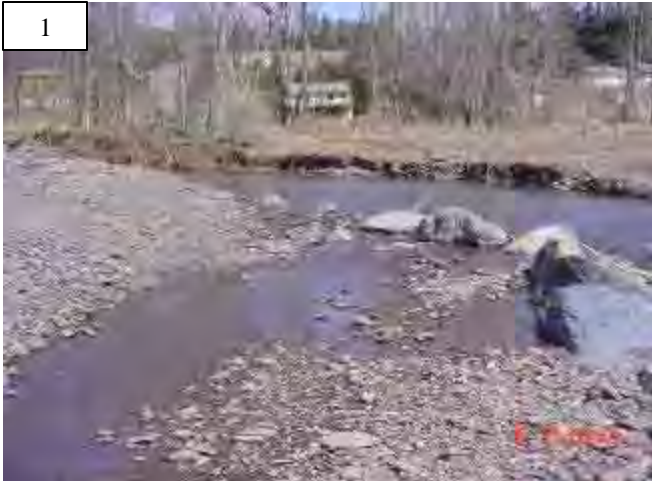
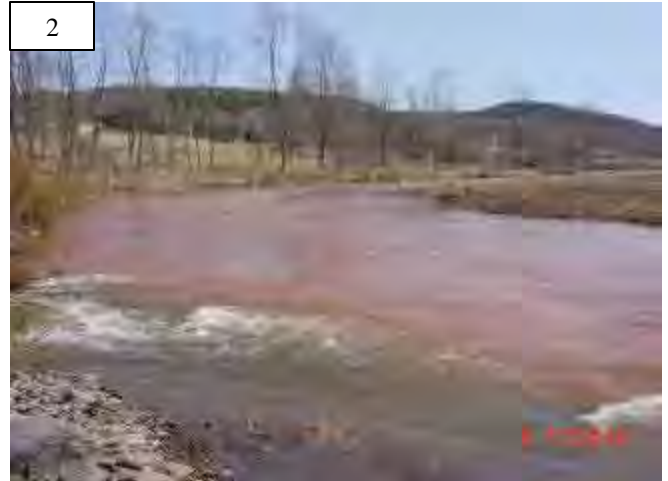
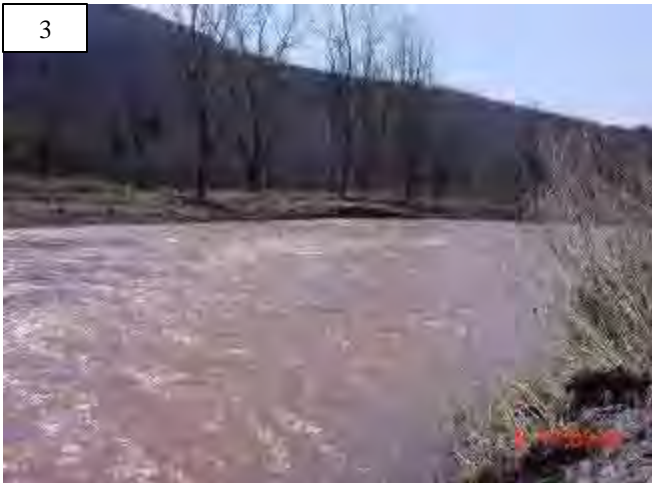
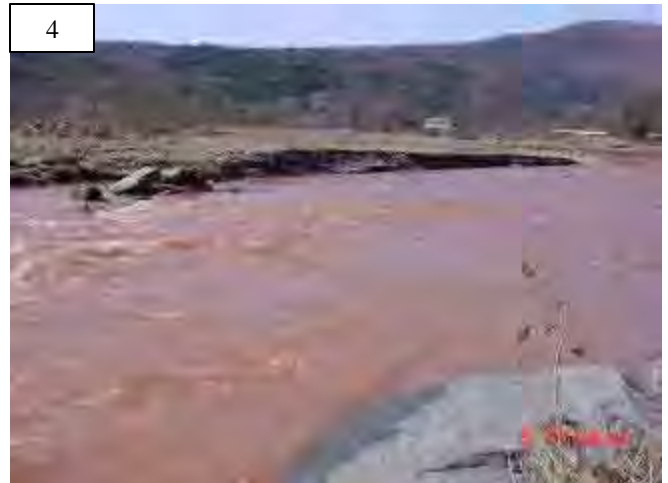
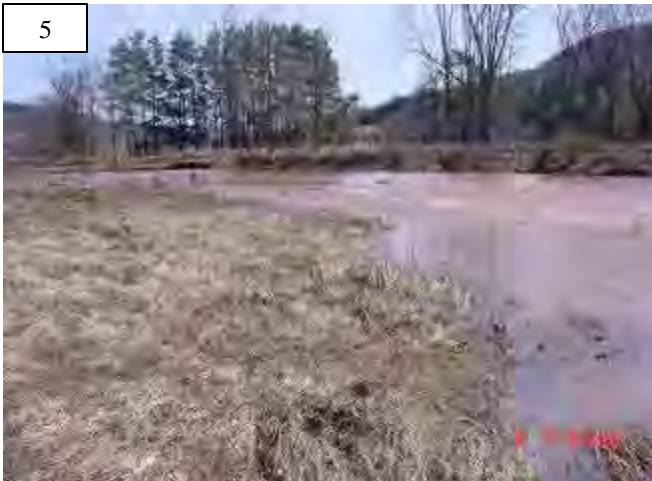
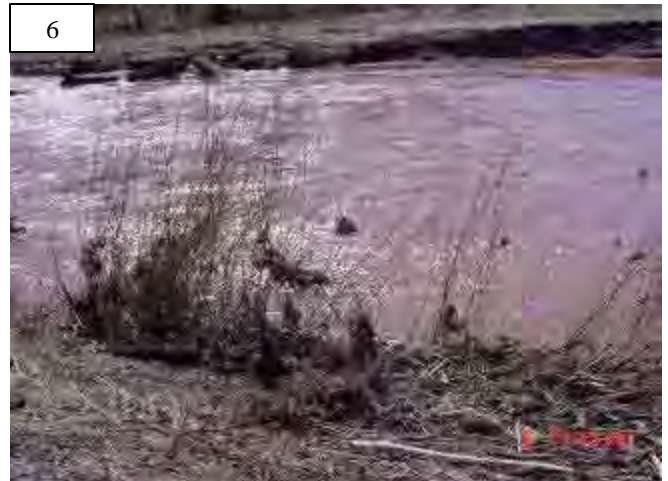
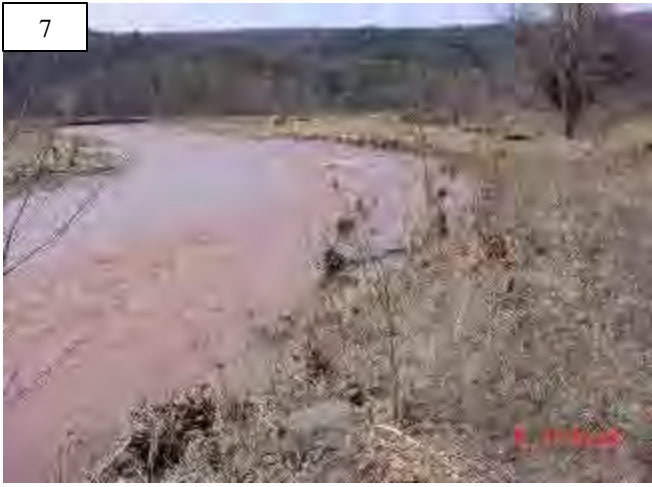
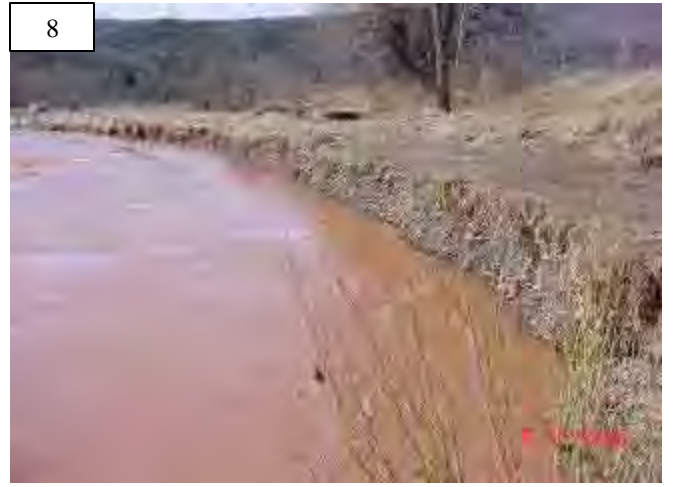
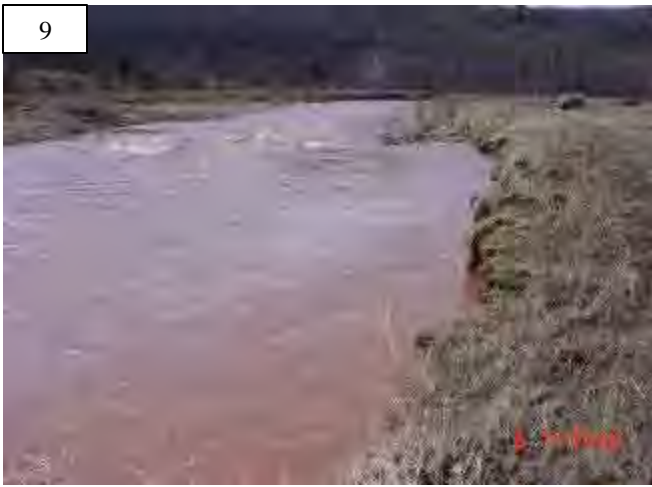
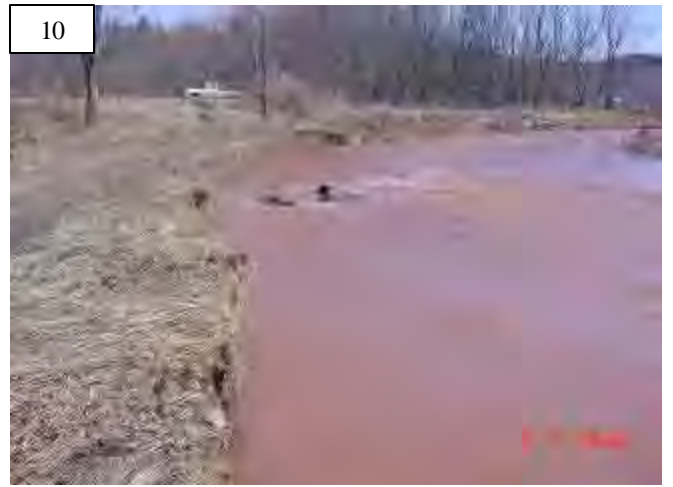
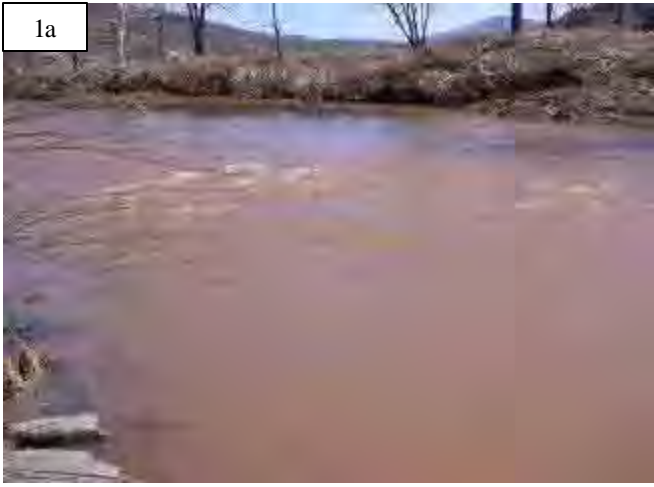
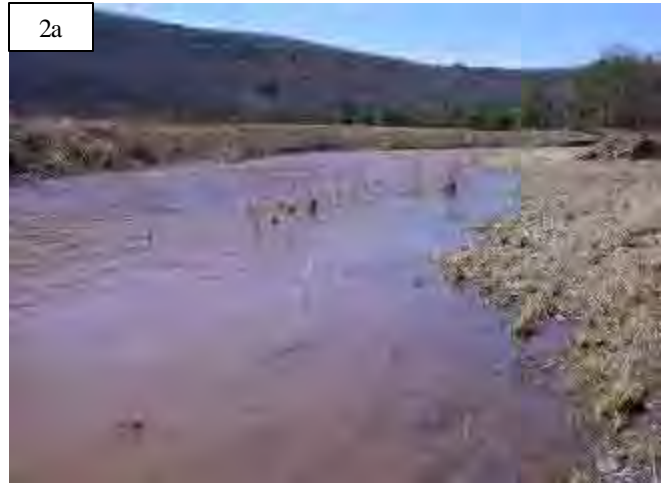
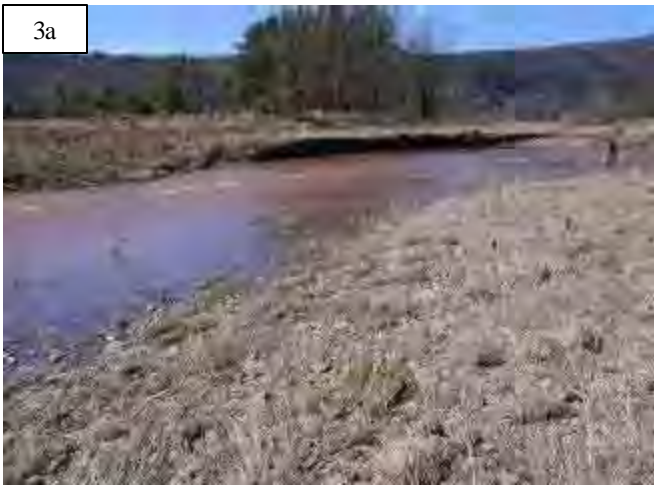
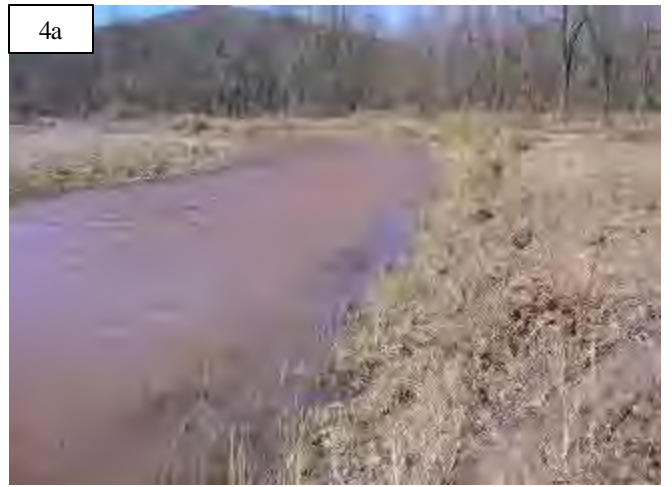
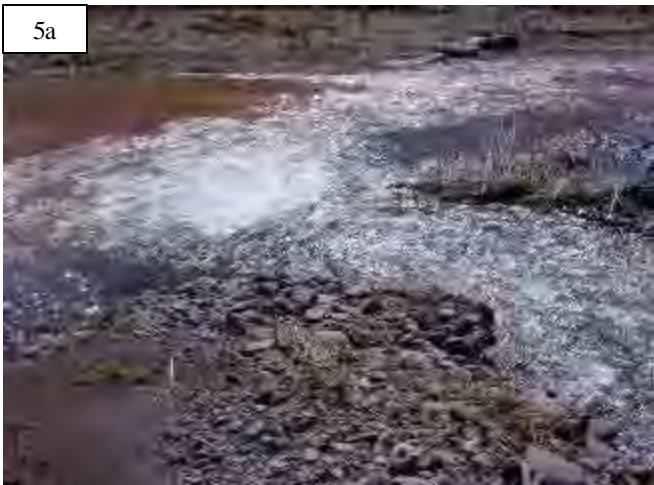
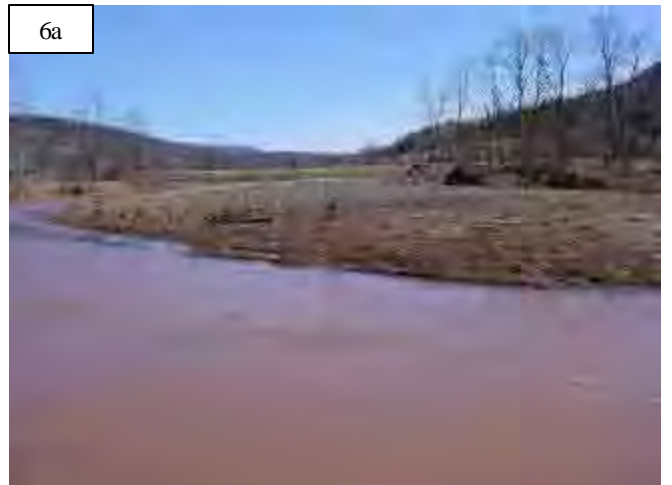
**BATAVIA KILL RESTORATION PROJECT
BRANDYWINE STORM ASSESSMENT
APRIL 2-3, 2005**

Four of the nineteen rock structures experienced continued damage as a result of the flood flow. All four structures originally sustained damage during previous high flow events and have been scheduled for repair/modification for several years. The damaged structures include one cross vane at Station 15+25 and three rock vanes located at Stations 14+00, 18+00, and 19+00.

Previous damage to the cross vane structure includes rotational collapse and movement of top rocks along the left arm and sill. The primary cause of the rotational collapse is attributed to excess scour of the plunge pool immediately downstream of the structure. The scour exceeded the maximum installation depth of the footer rocks, which resulted in a partially collapse into the scour pool area. Several top rocks along the left arm and sill were dislodged during previous flow events and were further displaced during the recent flood event.

Previous damage to the rock vane structures included rotational collapse and movement of top rocks along the vane arm. Problems associated with the structure included undesirable scour in areas where voids occurred between the top and footer rocks. Voids in the structures, larger than the available channel sediment, lead to increased scour caused by the convergence of flow through areas of the structure. Proper deposition of sediment, along the upstream face of the vane arm scoured as a result of the flow concentration through the voids.

The channel showed no evidence of large-scale deposition (aggradation) or incision (degradation) through the reach. Bank erosion was present in areas surrounding the damaged rock structures and primarily limited to the lower meander bend. Two isolated areas of erosion were noted upstream of the rock vanes near Stations 4+00 and 12+00. It is presumed that the bank erosion would have been partially if not entirely mitigated if the vegetation had been able to establish prior to the increased stresses caused by the flood event.

Fine sand deposition was noted on the outer streambank along the first meander bend as well as along the upstream portions of several rock vane and cross vane arms.

Photograph 11a. Sta. 20+00 Downstream stable cross vane.

- Monitoring of the entire site should be completed prior to the initiation of any modification or repair. Additionally, the monitoring should be completed again immediately after the modification/repair is completed.

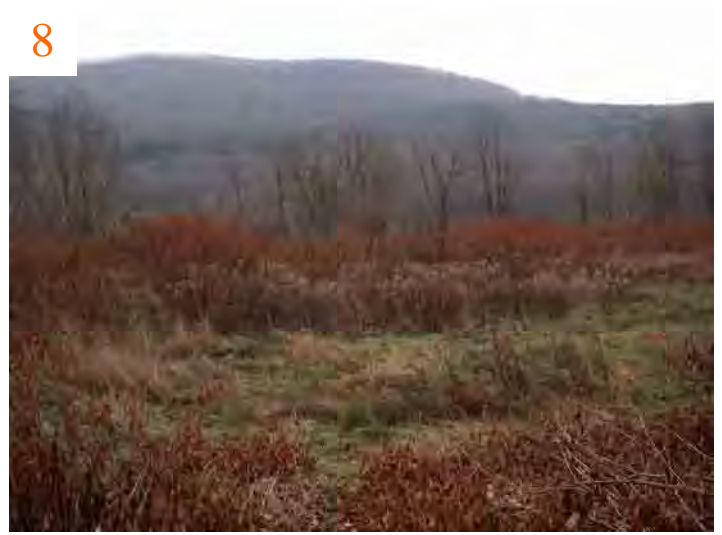
8

- Photograph 8: View across stream from right bank at cross section 6.
- Photograph 9: Cross vane with bank erosion behind left vane arm located downstream of cross section 6.

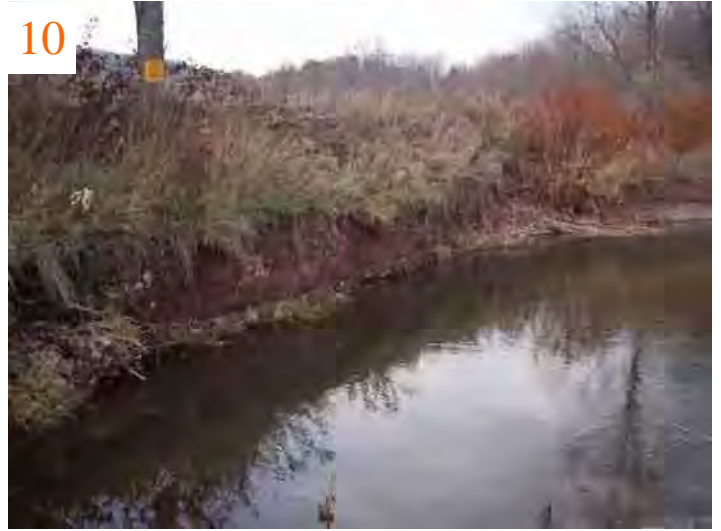
10

- Photograph 10: Bank erosion on right bank exposing the sand and gravel soil.
- Photograph 11: Rock vane with bank erosion behind vane arm.
- Photograph 12: Cross vane near cross section 6 with substantial bank erosion behind right vane arm.

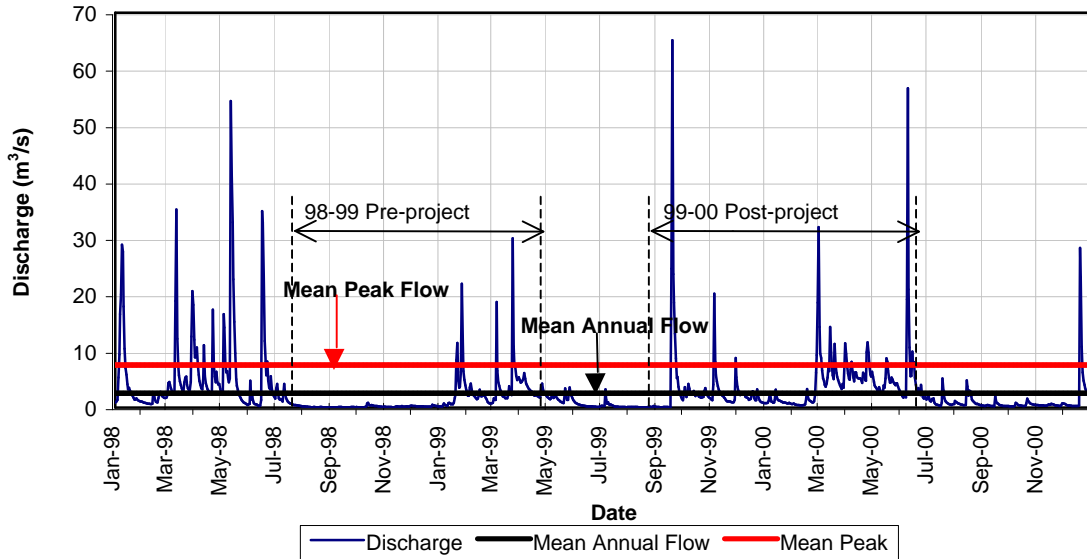
Figure 4: Daily Mean Stream Flow at Batavia Kill Near Ashland NY (USGS 01349900)

For the hydrological consideration, the daily mean stream flow data (Figure 4) is obtained from USGS gage 01349900 (Near Ashland), which is located upstream of the Maier Farm reach. From August 26, 1999 to June 21, 2000 (post-project period), eight storm events with the daily mean discharge higher than the mean peak flow (mean value of the flood events) were recorded. The highest daily mean stream flow, which occurred on September 17, 1999, exceeded 65 m³/s (Notice that this is the daily mean flow, not the peak flow; the peak flow exceeded 420 m³/s). It was followed by another major flood event on June 7, 2000, with a daily mean stream flow higher than 56 m³/s. However, during the pre-project monitoring season (from July 17, 1998 to April 27, 1999) only three storm events exceeded the mean peak flow, while the highest daily mean stream flow is 30 m³/s. Apparently, the post-project monitoring season experienced more storm events and higher flow than the pre-project monitoring season, but the erosion is almost the same (Table 3) during these two monitoring seasons. Therefore, one can conclude that the stream restoration project did contribute to the stream stability.

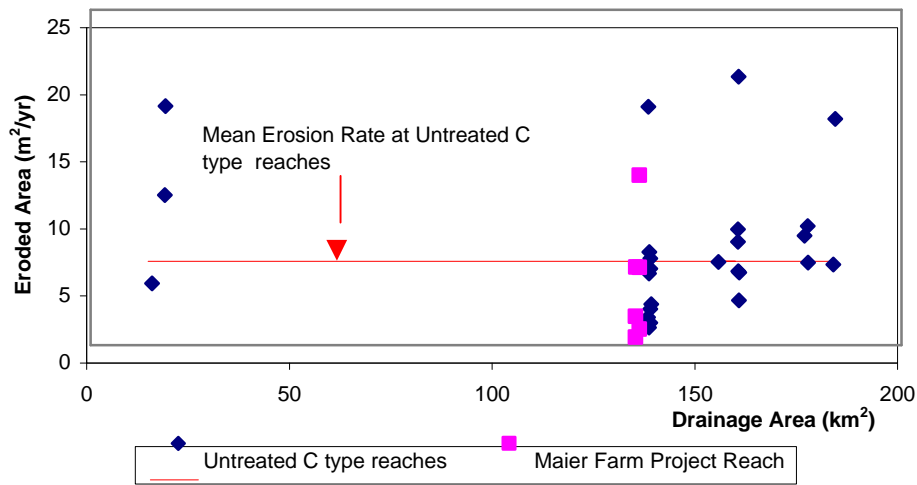
Figure 5: Comparison Erosion Rate between the Project Reach and Untreated C type Reaches in the Batavia Kill watershed

Another way to evaluate the effectiveness of the restoration project on stabilizing the stream bank is to compare the erosion rate at project reach to that of untreated stream reaches (unstable reaches). Since the project reach is a C4 type, it is interesting to compare the erosion rate between it and the untreated C-type stream reaches. There are 95 monitoring cross-sections on the Batavia Kill stream. Among them, 25 are set up on untreated C-type stream reaches. The erosion rate during 1999-2000 monitoring season can be determined by overlaying surveyed cross-sections in 1999 and 2000 to measure the eroded area. The 25 untreated C-type reaches are located from the headwaters to the mouth of the watershed, and the drainage area ranges from 13 km² to 182 km². The results are summarized in Figure 5. The mean erosion rate of 25 cross-sections on untreated C-type reaches is 7.58 m²/year, and the mean erosion rate of 6 project cross-sections on the Maier Farm site is 4.7 m²/year. The average erosion rate at untreated reaches is 61% higher than that of the project reach.

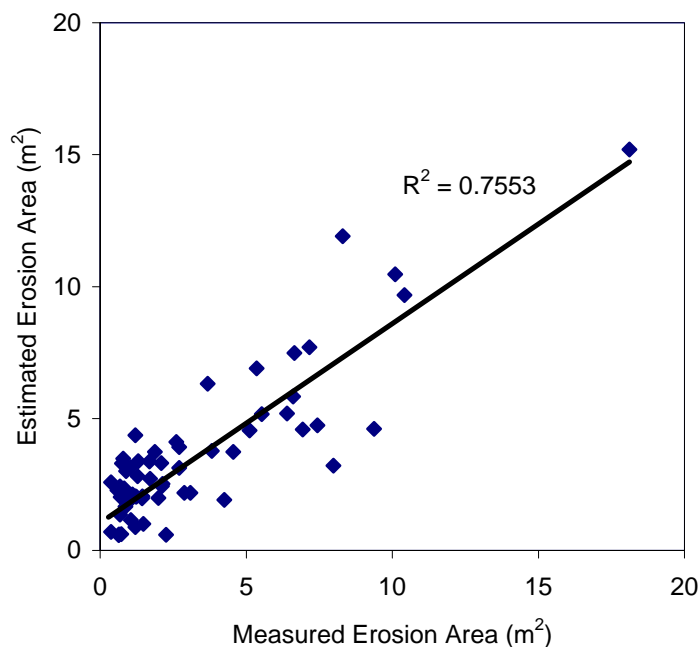
Figure 3: Estimated Bank Erosion by the Final Model vs. Measured Erosion

The final model indicates that bank angle, sinuosity, and stream flow are directly related to stream bank erosion, while the vegetation index has an inverse relationship to bank erosion. Actually, field observations in the Batavia Kill watershed support the above model's interpretation. A large amount of bank erosion is observed at reaches where the banks are steep and the channels are sinuous, such as Kastanis and Red Falls. High flow events generally produce more bank erosion, and this is consistent with observations made by many researchers (Hooke 1979; Knighton 1998). At bank-erosion monitoring sections on the Batavia Kill stream, banks with high vegetation coverage in general have much less erosion than banks with little or

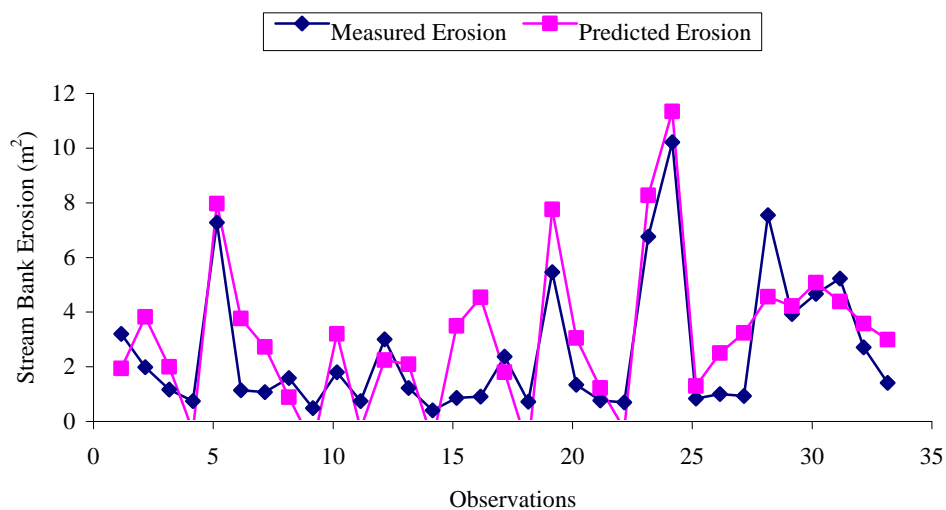
Figure 4: Comparison between the Predicted Erosion and Measured Erosion

One data set is used to develop a prediction model, and the other data set containing out of sample data is used to validate the prediction model. The same general to specific method is used to specify the prediction model, and the predicted values are compared with the measured erosions (Figure 4). The R^2 between the predicted erosions and the measured erosions is 0.7084, which means that more than 70% of the measured bank erosions could be explained by the regression model. The methodology used in the model specification well predicts the characteristics of stream bank erosion. Notice that the relevant explanatory variables in the regression model generated from the validation process are not necessary the same as those in the final model specified using all observations because those two models are specified using a different number of observations.
