IMPLEMENTATION &
MONITORING REPORT
MAIER FARM PROJECT - BATAVIA KILL

TOWN OF ASHLAND, GREENE COUNTY, NY

UPDATED
MARCH 2008

MAIER FARM RESTORATION PROJECT

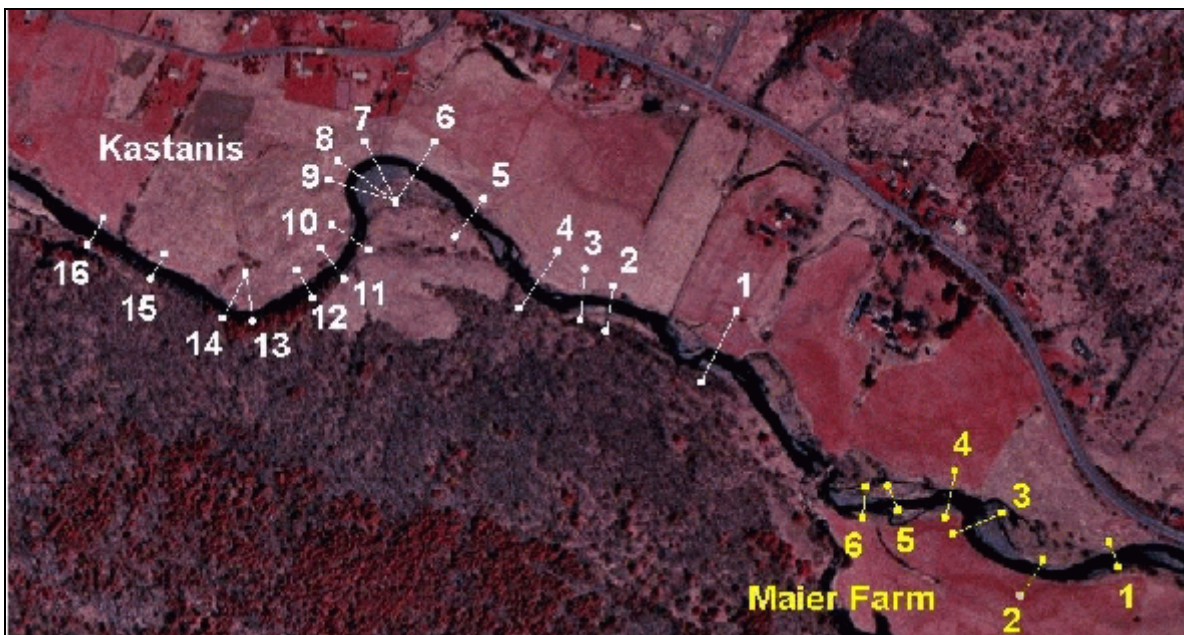
Figure 1: Approximate location of monitoring cross sections, located on a pre-restoration aerial photograph (1995).

At the time of the as-built survey, six monumented cross sections were installed for use in future detailed monitoring efforts, Figure 1. Cross sections were monumented using capped rebar pins, located during the topographic survey, and recorded using GPS. Cross sections were stationed at various locations along the channel profile in order to provide monitoring for stream process and stability. The cross sections were installed through various stream features (pools, riffles, etc.) and structures in order to document stream classification, potential erosion and scour, and to document the overall channel stability. Additionally, a longitudinal profile was surveyed to include sampling of ground, water and bankfull surface elevations along the channel thalweg. Sediment inventories were conducted to document the dominant channel materials, using a modified Wolman pebble count procedure.
