**Project Design Report
R.A. Hill Stables Demonstration Project
West Kill Creek**

**December 31, 2006
Prepared by Mark Vian¹ and Joel Dubois²**

¹ New York City Department of Environmental Protection Stream Management Program

² Greene County Soil and Water Conservation District

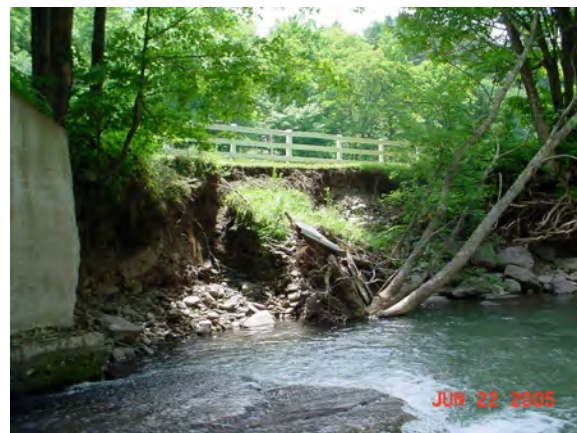
again on bedrock. Vertical adjustment through the reach is controlled by these bedrock sills at the top and bottom of the reach. High flows backwater at the bridge, causing channel aggradation upstream.

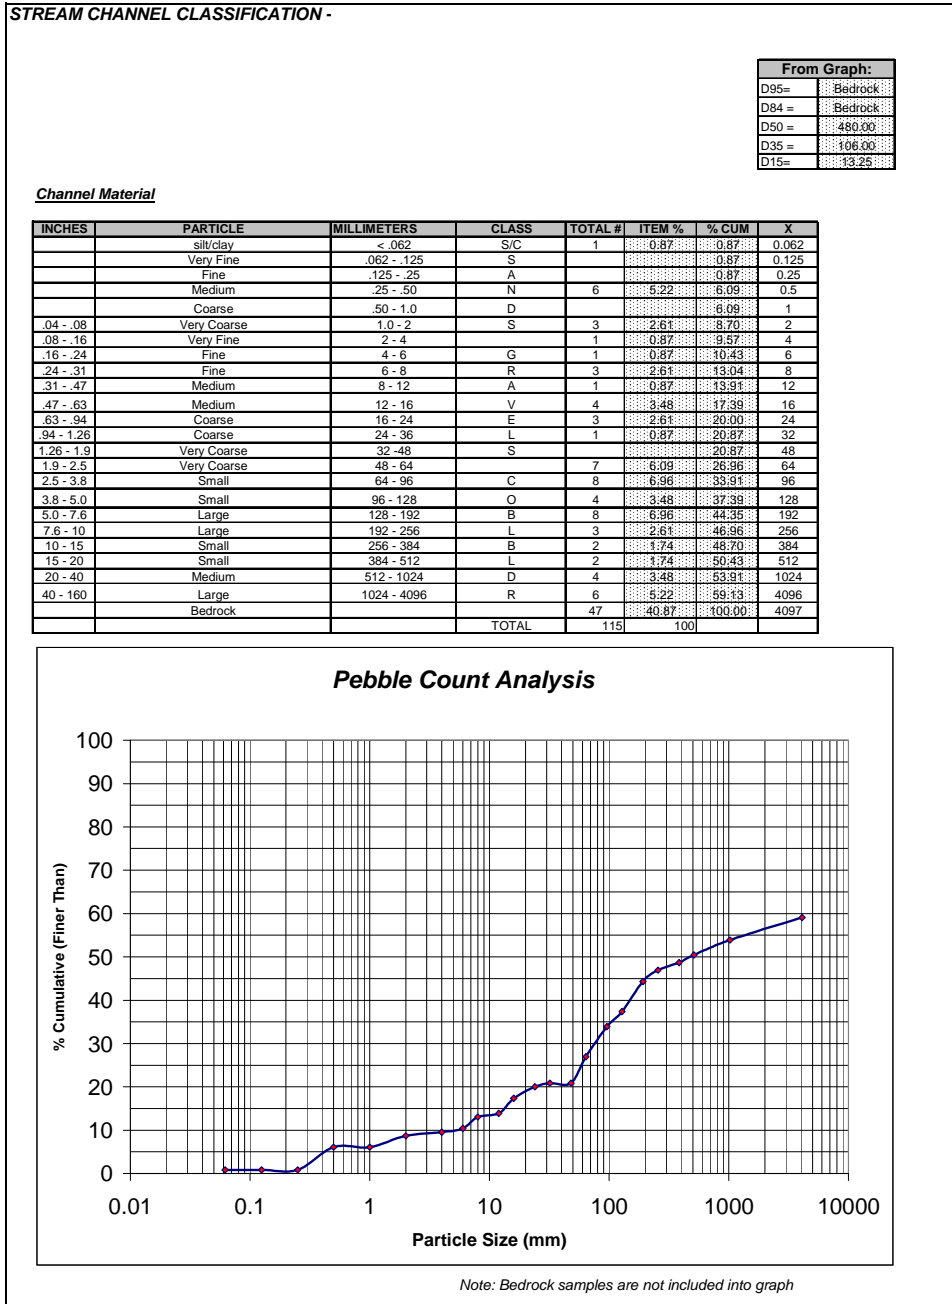
Bed material characterization, classification XS10-20, at the project site, prior to construction.

The statistics presented in the table above the chart for XS10-20 include the bedrock sampled during the pebble count. In the entrainment analysis below, we use the statistics for only the mobile portion of the bed material. Thus the D84 of the mobile portion is approximately the D50 (480mm) of the full count, and the D50 of the mobile portion is approximately the D30 (74mm) of the total count.
