**Management Unit 1**  
Greene County - Town of Hunter  
NYS DEC Forest Preserve to Notch Inn Bridge

**Management Unit Description**

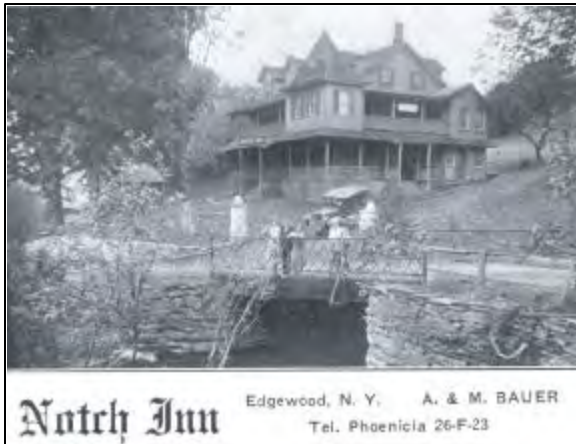
The photograph of the highway somewhere in the vicinity of Edgewood would suggest that maintenance of NYS Route 214 (and perhaps of the railroad bed as well in places) would have involved a recurrent struggle with erosion of the toe of the embankments by the stream during floods, as it still does (Fig. 4). The absence of large trees illustrates the extent of deforestation in the valley. Stacked rock walls were frequently used for bridge abutments and stream bank revetment (Fig. 3).

**Figure 3 (above) The Notch Inn, ca. 1920s**  
**Note that NYS Route 214 runs between the inn and the creek. This roadbed is still discernible behind the inn.**

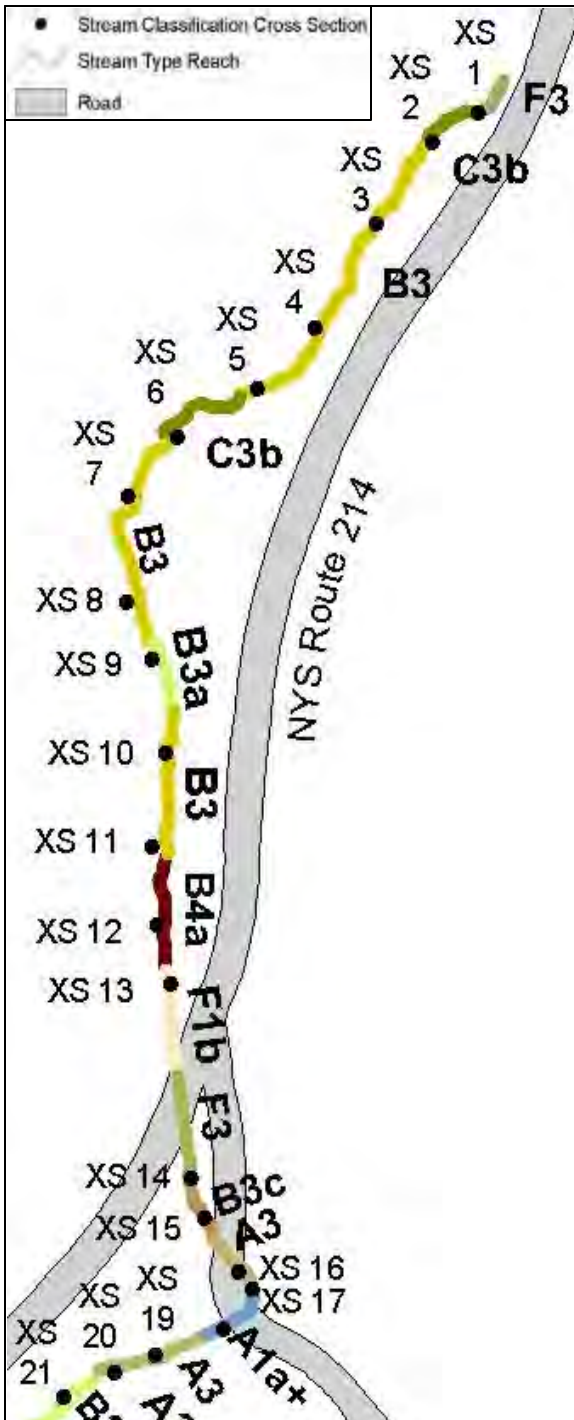
Figure 5 Cross-sections and Rosgen stream types in Management Unit 1

Stream morphology, or shape (i.e., slope, width and depth) changes frequently in this unit (Fig. 5), creating small reaches with differing morphologic characteristics, which are classified as different *stream types* (See Section 3.1 for stream type descriptions).

This management unit starts with a short 80 ft. reach of F3 stream (Fig. 6). This reach is dominated by small cobble bed material and is *entrenched*, or confined within its banks during flood events. This entrenchment is partially due to the 146 ft. cobble *berm* constructed on the right bank (Inset C). This old berm may once have protected a pasture or residence from flooding but presently the land use is forested. This berm prevents flood waters from spilling into the floodplain. As a result flood velocity is increased, which has caused moderate stream *degradation*, and which is destabilizing the adjacent road embankment.

The berm, however, has become vegetated with fairly mature woody vegetation, the benefits of which probably outweigh those of complete removal. Therefore, it is recommended that the berm be breached in strategic locations to provide floodplain access for stormwaters while preserving mature trees. The embankment could then be repaired using *bioengineering* techniques.

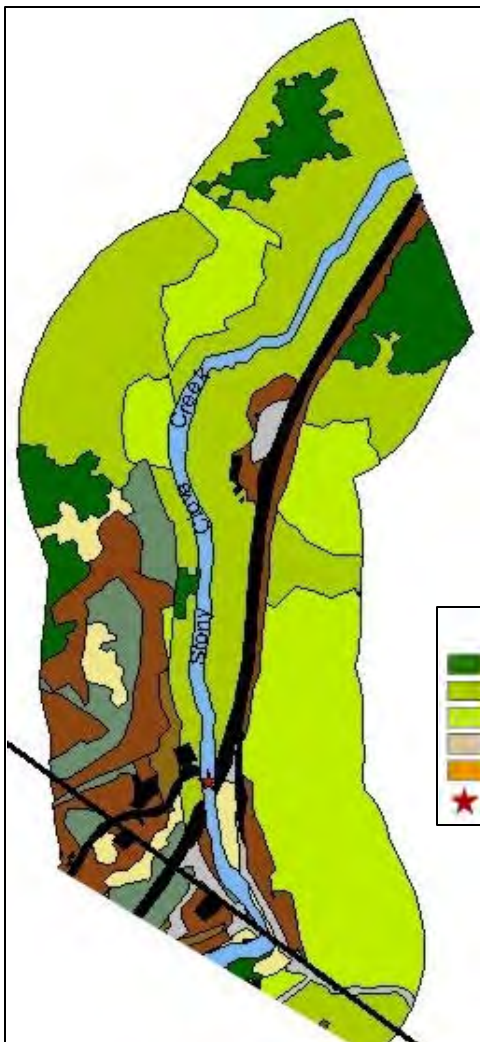
Figure 14 Riparian vegetation map for Management Unit 1

An analysis of vegetation was conducted using aerial photography from 2001 and field inventories (Fig. 14, Appendix A). Japanese knotweed occurrences were documented as part of the MesoHABSIM aquatic habitat inventory conducted during the summer of 2002 (Appendix B).

In June 2003, suitable riparian improvement planting sites were identified through a watershed-wide field evaluation of current riparian buffer conditions and existing stream channel morphology. These locations indicate where plantings of trees and shrubs on and near stream banks can help reduce the threat of serious bank erosion, and can help improve aquatic habitat as well. In some cases, eligible locations include stream banks where rock rip-rap has already been placed, but where additional plantings could significantly improve stream channel stability in the long-term, as well as biological integrity of the stream and floodplain. Areas with serious erosion problems where the stream channel requires extensive reconstruction to restore long-term stability have been eliminated from this effort. In most cases, these sites can not be effectively treated with riparian enhancement alone, and full restoration efforts would include re-vegetation components. No appropriate planting sites were documented within this management unit.

While excluded from the Streamside Planting Program described above due to the need to first treat the bank erosion problem, bioengineering treatments of eroding banks between the bridges adjacent to the Notch Inn are recommended. This treatment could include additional plantings in the riparian zone to improve buffer function and erosion resistance.

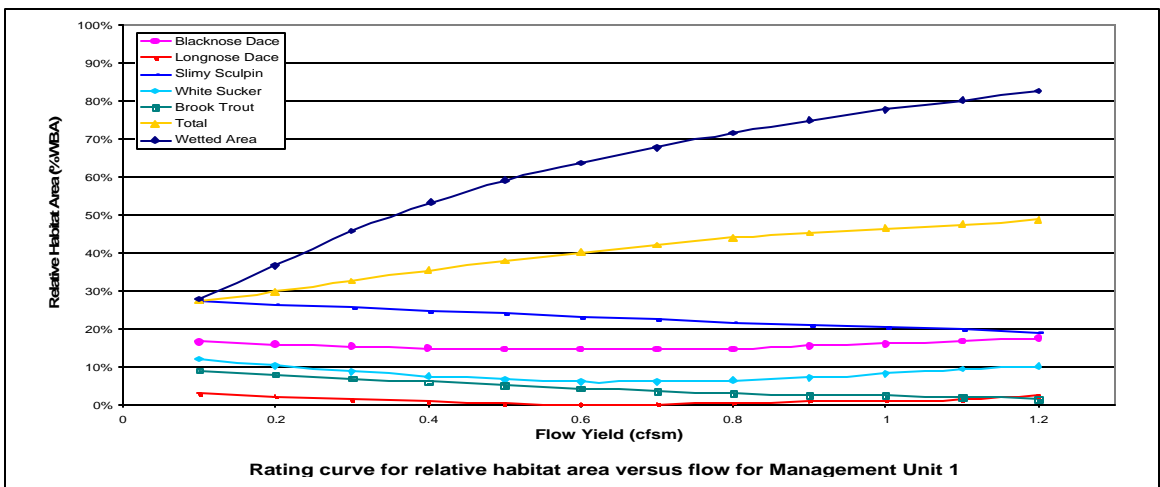
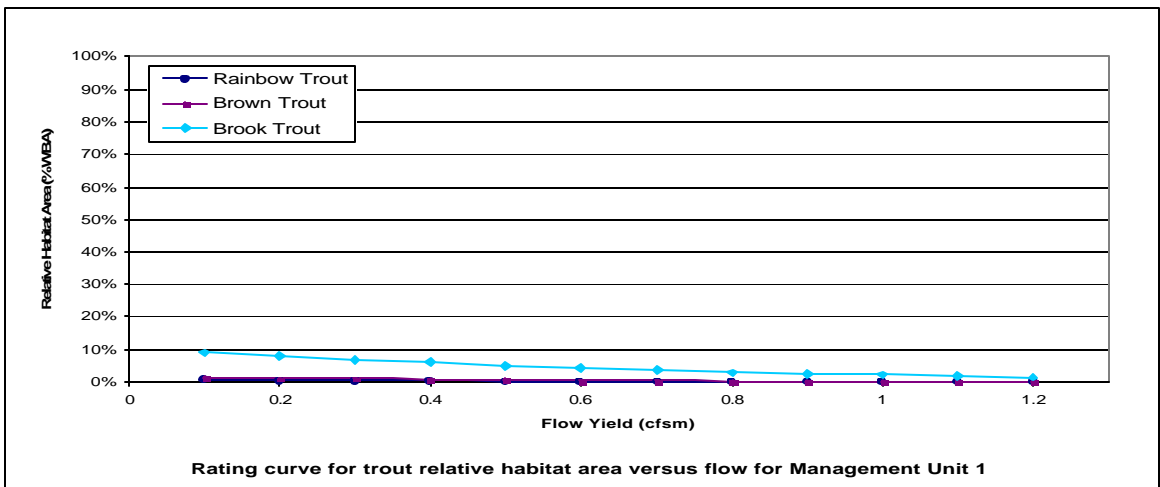
Figure 15 MesoHABSIM habitat rating curves for Management Unit 1

Management unit #1 is dominated by riffles and rapids and is shallow with relatively fast, diverse flow velocities. At very low flows, the *wetted area* is only a third of bankfull wetted area, but then increases steadily with flow to almost bankfull. At the lowest flow, almost the entire wetted area is suitable for the target community. Suitable area then declines with increasing flows to a little over half.

Slimy sculpin habitat fills the entire wetted area at 0.1 cfs/m and then declines slowly with increasing flow. Blacknose dace habitat is about half as large as slimy sculpin habitat for low flows, but then increases toward the same level as slimy sculpin at higher flow. White sucker follow the same trend as blacknose dace, with a minimum around 0.5 cfs/m. Brook trout habitat steadily declines with increasing flows and longnose dace has barely any habitat. Overall, habitat conditions are relatively stable. Of all investigated species, brook trout has the greatest disadvantage; it is one of the largest and most mobile species and also has very low levels of suitable habitat present, which decline with flow. Even at very low flows that could provide more habitat, rising water temperature poses serious limitations for brook trout. Interestingly, brown and rainbow trout do not have much prime habitat ( $p > 50\%$ ), but the amount of low quality habitat ( $p = 20\% - 50\%$ ) is still substantial. (See general recommendations for fish habitat improvement in Section 6.6)
