Management Unit 2

Greene County - Town of Hunter
Notch Inn Bridge to Cross Section 34

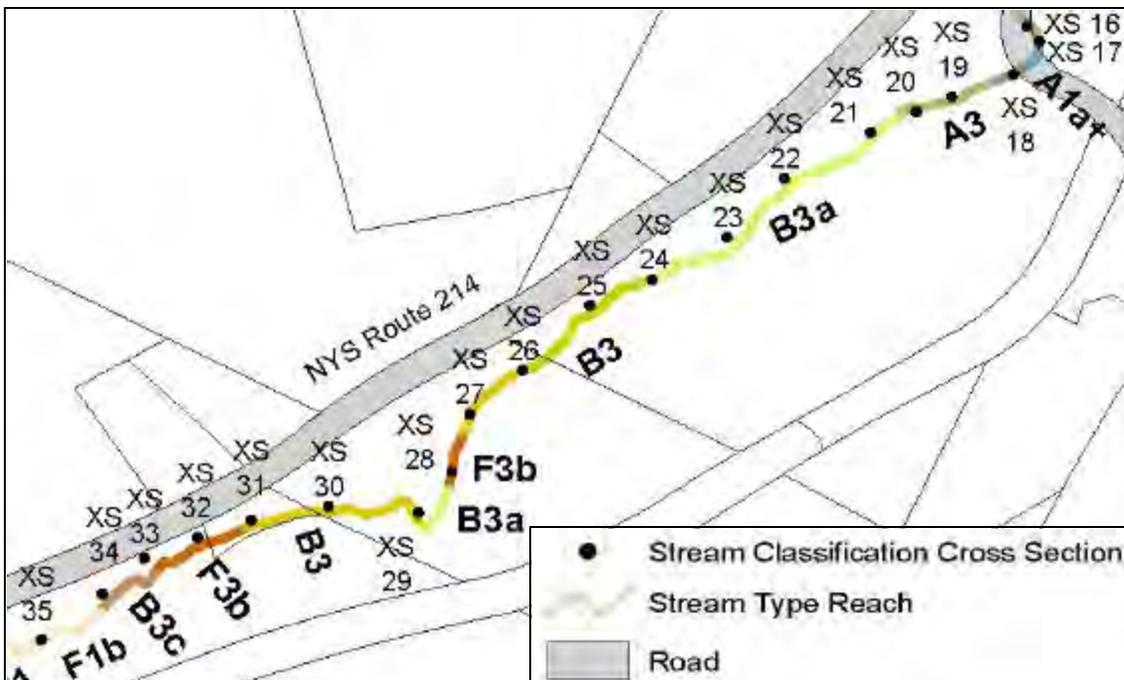
Figure 3 Cross-sections and Rosgen stream types for Management Unit 2

Stream morphology, or shape (i.e., slope, width and depth) changes frequently in this unit (Fig. 3), creating small reaches with differing morphologic characteristics, which are classified as different *stream types* (See Section 3.1 for stream type descriptions).

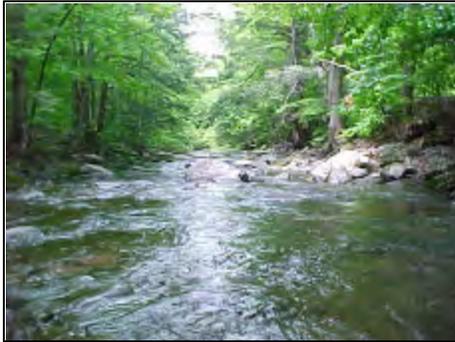
**Figure 14 Cross-section 32
Stream Type F3b**

Continuing downstream the channel widens and becomes entrenched, as stream type changes to F3b for this 248 ft. reach. The slope decreases slightly to 2.4%.

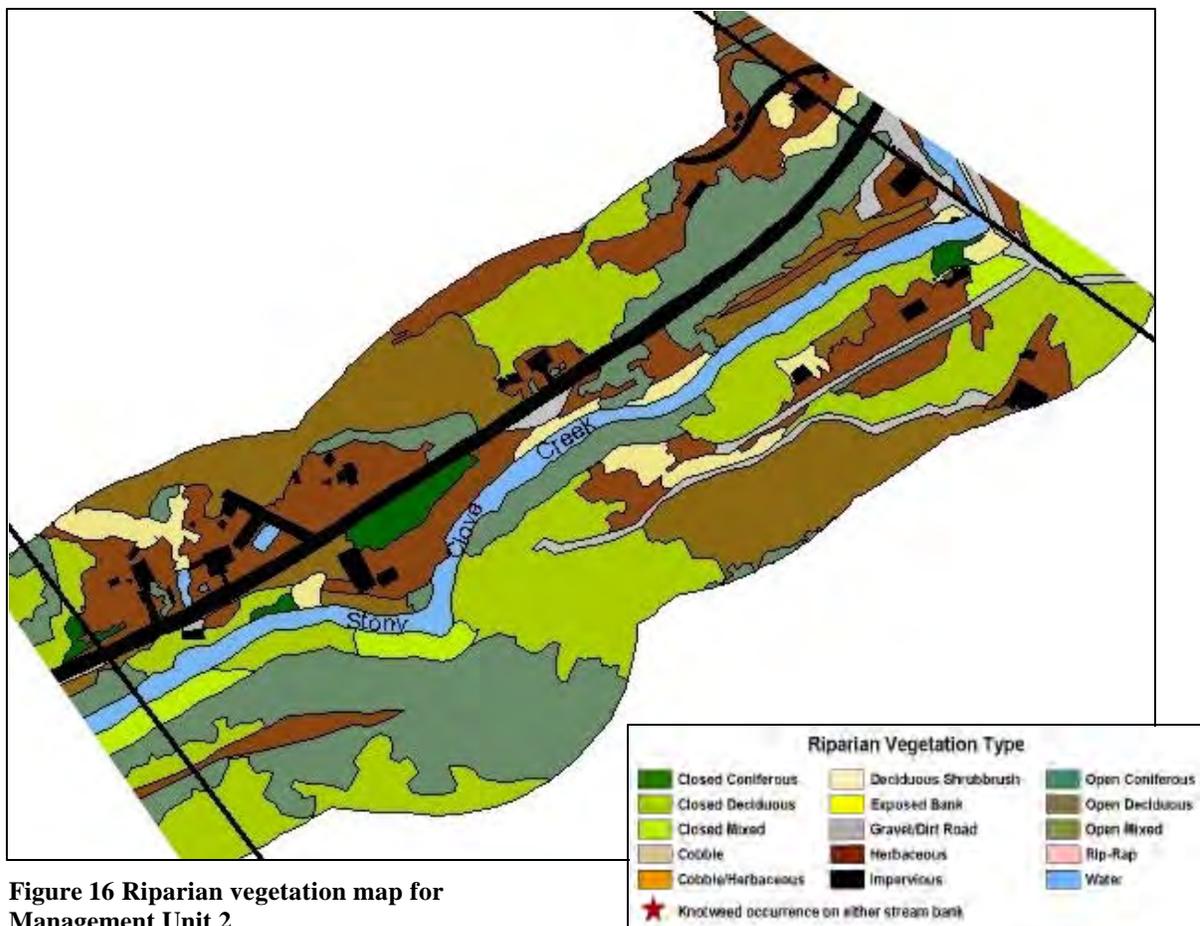
Figure 16 Riparian vegetation map for Management Unit 2

The predominant vegetation type within the 300 ft. buffer is forested (67%) followed by herbaceous (20%). Areas of herbaceous (non-woody) cover present opportunities to improve the riparian buffer with plantings of more flood-resistant species. *Impervious* area (6%) within this unit's buffer is primarily the NYS Route 214 roadway and private residences.

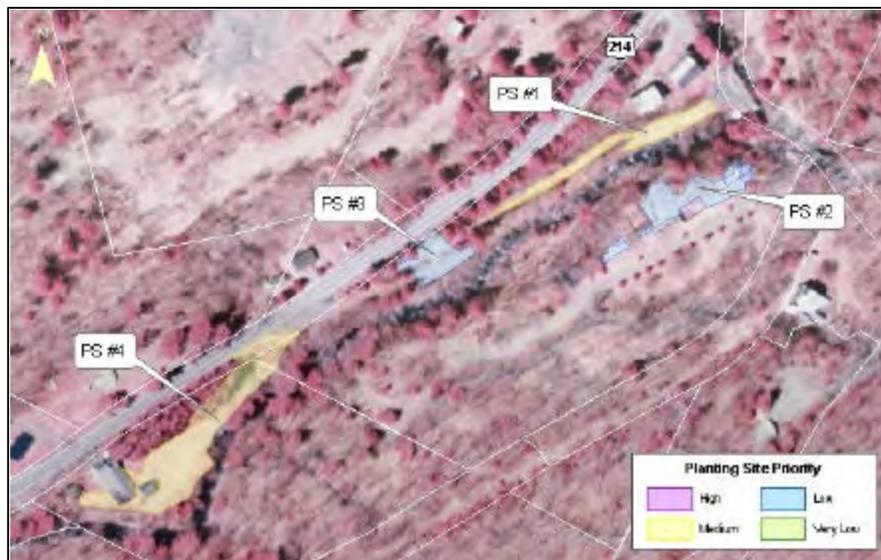
Figure 17 Planting sites location map for Management Unit 2

In June 2003, suitable riparian improvement planting sites were identified through a watershed-wide field evaluation of current riparian buffer conditions and existing stream channel morphology (Fig. 17). These locations indicate where plantings of trees and shrubs on and near stream banks can help reduce the threat of serious bank erosion, and can help improve aquatic habitat as well. In some cases, eligible locations include stream banks where rock rip-rap has already been placed, but where additional plantings could significantly improve stream channel stability in the long-term, as well as biological integrity of the stream and floodplain. Areas with serious erosion problems where the stream channel requires extensive reconstruction to restore long-term stability have been eliminated from this effort. In most cases, these sites can not be effectively treated with riparian enhancement alone, and full restoration efforts would include re-vegetation components. Four appropriate planting sites were documented within this management unit.

Planting site #1 is located at the top of the management unit on the right bank at Notch Inn (Fig. 18). At the top of the stacked rock wall is a narrow swath of trees and shrubs, along which runs a relic alignment of NYS Route 214, which is currently mowed. To improve buffer function of the riparian zone here, it is recommended to plant this mowed area with native trees and shrubs.

Planting site #2 (Fig. 19) is also located at the top of the management unit, at an old campground which is no longer in use, at the top of the left bank. A large mowed grass area still exists at this campground. To improve the buffer function of this area, it is recommended to plant this mowed area with native trees and shrubs.

Planting site #3 is a gravel and grass pullout area on NYS Route 214 (Fig. 20). There are currently a few trees on this steep right bank. To improve buffer function, it is recommended to plant this mowed area with native trees and shrubs. Shrub plantings may be preferred at this site as there is a telephone line above the site. Depending on landowner use of this area, the gravel pullout area or a portion of this area should also be considered for similar plantings.

Planting site #4 is located at the newly renovated red barn on the right side of NYS Route 214 (Fig. 21). The right stream bank located on this property is fairly steep with scattered trees and shrubs. This stream bank is slightly eroded and is susceptible to erosion in the future. To reduce this risk the stream bank should be planted with trees and shrubs. Due to the steepness of this bank, use of a *geotextile* may be necessary to ensure planting success. To improve buffer function in this area, it is recommended to plant the mowed area with native trees and shrubs. If this option is

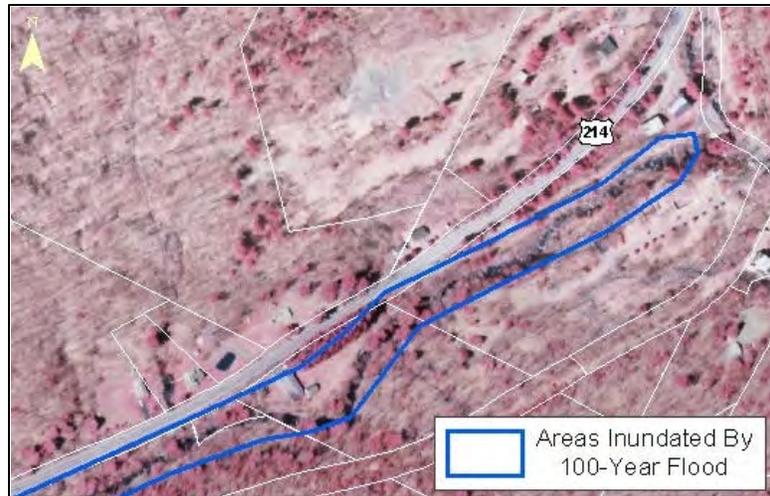
Figure 22 100-year floodplain boundary in Management Unit 2

According to the NFIP maps, there are two houses located within the 100-year flood boundary in this management unit (Fig. 22). The current NFIP maps are available for study at the Greene and Ulster County Soil & Water Conservation District offices.

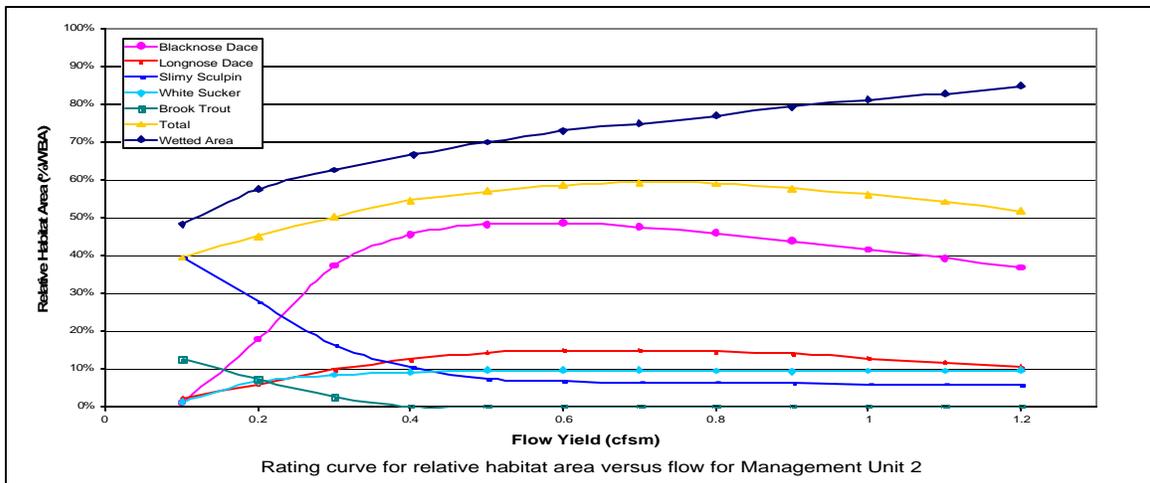
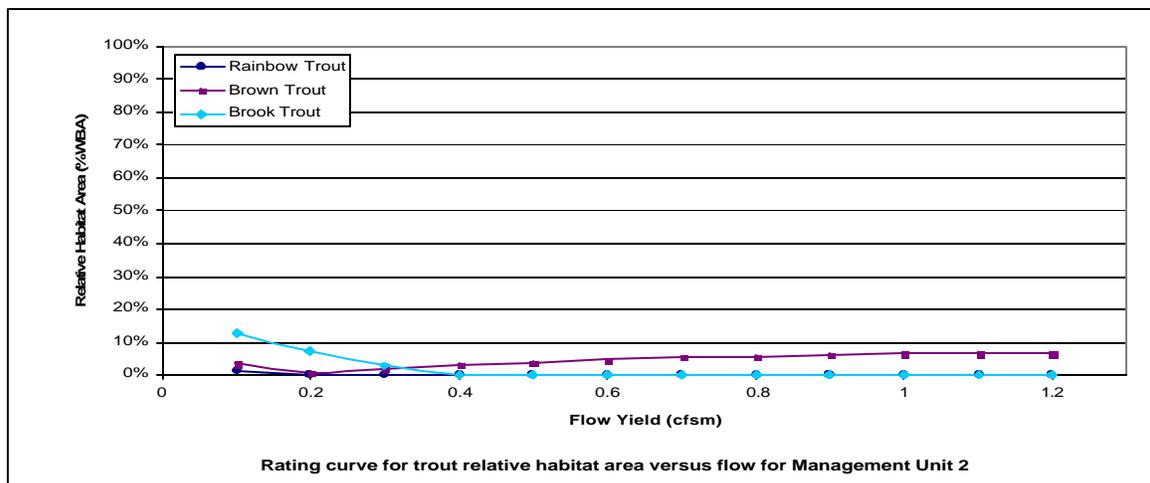
Figure 23 MesoHABSIM habitat rating curves for Management Unit 2

This management unit is comprised largely of cascades and has some rip-rap, woody debris, and canopy cover. It is a shallow area with relatively fast, but varying velocities. At very low flows, wetted area is half the size of bankfull wetted area and increases steadily to 90% of bankfull wetted area at 1.5 cfs/m. At the highest measured flows, the size of the management unit increases only laterally, not lengthwise. Overall habitat increases gradually until mid-flows, when it then declines. The largest amount of habitat is available for blacknose dace, whose rating curve increases steeply at low flows and then gradually declines. The amount of habitat considered to be excellent for slimy sculpin declines sharply with flow. White sucker and longnose dace have relatively stable, moderate levels of habitat available. With the exception of lowest flows, no habitat is available for brook trout. Rainbow and brown trout have only low levels of habitat available.
