**Management Unit 4**  
Greene County - Town of Hunter  
Cross Section 65 to Cross Section 90

**Management Unit Description**

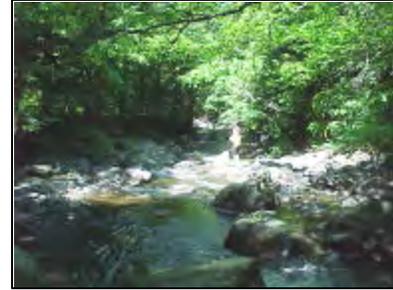
**Figure 5 Cross-section 66  
Stream Type B3a**

Management unit #4 begins with a B3 stream type for the first 32 ft. The stream channel is moderately *entrenched* with a slope of 3.3% and cobble-dominated channel bed material. At the end of this reach, the slope increases significantly, to 5.3%, changing the stream type to B3a for the next 106 ft. (Fig. 5).

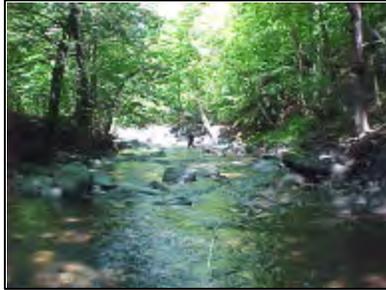
**Figure 6 Cross-section 67  
Stream Type F3**

As the stream continues, it becomes entrenched, preventing floodwaters from spilling onto the floodplain. Stream slope flattens to 1.7% through this 137 ft. F3 stream reach (Fig. 6).

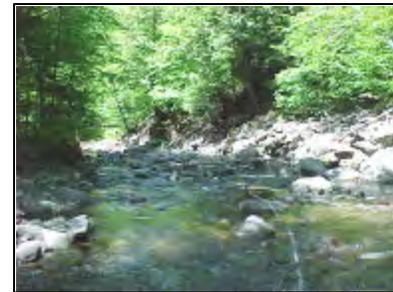
**Figure 7 Cross-section 68  
Stream Type B3**

entrenched with a channel slope of 3.2% (Fig. 7). Rip-rap has been placed along 67 ft. of the upstream portion of an outside meander bend on the right stream bank, at the bottom of this reach (Inset D). Stream bank erosion often occurs on the outer banks of streams where velocity is greatest.

As the stream transitions into a B3 stream type for the next 117 ft., it becomes moderately

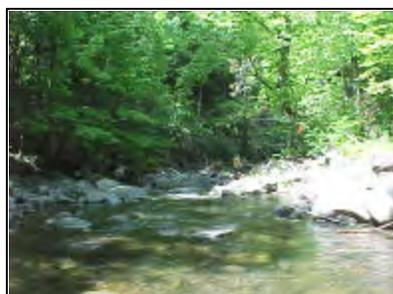
**Figure 8 Cross-section 69  
Stream Type F3b**

In the middle of the meander bend, at the end of the rip-rap section, stream type changes to F3b (Fig. 8). This 183 ft. reach is entrenched, with a wider cross section compared to other sections of this unit. The slope remains fairly steep, at 3.4%.

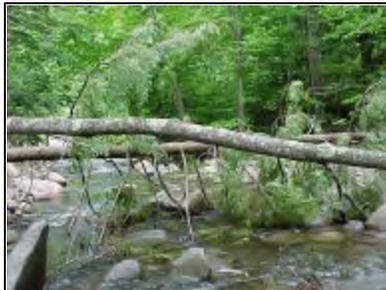
**Figure 11 Cross-section 71  
Stream Type B4**

Approximately halfway through bank erosion site #8, stream slope decreases to 3.3% as stream type changes to B4 (Fig. 11). This 116 ft. reach remains moderately entrenched with coarse gravel bed material.

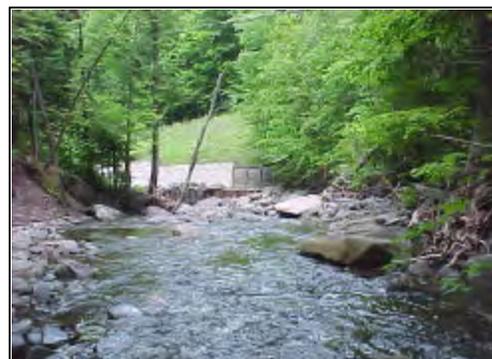
**Figure 12 Cross-section 72  
Stream Type F3b**

Downstream of Myrtle Brook, the stream becomes entrenched and dominant channel material size increases to cobble (Fig. 12). This

F3b stream reach is 81 ft. in length with a slope of 2.5%. Bank erosion site #8 ends at the bottom of this reach. There is a large clay-rich exposure of lodgement till on the left bank (Fig. 13).

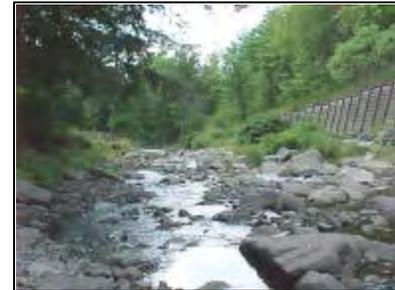
**Figure 15 Cross-section 75  
Stream Type F3b**

Aggradation also steepens stream channel gradient downstream of the deposition site. This proves true for the next 578 ft. reach of F3b stream type (Fig.15). Slope at the top of this entrenched reach increases to 4.1%. Along 217 ft. of the right bank, road embankment protection continues as concrete T-wall with sheet piling at the toe (Inset C). After the first 50 ft. of this reach, stream slope decreases to 2.3%

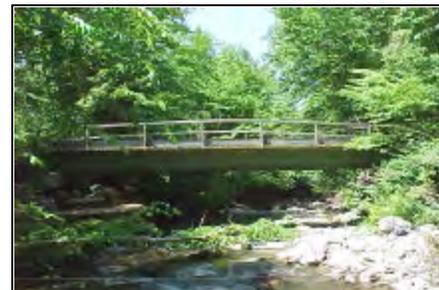
**Figure 18 Private Bridge**

Proceeding downstream, the channel once again widens and becomes entrenched. Stream type changes to F3b with the slope remaining nearly constant at 3%. Near the top of this reach, the stream passes under a private bridge (Fig. 18). This bridge appears to be in good condition and to have adequate capacity to pass high flow events. There are no records of NYS DEC stream disturbance permits for this bridge.

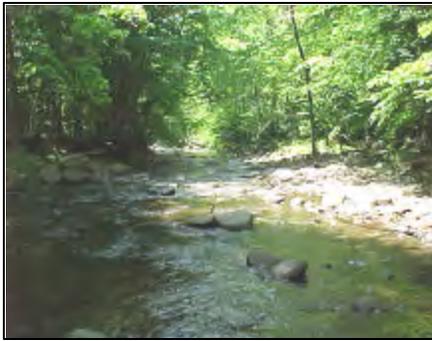
**Figure 19 Cross-section 81  
Stream Type C3**

Continuing downstream, the channel reconnects with its floodplain, the stream straightens and the slope flattens to 1.7% (Fig. 19). A small gravel bar has formed on the right bank. Gravel bar formation is typical of C3 type streams.

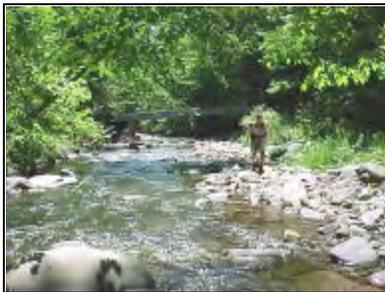
**Figure 21 Cross-section 83  
Stream Type F3b**

As the channel begins to meander toward the right bank, stream type changes to F3b (Fig. 21) for the next 421 ft. of stream. Once again the stream becomes entrenched, unable to access its floodplain and steepens to 2.8%.

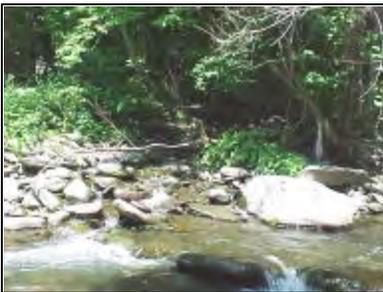
**Figure 24 Tributary**

Near the bottom of this reach, another tributary enters the creek from the right bank (Fig. 24). This unnamed tributary, over a mile in length, begins on the steep slopes of South West Hunter Mountain, runs along Heavenly Valley Road, and finally crosses under NYS Route 214 to enter the Stony Clove. This tributary is rated D, under the NYS DEC best usage classification system. This is the lowest classification indicating the water is only suitable for fishing.

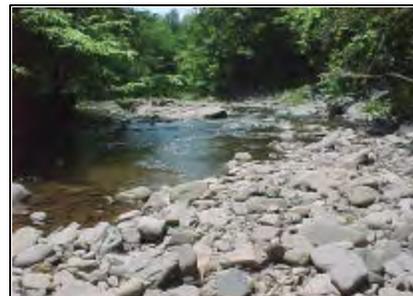
**Figure 25 Cross-section 86  
Stream Type B3c**

As the stream widens and slope flattens to 1.6%, stream type changes to B3c for 190 ft. (Fig. 25). There is sparse vegetation at the residential property along the right stream bank. This area would benefit from upland plantings to increase the stream riparian buffer. This reach appears to be aggrading. Aggradation steepens stream channel gradient downstream of the deposition site.

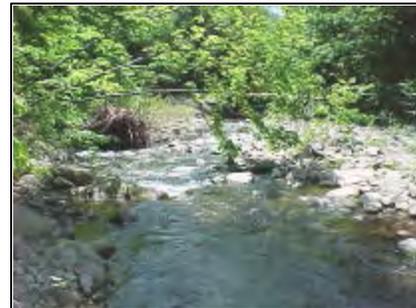
**Figure 28 Cross-section 90  
Stream Type F3**

As the stream narrows to pass under a private bridge near the bottom of this management unit, stream type changes to F3 for the last 88 ft. of this management unit (Fig. 28). There is a large gravel deposit along the right stream bank. Inadequate sizing of bridge openings commonly causes gravel deposits upstream of bridges. An undersized bridge opening (i.e., too narrow) causes water to back up upstream of the bridge, reducing stream velocity, which results in sediment deposition. At high stage, floodwater may seek conveyance through alternative paths, forming new channels around the

The history of stream disturbance permits indicates that the third private bridge in this management unit has been severely damaged in past flood events, is currently impassable, and may be constricting and diverting flood flows. This bridge should be evaluated for upgrade or removal.
