Management Unit 5
Greene County - Town of Hunter
Cross Section 90 to Cross Section 107

Management Unit Description

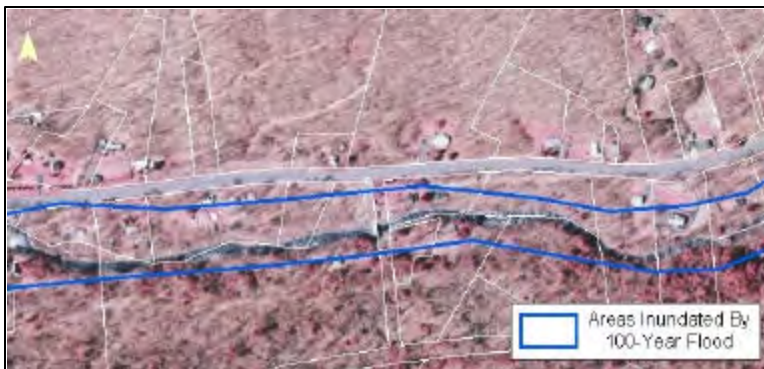
Figure 26 100-year floodplain boundary in Management Unit 5

According to the NFIP maps, there are eighteen houses located within the 100-year flood boundary in this management unit (Fig. 26). The current NFIP maps are available for review at the Greene and Ulster County Soil & Water Conservation District offices.
