Management Unit 9
Greene County - Town of Hunter
Cross Section 131 to Cross Section 135

Management Unit Description

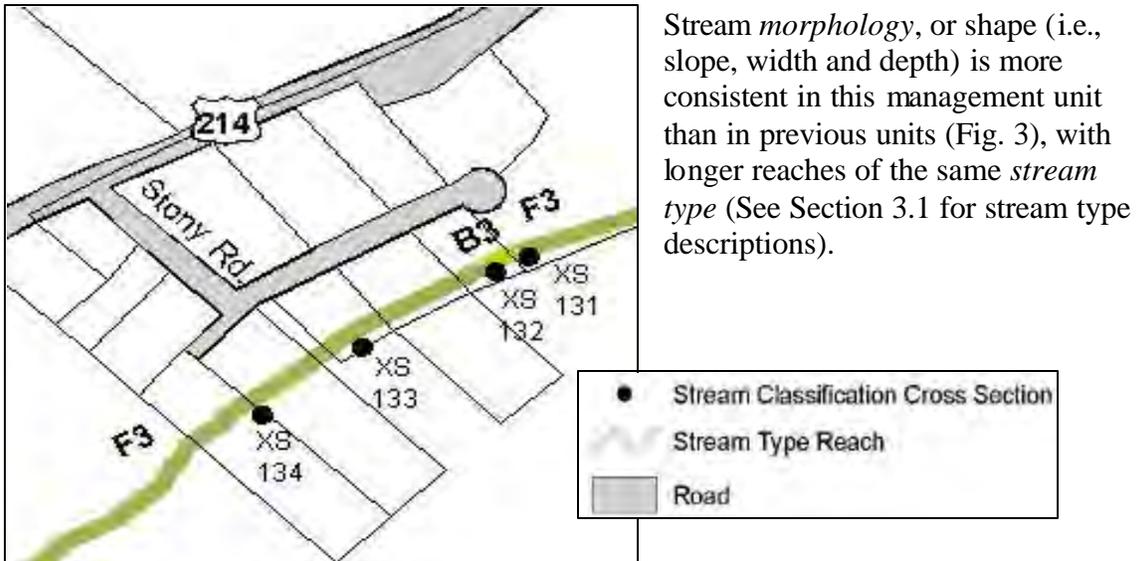
Figure 3 Cross-section and Rosgen stream types in Management Unit 9

The predominant stream type in this unit is “F” channel, which are usually deeply *incised* with flat channel slopes, and subject to sediment supply fluctuations. This unit however appears to be relatively stable with minimal sediment yield from the bed and banks.

Management unit #9 begins downstream from cross-section 131, with a short 19 ft. reach of F3 stream type. This stream reach is *entrenched*, or it is confined within the stream banks during high flow events. Channel slope is fairly flat at 1.9% and the dominant bed material is cobble.

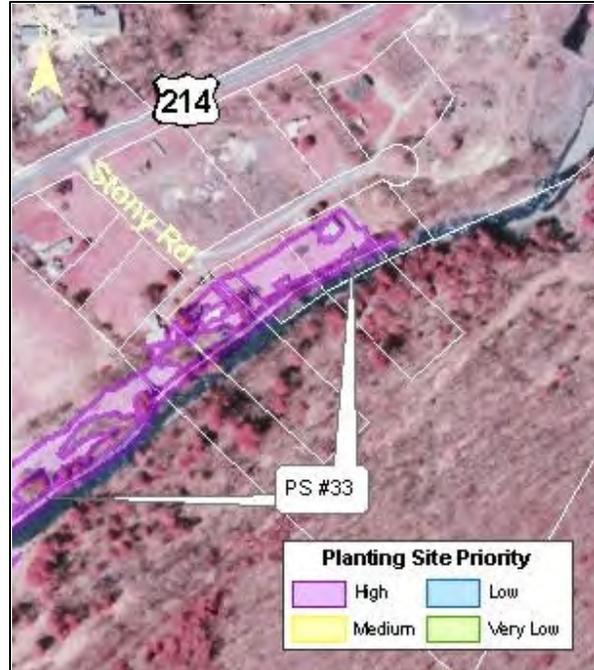
Figure 8 Planting site location map for Management Unit 9

In June 2003, suitable riparian improvement planting sites were identified through a watershed-wide field evaluation of current riparian buffer conditions and existing stream channel morphology (Fig. 8). These locations indicate where plantings of trees and shrubs on and near stream banks can help reduce the threat of serious bank erosion, and can help improve aquatic habitat as well. In some cases, eligible locations include stream banks where rock rip-rap has already been placed, but where additional plantings could significantly improve stream channel stability in the long-term, as well as biological integrity of the stream and floodplain. Areas with serious erosion problems where the stream channel requires extensive reconstruction to restore long-term stability have been eliminated from this effort. One appropriate planting site was documented within this management unit.

Planting site #33 is located on six separate residential properties on the right stream bank, beginning along Stony Road (Fig. 9). Presently there is scattered vegetation along the stream and upland grass lawn areas on these properties. It is recommended to plant native tree and shrub species along the stream bank to increase the density of vegetation. It is also recommended to increase the upland buffer width as much as possible. This will increase the buffer functionality and improve stream bank stability while still allowing a lawn area.

Along the stream bank of the first property, approximately 110 ft. of rip-rap has been installed (Inset D). Inserting plant materials into the soil between rip-rap rocks, or *joint planting*, is recommended. Joint planting will strengthen and increase the longevity of this wall. These plantings will also improve the aquatic habitat by providing shade, thereby cooling water temperatures.

The stream channel along this reach is overwide. Planting native willow and sedge species along both sides of the stream is recommended. These plantings will encourage the stream channel to narrow, improving stream habitat and function.

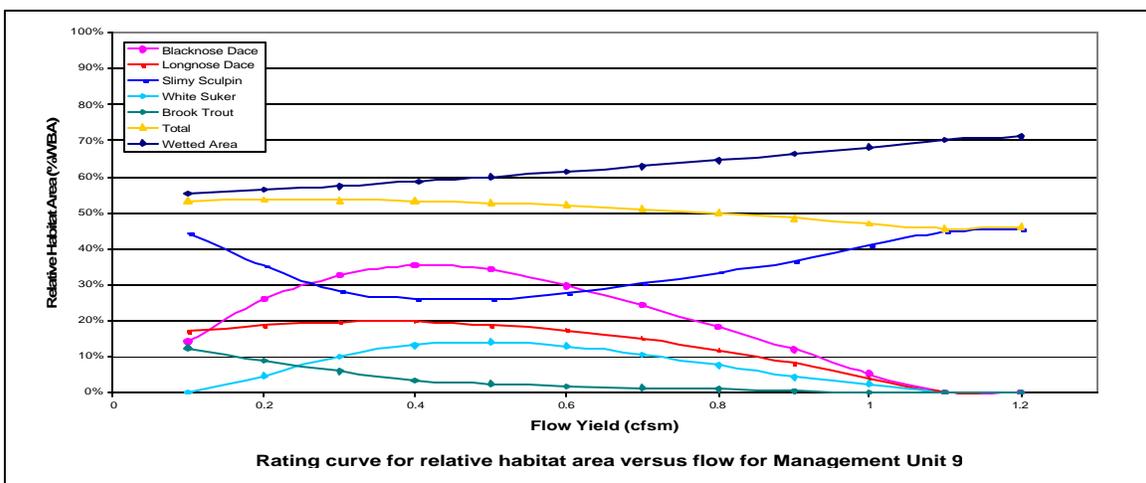
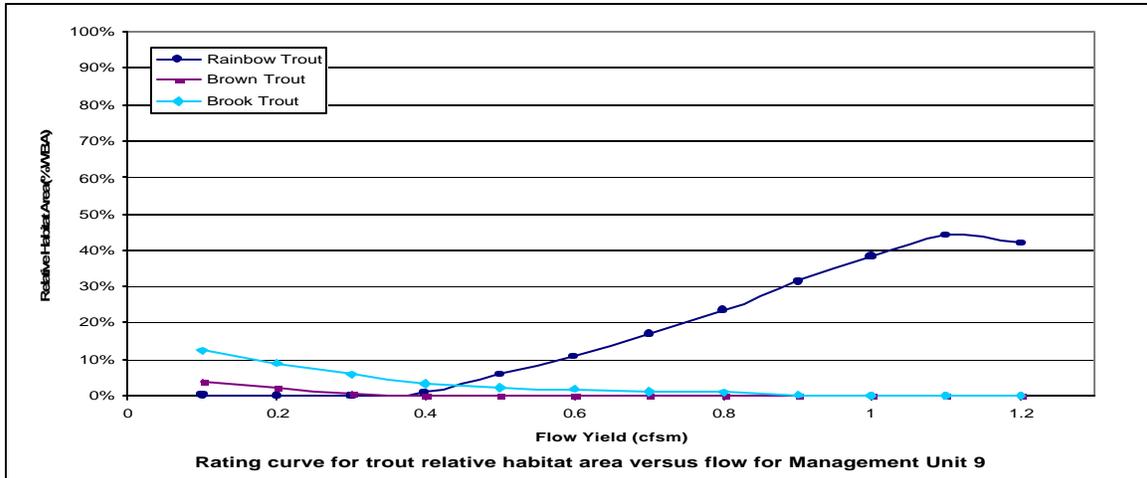
Figure 11 MesoHABSIM habitat rating curves for Management Unit 9

Management unit #9 contains boulders, a small amount of overhanging vegetation, and substrate that is small in size. At investigated flows, the water covers from 55% to 80% of the bankfull *wetted area*. Wetted area increases steadily as flow increases, but hydro-morphological units change dramatically. This is reflected in the strong habitat suitability changes for individual species across the flows, even though the overall amount of habitat stays constant. Slimy sculpin loses habitat and then gains it back at higher flows. Both dace species and white sucker species show habitat increases until 0.3 cfs, and then a complete loss above 1.0 cfs. Brook trout has very little habitat except at very low flows, however, this habitat is probably useless due to thermal impacts. The brown trout has low levels of poor habitat and only rainbow trout shows a significant increase in habitat suitability at higher flow levels. Overall, this unit has poor habitat conditions due to constant hydro-morphological fluctuations and a lack of permanently available habitat.

Implementation of planting recommendations in this unit would provide significant benefit to habitat quality. These plantings would encourage deeper holding pools to develop while mitigating thermal impacts. (See Section 6.6 general recommendations for aquatic habitat improvement)
