Management Unit 10
 Greene County - Town of Hunter
 Cross Section 135 to Bank Erosion Monitoring Site #18

Management Unit Description

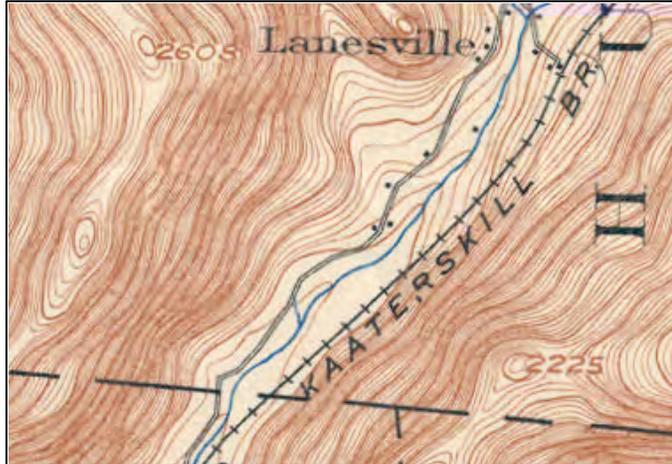
Figure 2 Excerpt from USGS 15’ topo, 1903

In most of this management unit, just upstream of the county line, there were no buildings indicated on the Geological Survey’s 1903 15’ topographic map, despite the fairly broad, flat valley bottom landform (Fig. 2). A map of forest cover also indicates that the floodplain here remained forested until that same date. The rail line hugs the southeast valley wall. This evidence suggests that much of the floodplain in this unit may have historically been forested wetland.

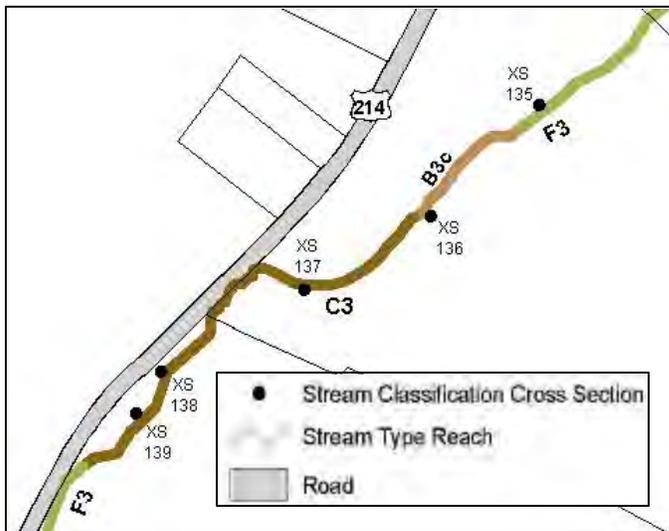
Figure 4 Cross-sections and Rosgen stream types in Management Unit 10

Stream morphology, or shape (i.e., slope, width and depth) changes several times in this unit (Fig. 4), creating reaches with differing morphologic characteristics, which are classified as different *stream types* (See Section 3.1 for stream type descriptions).

Management unit #10 begins slightly up stream from cross section 135, with a 171 ft. reach of F3 stream type (Fig. 5 & Inset D). This reach is *entrenched*, or confined within the stream banks during high flow events. Channel slope is fairly flat at 1.4%, and the dominant bed material is cobble. The channel is wide, shallow and straight. Despite entrenched conditions, the toe of the stream banks remains fairly

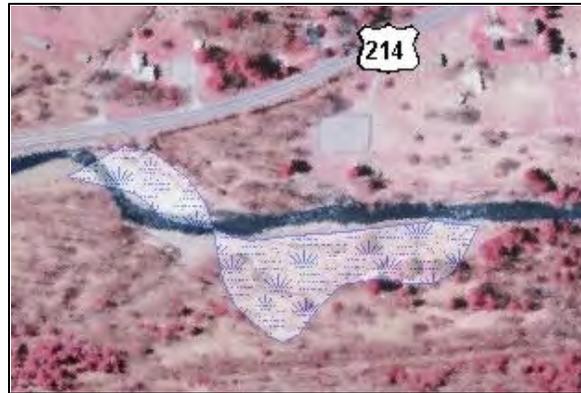
Figure 9 Federally Designated Wetlands

There are two federally designated wetlands in this reach, totaling 2.8 acres (Fig. 9). These wetlands are characterized as riverine upper perennial with an unconsolidated shore, and are temporarily flooded. Wetlands are recognized as important features in the landscape that provide numerous beneficial services for people and for fish and wildlife. These functions include protecting and improving water quality, providing fish and wildlife habitat, storing floodwaters,

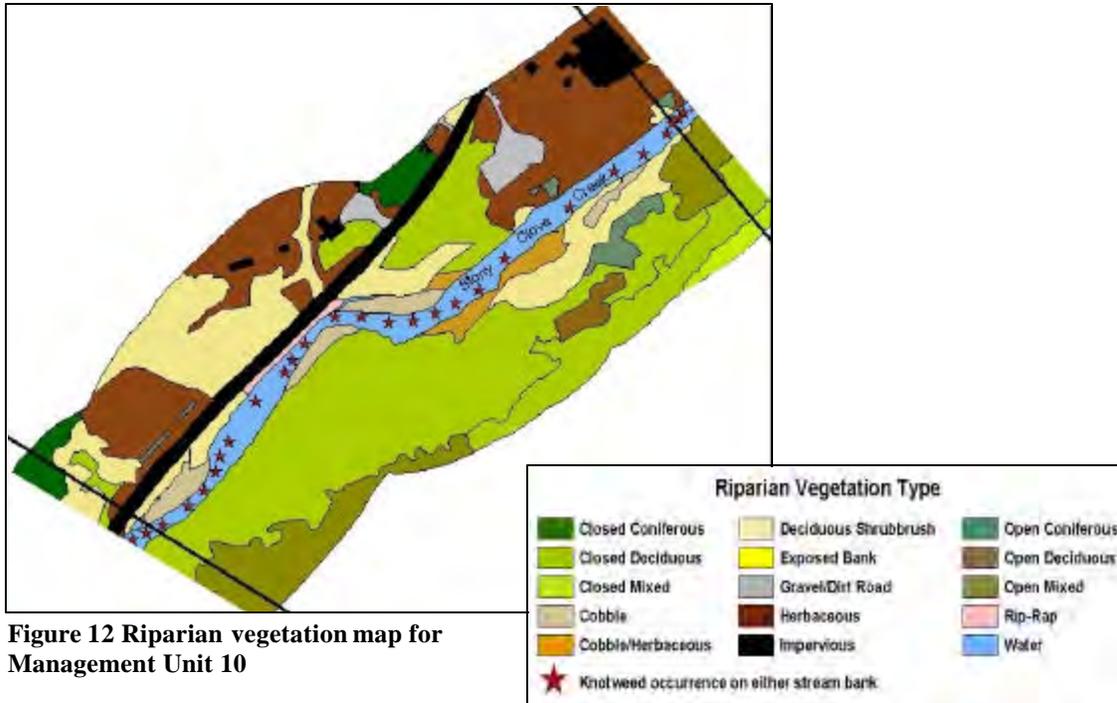
Figure 12 Riparian vegetation map for Management Unit 10

The predominant vegetation type within the 300 ft. riparian buffer is forested (50%) followed by herbaceous (20%) and deciduous shrubbrush (17%). Areas of herbaceous (non-woody) cover present opportunities to improve the riparian buffer with plantings of more flood-resistant species. *Impervious* area (6%) within this unit's buffer is primarily the NYS Route 214 roadway and private residences.

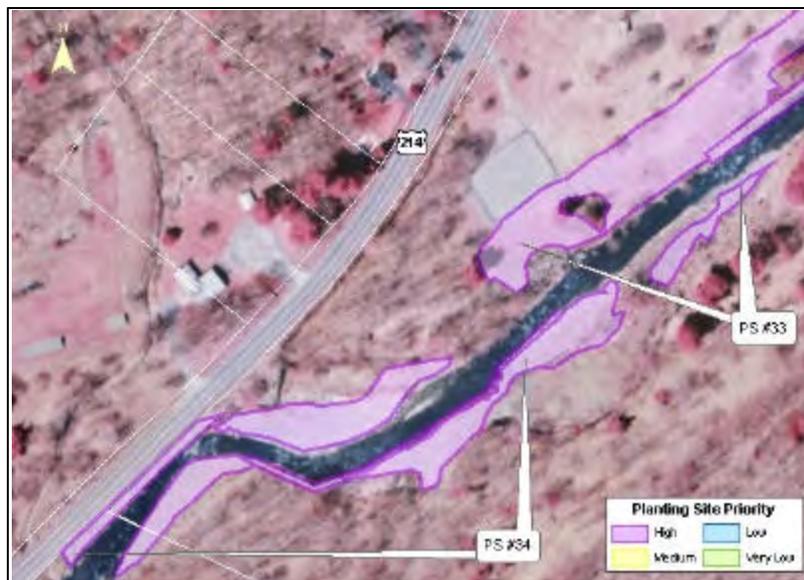
Figure 13 Planting site location map for Management Unit 10

In June 2003, suitable riparian improvement planting sites were identified through a watershed-wide field evaluation of current riparian buffer conditions and existing stream channel morphology (Fig. 13). These locations indicate where plantings of trees and shrubs on and near stream banks can help reduce the threat of serious bank erosion, and can help improve aquatic habitat as well. In some cases, eligible locations include stream banks where rock rip-rap has already been placed, but where additional plantings could significantly improve stream channel stability in the long-term, as well as biological integrity of the stream and floodplain. Areas with serious erosion problems where the

stream channel requires extensive reconstruction to restore long-term stability have been eliminated from this effort. In most cases, these sites can not be effectively treated with riparian enhancement alone, and full restoration efforts would include re-vegetation components. Two appropriate planting sites were documented within this management unit.

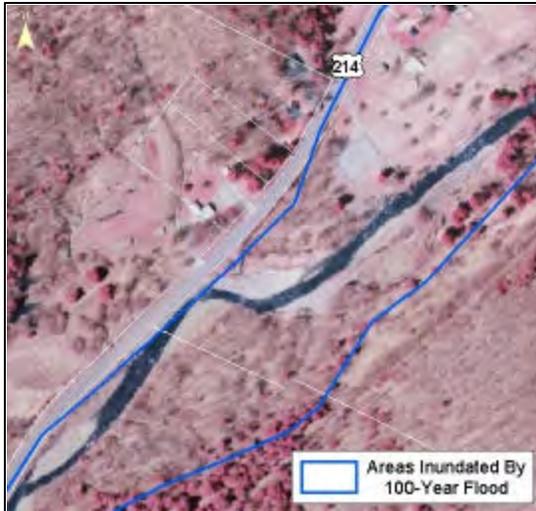
Figure 16 100-year floodplain boundary of Management Unit 10

According to the NFIP maps, there is one house located within the 100-year floodplain boundary in this management unit (Fig. 16). The current NFIP maps are available for review at the Greene and Ulster County Soil & Water Conservation District offices.

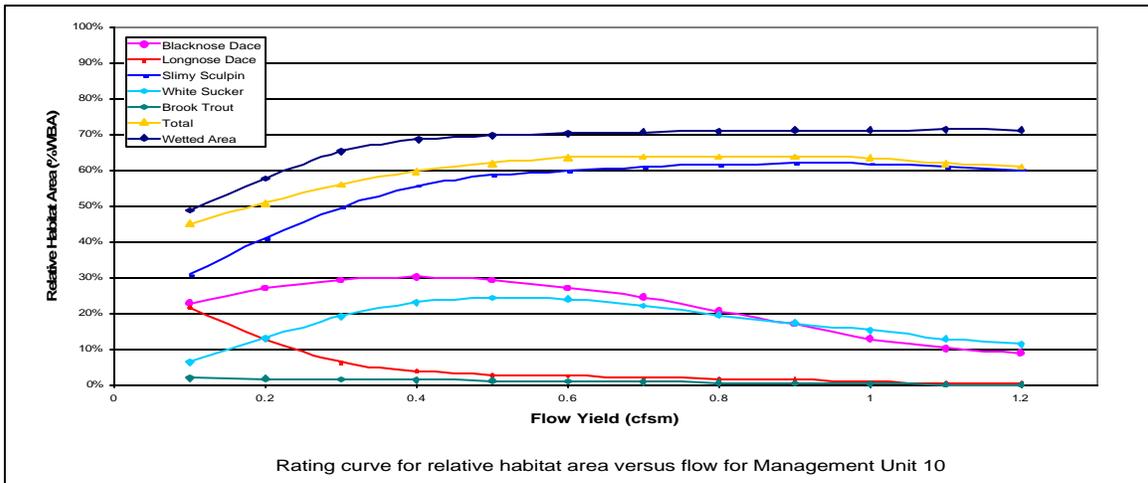
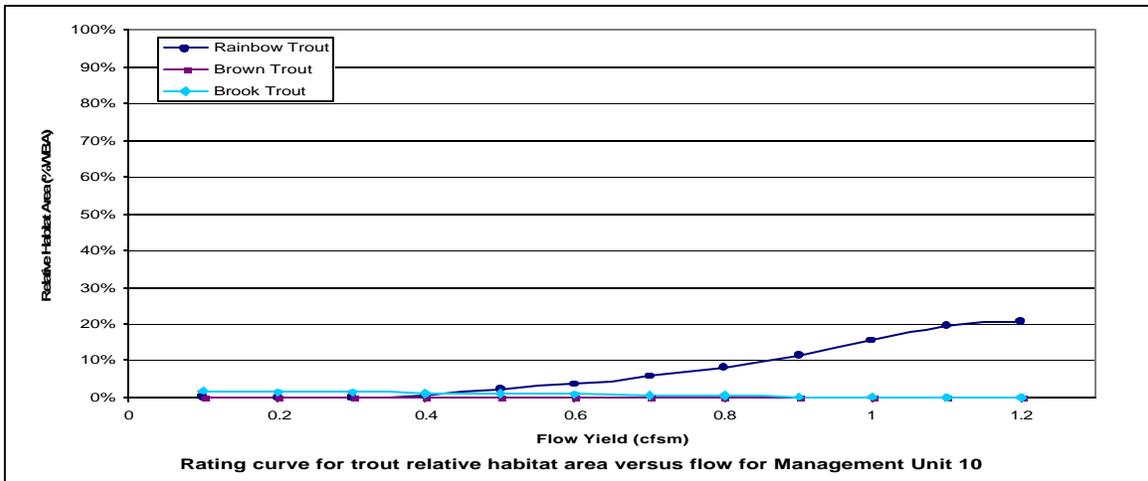
Figure 17 MesoHABSIM habitat rating curves for Management Unit 10

Management unit #10 is channelized through much of its length. The substrate found in this unit is smaller in size than that found upstream. Some woody debris and shallow margins are present. *Wetted area* increases sharply until 0.4 cfs/m, above which it stays constant at a 70% level. The fluctuations in habitat levels with flow are less dramatic than those found in management unit #9. Hydro-morphological units (HMUs) are fewer and larger in area. Both dace species and white sucker lose their habitat with increasing flow. Brook trout habitat is very low, whereas the remaining two trout species have some usable habitat available.
