## Management Unit 13

Ulster County - Town of Shandaken  
Between Cross Section 149 & 150 to Cross Section 153

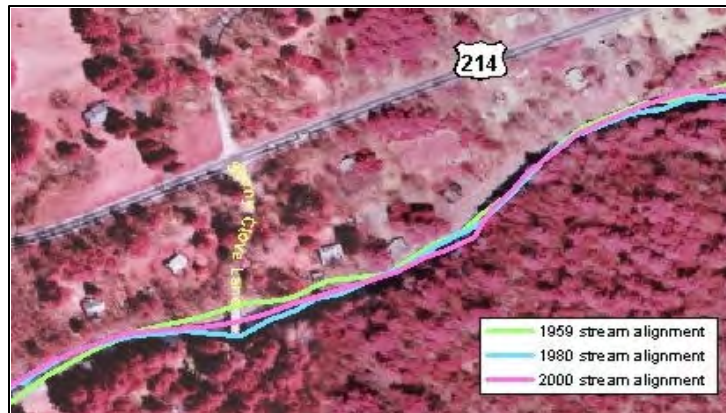
Figure 3 Historical stream channel alignment in Management Unit 13

Historical channel alignments indicate that the *planform* of the stream has not changed to any significant degree since 1959, with the exception of the reaches directly upstream and downstream of the bridge at Stony Clove Lane (Fig. 3). Upstream of the bridge, the channel is confined by a “pinch point” in the valley form.

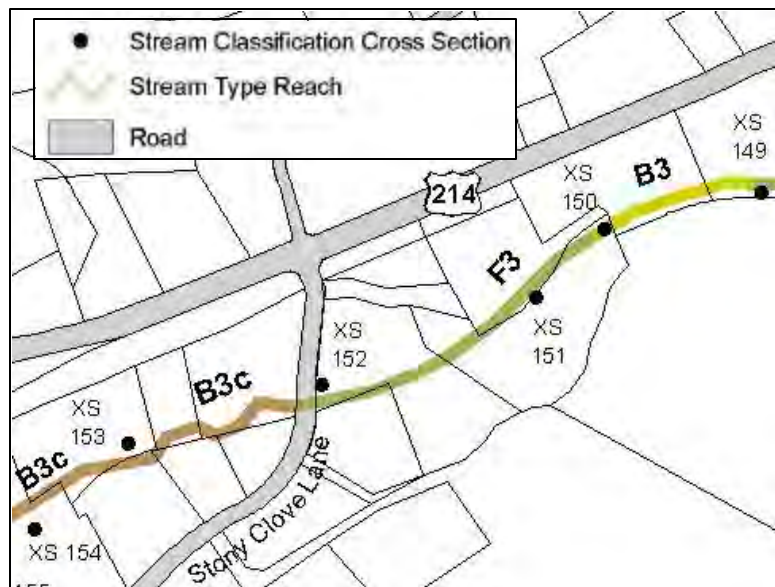
**Figure 5 Cross-sections and Rosgen stream types in Management Unit 13**

The stream morphology, or shape (i.e., slope, width and depth) changes several times in this unit (Fig. 5), creating reaches with differing morphologic characteristics, which are classified as different *stream types* (See Section 3.1 for stream type descriptions).

Management unit #13 begins with a 320 ft. reach of B3 stream type (Fig. 6). This stream reach is moderately *entrenched*, or confined within the stream banks during high flow events. Stream channel slope is 2.1% and the dominant bed material is cobble.

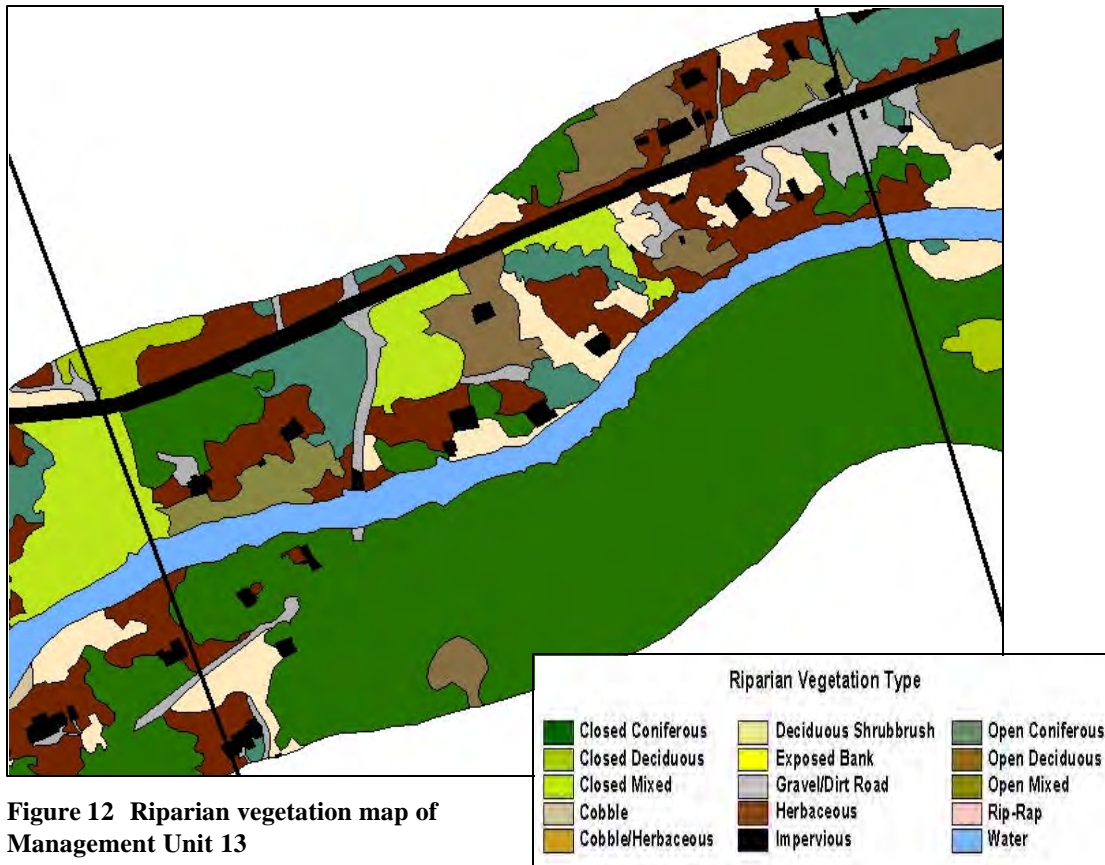
**Figure 12 Riparian vegetation map of Management Unit 13**

The predominant vegetation type within the 300 ft. riparian buffer is forested (71%) followed by herbaceous (14%) and deciduous shrubbrush (6%). Areas of herbaceous (non-woody) cover present opportunities to improve the riparian buffer with plantings of more flood-resistant species. *Impervious* area (6%) within this unit's buffer is primarily the NYS Route 214 roadway and private residences.

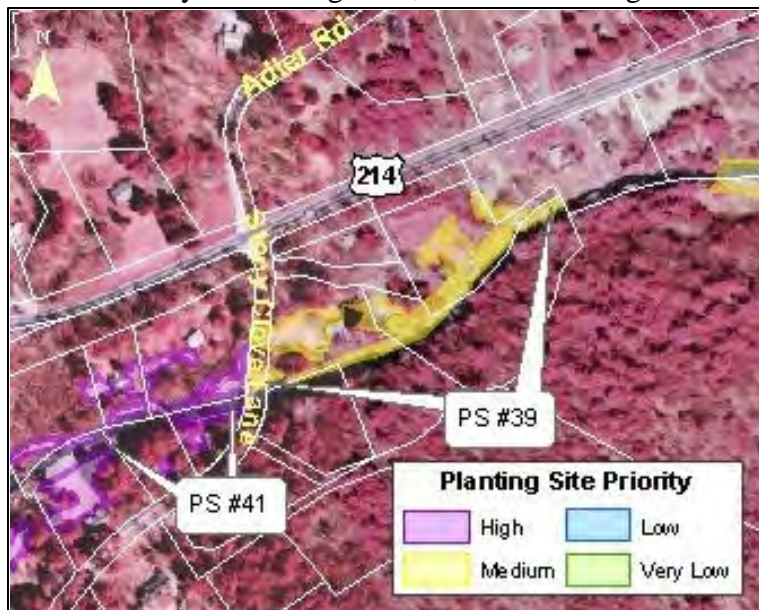
Figure 13 Planting sites location map for Management Unit 13

In June 2003, suitable riparian improvement planting sites were identified through a watershed-wide field evaluation of current riparian buffer conditions and existing stream channel morphology (Fig. 13). These locations indicate where plantings of trees and shrubs on and near stream banks can help reduce the threat of serious bank erosion, and can help improve aquatic habitat as well. In some cases, eligible locations include stream banks where rock rip-rap has already been placed, but where additional plantings could significantly improve stream channel stability in the long-term, as well as biological

integrity of the stream and floodplain. Areas with serious erosion problems where the stream channel requires extensive reconstruction to restore long-term stability have been eliminated from this effort. In most cases, these sites can not be effectively treated with riparian enhancement alone, and full restoration efforts would include re-vegetation components. Two appropriate planting sites were documented within this management unit.

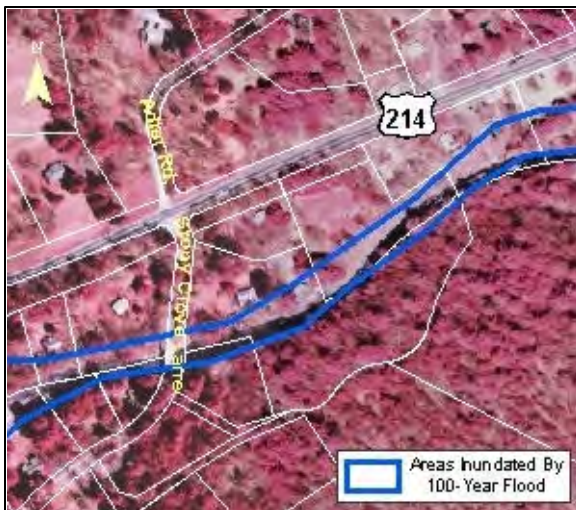
**Figure 16** 100-year floodplain boundary in Management Unit 13

According to the NFIP maps, there are four houses located within the 100-year boundary in this management unit (Fig. 16). The current NFIP maps are available for review at the Greene and Ulster County Soil & Water Conservation District offices.
