**Management Unit 15**  
 Ulster County - Town of Shandaken  
 Weiss Road Bridge to Warner Creek Confluence

**Management Unit Description**

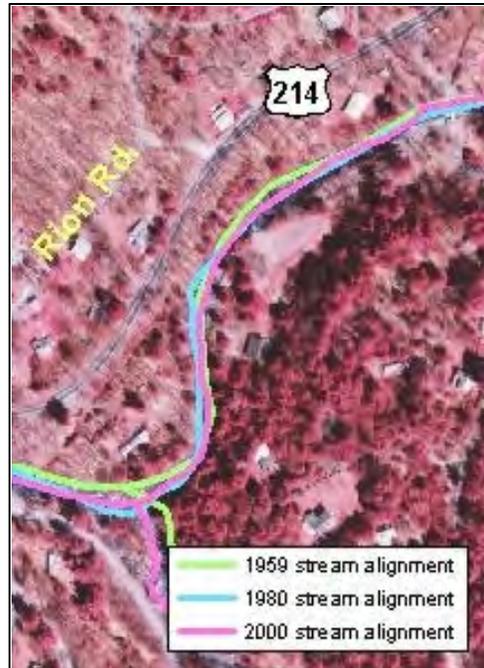
**Figure 2 Historic stream alignments in Management Unit 15**

As seen from the historical stream alignments, the planform of the stream channel has remained relatively stable since 1959 (Fig. 2).

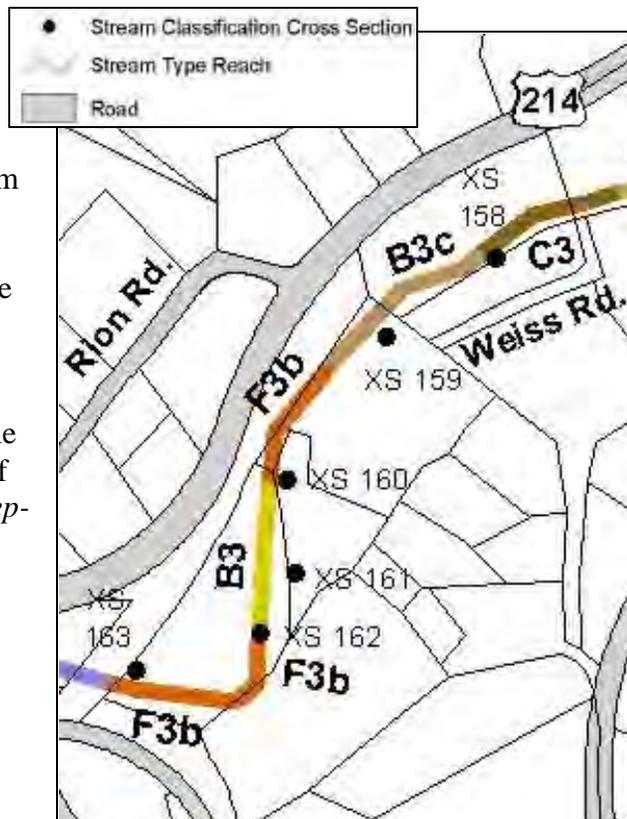
Figure 4 Cross-sections and Rosgen stream types in Management Unit 15

Stream morphology, or shape (i.e., slope, width and depth) changes frequently in this unit (Fig. 4), creating small reaches with differing morphologic characteristics, which are classified as different *stream types* (See Section 3.1 for stream type descriptions).

The upstream half of this management unit is well connected to its floodplain, and becomes more entrenched moving downstream. Channel slope increases dramatically approaching the downstream end of the management unit. The high channel gradient in the downstream half of the management unit is reflected in the coarsening of bed material. Entrenched channels with high gradients are often prone to incision, or degradation of the bed elevation. However, the large particle sizes found in the downstream reaches of the unit have resulted in a very stable *step-pool morphology*, where large boulders control the bed elevation, and armor the channel against incision.

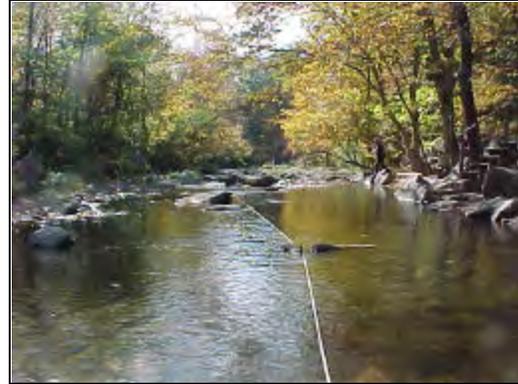
**Figure 5 Cross-section 158  
Stream Type C3**

Management unit #15 begins as the stream emerges from underneath the Weiss Rd. Bridge, with a 210 ft. reach of C3 stream type (Fig. 5). This stream reach is only slightly *entrenched*, or usually able to spill into its floodplain during high flow events. Stream channel slope is quite flat at 1.1% and the dominant by cobble sized bed material.

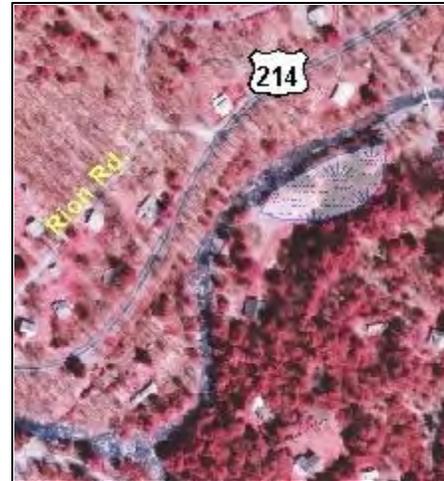
**Figure 8 Federally Designated Wetland**

At the top of this reach on the left stream bank, is a federally designated wetland (Fig. 8). This wetland, which is 0.7 acres in size, is classified as palustrine, scrub-shrub, broad-leaf deciduous, temporarily flooded (PSS1a). Wetlands are important features in the landscape, providing numerous beneficial functions, including protecting and improving water quality, providing fish and wildlife habitats, storing floodwaters, and maintaining surface water flow during dry periods. (See Section 2.6 for wetland type descriptions and regulations)

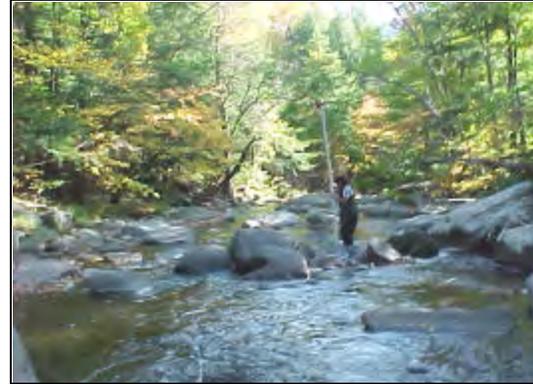
**Figure 11 Cross-section 161  
Stream Type B3**

As the channel becomes moderately entrenched, stream type changes to B3 (Fig. 11 & Inset A). This 231 ft. stream reach remains fairly steep, with a slope of 2.1%. Although this reach also has an abundance of boulders, the dominant bed material is still cobble. This reach is characterized by numerous cascades followed by plunge pools.

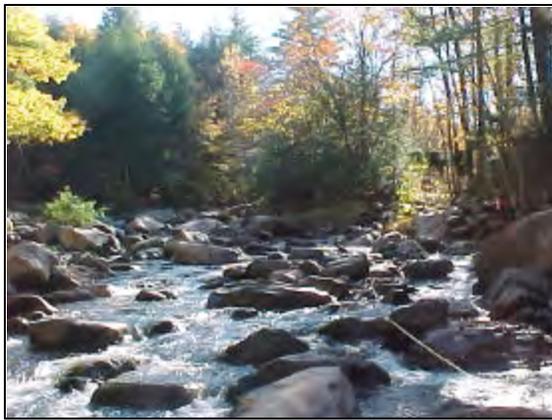
**Figure 12 Cross-section 163  
Stream Type F3b looking upstream**

As the stream *meanders* to the right, the channel becomes entrenched and slope increases, changing stream type to F3b for the last 172 ft. of this management unit (Fig. 12). This reach is extremely steep, with a slope of 4.1%. This reach also has numerous boulders, but the dominant bed material remains cobble.

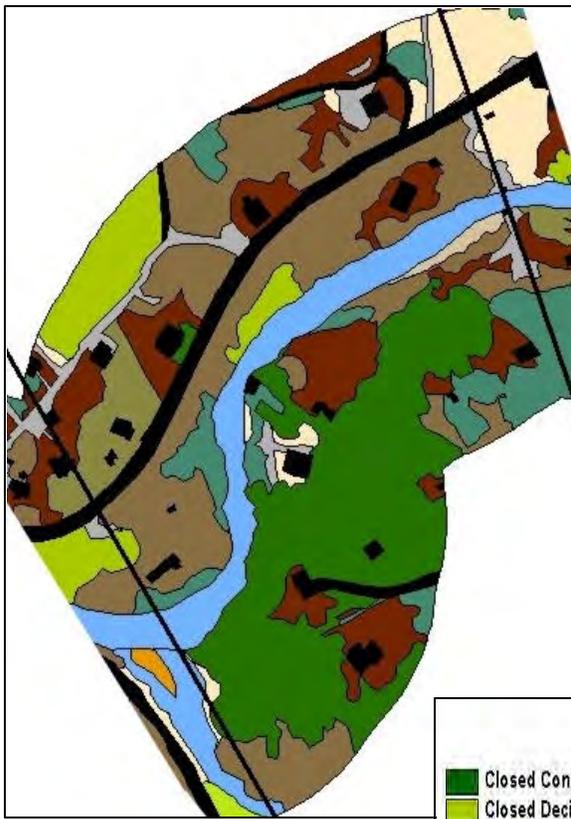
**Figure 13 Riparian vegetation map of Management Unit 15**

An analysis of vegetation was conducted using aerial photography from 2001 and field inventories (Fig. 13, Appendix A). Japanese knotweed occurrences were documented as part of the MesoHABSIM aquatic habitat inventory conducted during the summer of 2002 (Appendix B).

The predominant vegetation type within the 300 ft. riparian buffer is forested (71%) followed by herbaceous (14%) and deciduous shrubbrush (3%). Areas of herbaceous (non-woody) cover present opportunities to improve the riparian buffer with plantings of more flood resistant species. *Impervious* area (8%) within this unit's buffer is primarily the NYS Route 214 roadway and residences.

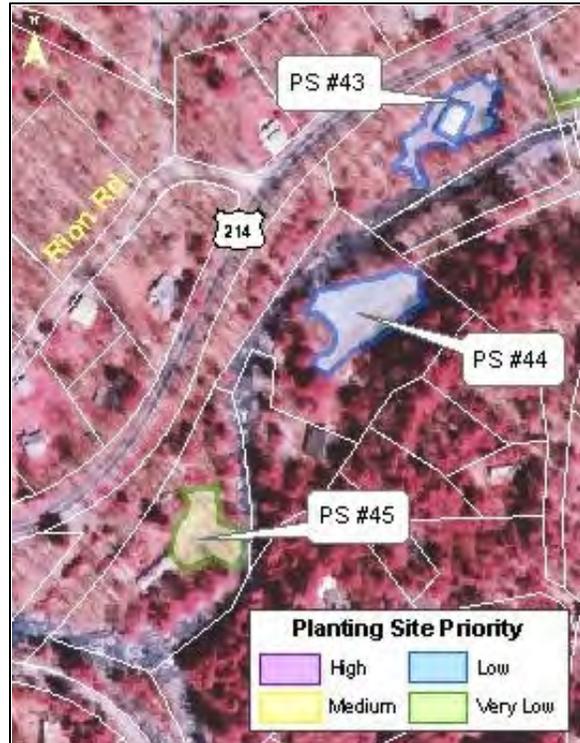
**Figure 14** Planting sites location map for Management Unit 15

In June 2003, suitable riparian improvement planting sites were identified through a watershed-wide field evaluation of current riparian buffer conditions and existing stream channel morphology (Fig. 14). These locations indicate where plantings of trees and shrubs on and near stream banks can help reduce the threat of serious bank erosion, and can help improve aquatic habitat as well. In some cases, eligible locations include stream banks where rock rip-rap has already been placed, but where additional plantings could significantly improve stream channel stability in the long-term, as well as biological integrity of the stream and floodplain. Areas with serious erosion problems where the stream channel requires extensive reconstruction to restore long-term stability have been eliminated from this effort. In most cases, these sites can not be effectively treated with riparian enhancement alone, and full restoration efforts would include re-vegetation components. Three appropriate planting sites were documented within this management unit.

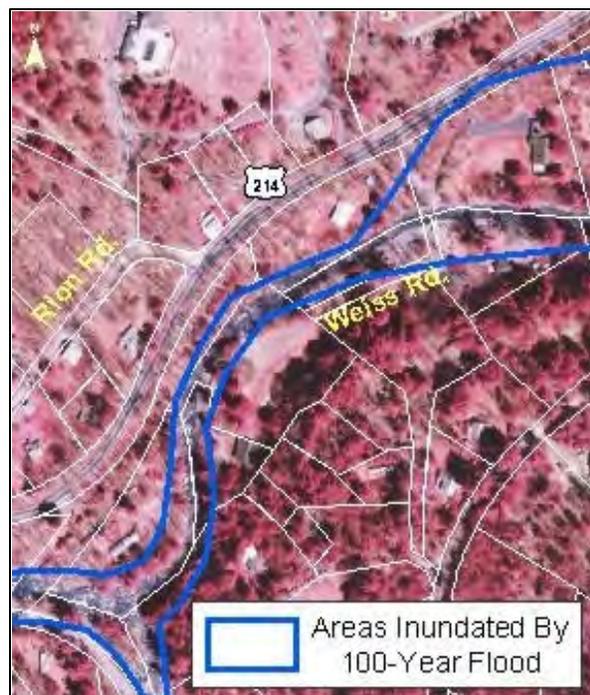
**Figure 18 100-year floodplain boundary in Management Unit 15**

According to NFIP maps, there is one house located within the 100-year floodplain boundary in this management unit (Fig. 18). The current NFIP maps are available for review at the Greene and Ulster County Soil & Water Conservation District offices.

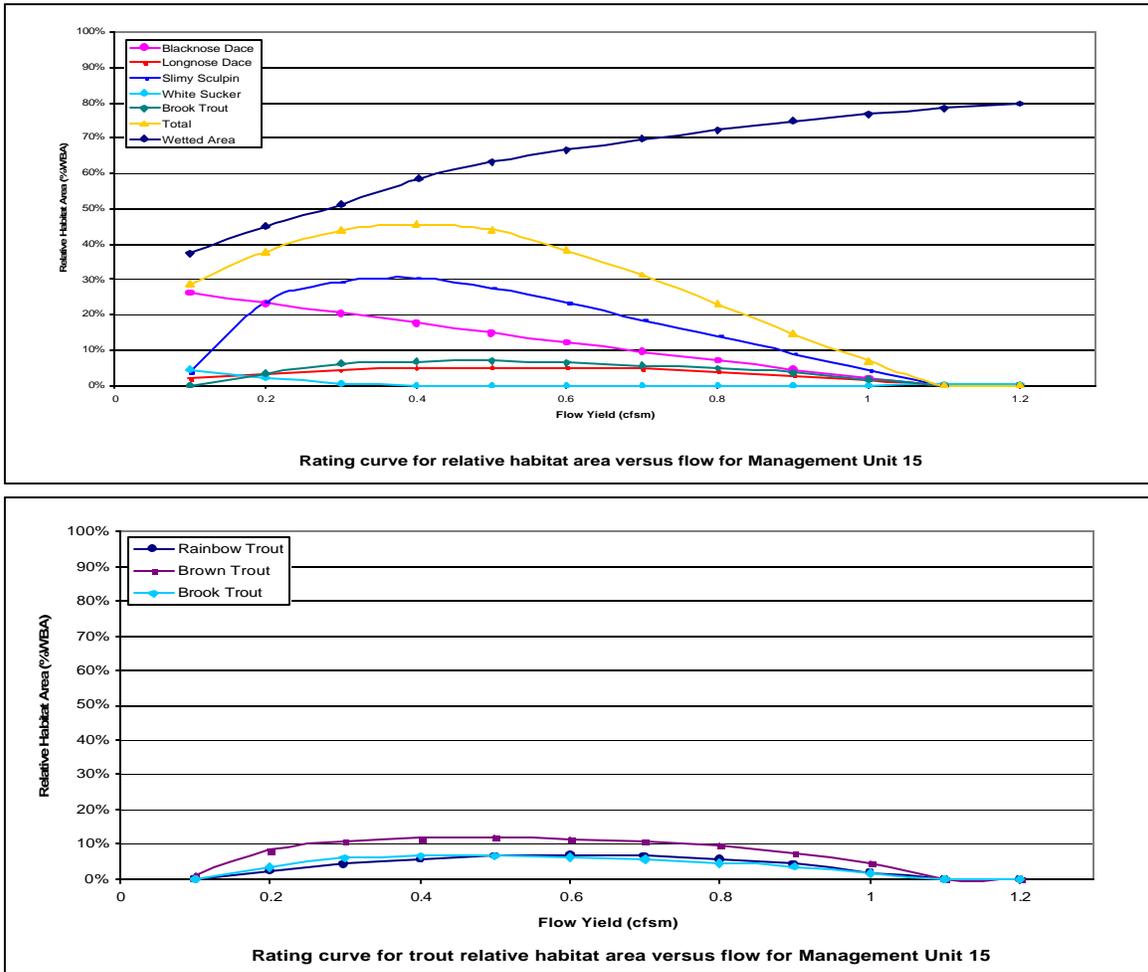
Figure 19 MesoHABSIM habitat rating curves for Management Unit 15

Management unit #15 has numerous boulders, shallow margins, good canopy cover shading, and some riprap (Fig. 19). Similar to management unit #14, the wetted area increases quickly between 0.1 cfs and 0.3 cfs. Suitable habitat also increases in this range, but it then drops to zero after 1.0 cfs for all species. This situation could indicate low-flow channel entrenchment. Slimy sculpin and blacknose dace have the highest habitat levels. Brook trout habitat is concentrated in one run and sidearm, with some small usable areas in cascade regions. Brown and rainbow trout also show higher amounts of habitat availability, especially at 0.3 cfs. Nevertheless, habitat declines

rapidly for these two species at higher flows. (See Section 6.6 general recommendations for aquatic habitat improvement)
