Management Unit 17
 Ulster County Town of Shandaken
 Silver Hollow Road Bridge to between XS 172 and XS 173

Management Unit Description

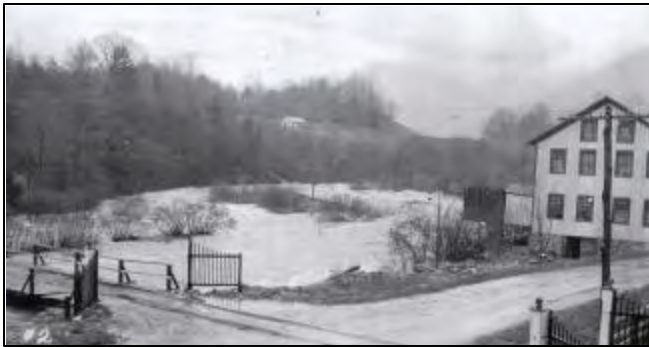
Figure 5 1910 flood at the crossing to the lumber storage on the south floodplain flat, Chichester
Courtesy of the Gale Collection

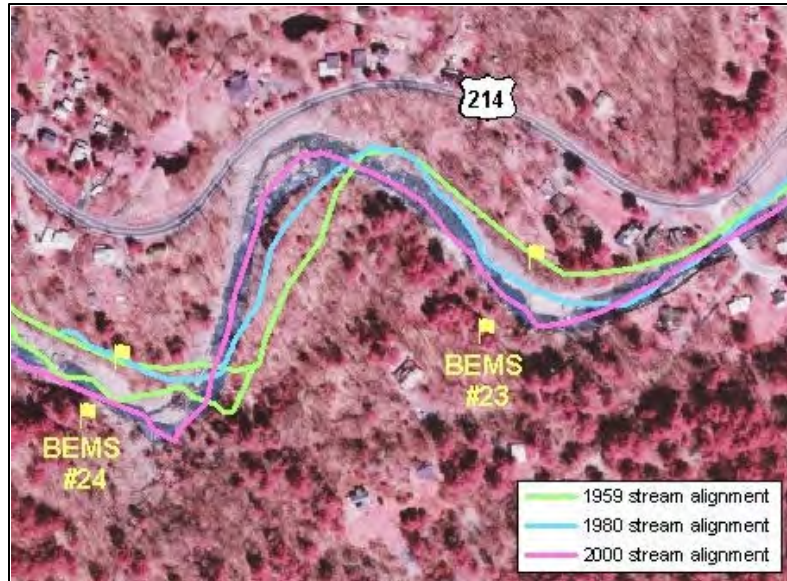
As seen from the historical stream alignments this management unit has experienced significant channel migration and manipulation in recent years (Fig. 7). At the top of the management unit the stream channel has migrated approximately 125 ft. This shift has forced the stream against the left stream bank resulting in severe erosion and clay exposures at bank erosion monitoring site #23. In the middle of the unit the stream channel has migrated approximately 120ft, in a classic pattern of down-valley meander migration. This shift has forced the stream against the right stream bank, threatening the stability of NYS Route 214. Following a road washout during the January 1996 floods, the NYS DOT installed rip-rap at this location in to protect the road from erosion. At the bottom of the unit the stream channel has migrated approximately 100 ft. This shift has forced the stream against the left stream bank resulting in severe erosion and clay exposures bank erosion monitoring site #24.

Figure 7 Historic channel alignments in Management Unit 17

bank erosion monitoring site #23. In the middle of the unit the stream channel has migrated approximately 120ft, in a classic pattern of down-valley meander migration. This shift has forced the stream against the right stream bank, threatening the stability of NYS Route 214. Following a road washout during the January 1996 floods, the NYS DOT installed rip-rap at this location in to protect the road from erosion. At the bottom of the unit the stream channel has migrated approximately 100 ft. This shift has forced the stream against the left stream bank resulting in severe erosion and clay exposures bank erosion monitoring site #24.

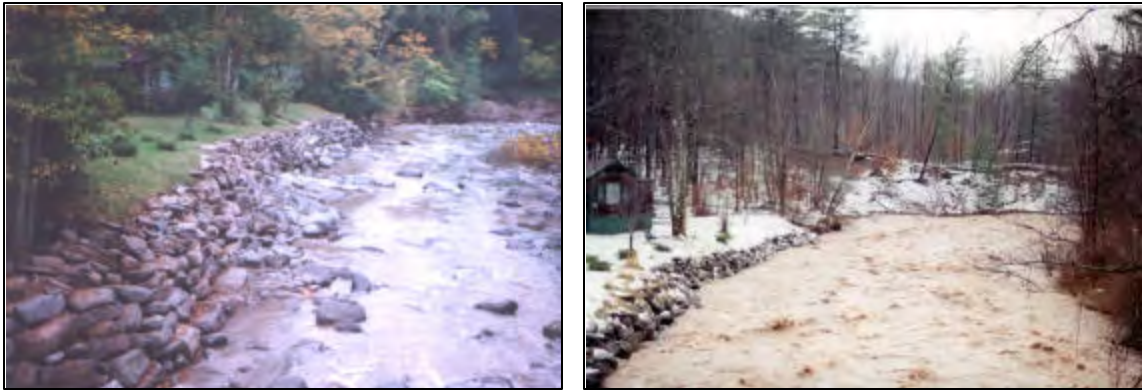
The photos below, looking downstream from the Silver Hollow Bridge, illustrate the difference between low and high flow conditions (Fig. 9).

Figure 9 Stony Clove Creek below Silver Hollow Bridge low flow vs. high flow conditions

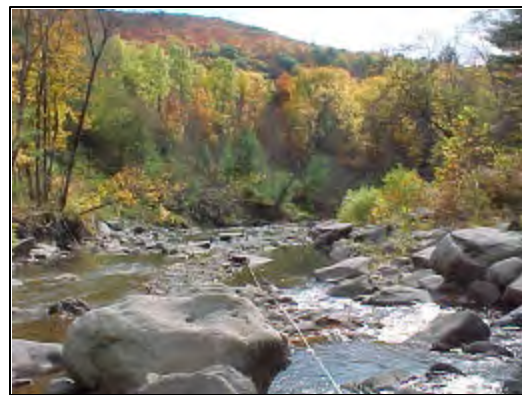
**Figure 16 Cross-section 170
Stream type C3**

Coming out of this reach, the channel straightens and flattens, with slope decreasing to 1% as stream type changes to C3 for 288 ft. (Fig. 15). Entrenchment moderates as the

channel moves away from the road and regains connection with its floodplain. The bed material becomes dramatically finer as the channel departs from the armored road embankment. Clay is exposed on the right stream bank here (Inset A).

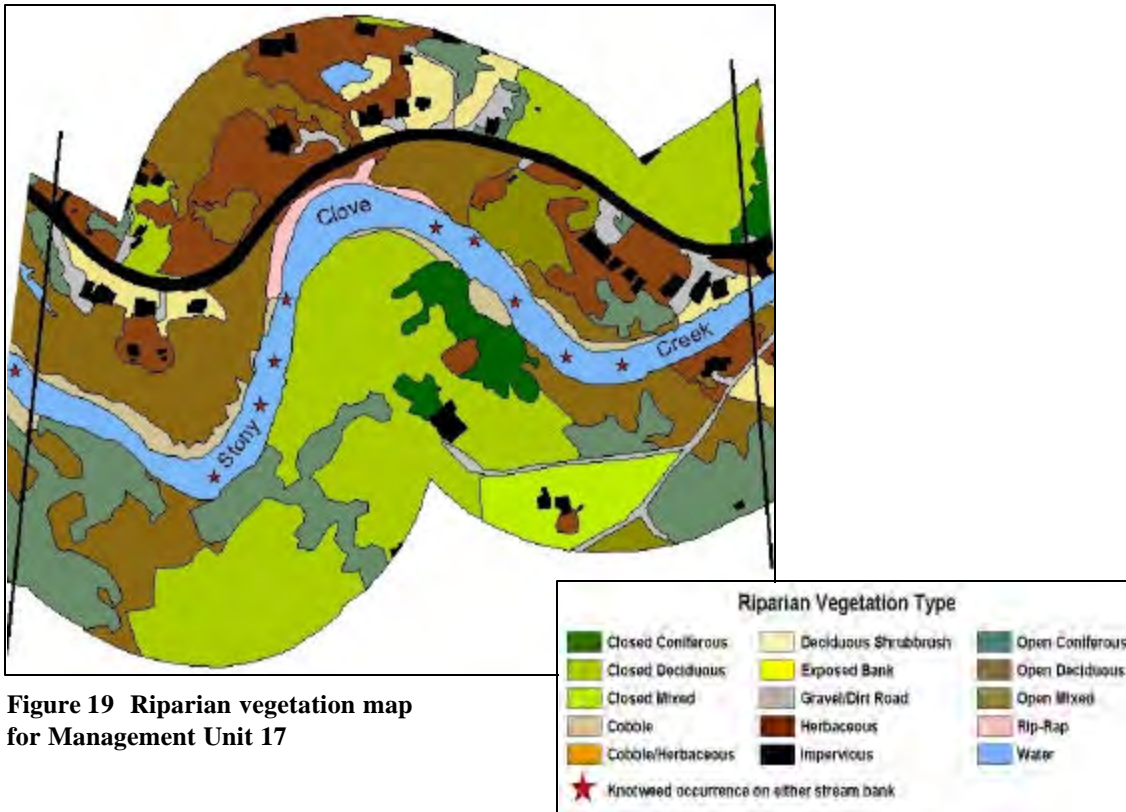
Figure 19 Riparian vegetation map for Management Unit 17

The predominant vegetation type within the 300 ft. riparian buffer is forested (71%) followed by herbaceous (14%) and deciduous shrubbrush (3%). Areas of herbaceous (non-woody) cover present opportunities to improve the riparian buffer with plantings of more flood-resistant species. *Impervious* area (8%) within this unit's buffer is primarily the NYS Route 214 roadway and residences.

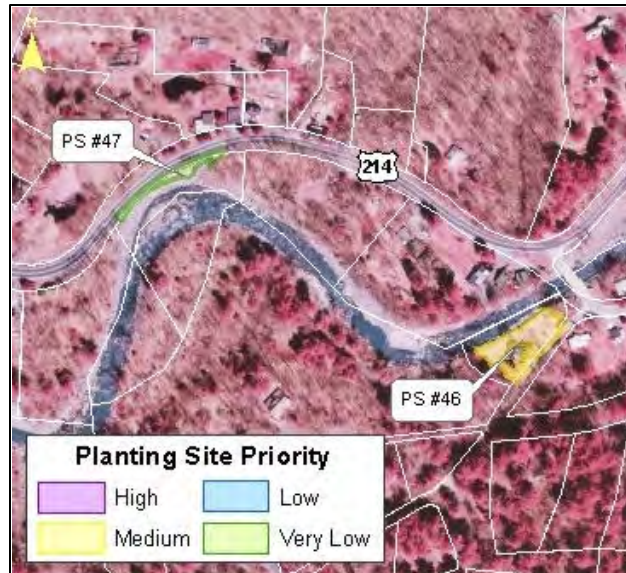
In June 2003, suitable riparian improvement planting sites were identified through a watershed-wide field evaluation of current riparian buffer conditions and existing stream channel morphology (Fig. 20). These locations indicate where plantings of trees and shrubs on and near stream banks can help reduce the threat of serious bank erosion, and can help improve aquatic habitat as well. In some cases, eligible locations include stream banks where rock rip-rap has already been placed, but where additional plantings could significantly improve stream channel stability in the long-term, as well as biological integrity of the stream and floodplain. Areas with serious erosion problems where the stream channel requires extensive reconstruction to restore long-term stability have been eliminated from this effort. In most cases, these sites can not be effectively treated with riparian enhancement alone, and full restoration efforts would include re-vegetation components. Two appropriate planting sites were documented within this management unit.

Figure 20 Planting sites location map for Management Unit 17

To increase stream buffer functionality, additional plantings of native trees and shrubs along the stream bank and upland area are recommended. Increasing the stream buffer width by at least 20 feet will improve stream

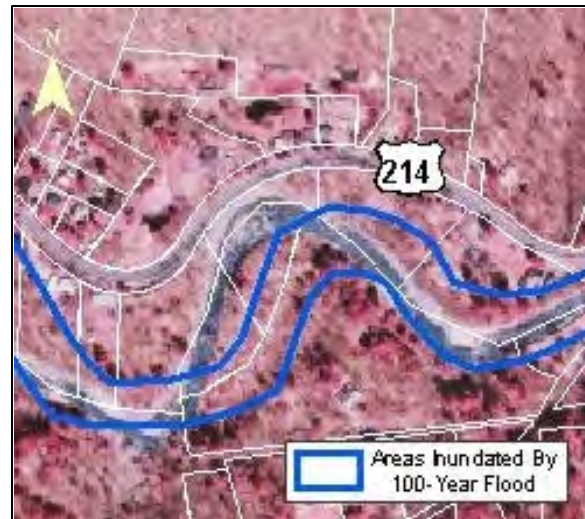
Figure 23 100-year floodplain boundary map in Management Unit 17

According to the NFIP maps, there is one house located within 100-year floodplain boundary in this management unit (Fig. 23). The current NFIP maps are available for review at the Greene and Ulster County Soil & Water Conservation District offices.

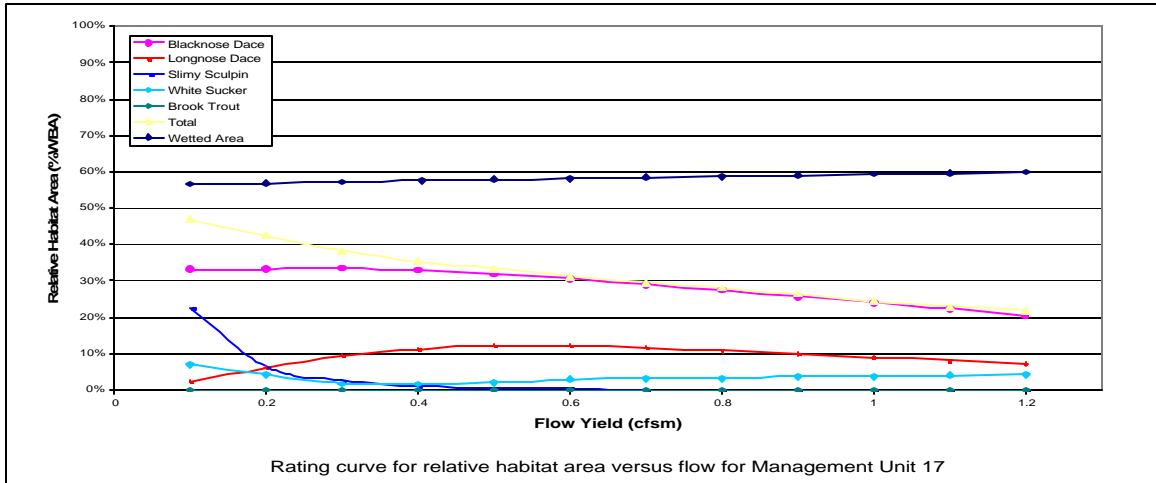
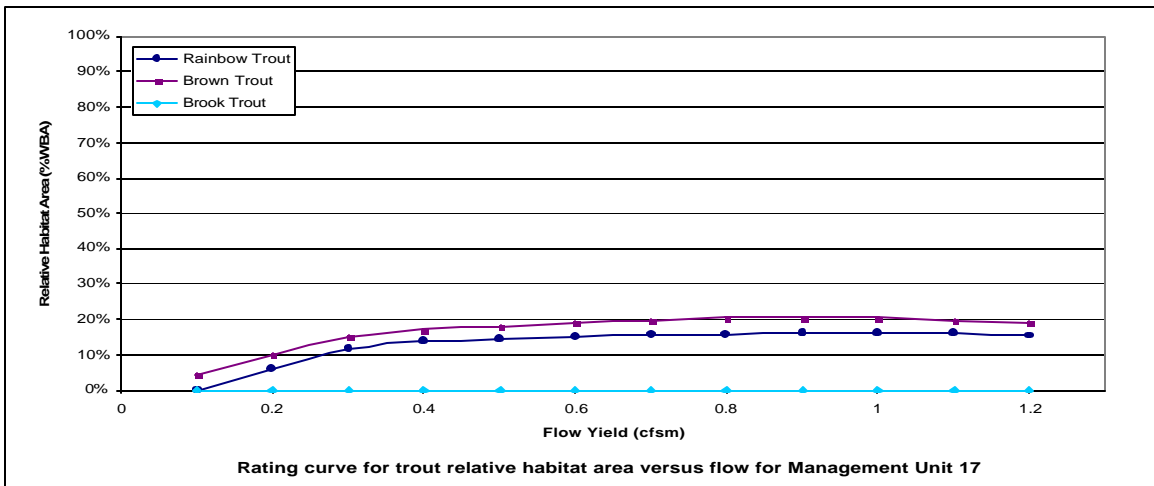
Management unit #17 is characterized by significant amounts of rip-rap and boulders, with some shallow margins (Fig. 24). It is slower and somewhat shallower than management unit #16. *Wetted area* covers only 60% of the bankfull wetted area at all investigated flows. At the high end of the investigated flow range, this unit is dominated by rapids and riffles. The amount of suitable habitat for the target community is generally low. Blacknose dace are favored, but their habitat declines as flow increases. Slimy sculpin have mostly low quality habitat, along with longnose dace, which have more suitable habitat than in the unit upstream. Habitat for white sucker is very low and for brook trout nearly absent. Interestingly, rainbow and brown trout have more high quality habitat in this unit than anywhere else in the Stony Clove mainstem, owing perhaps to the deep pools scoured into the clay subpavement.

Figure 24 Habitat rating curve for Management Unit 17
