## Broadstreet Hollow Management Unit 3

Management Unit 3 (MU3) is located in Greene County, NY, beginning at the outlet of County Bridge 3201230 near Regina's Way and continuing downstream approximately 1,150 feet to the inlet of Town Bridge 3201240 at Timber Lake Road. This management unit is the location of the Demonstration Stream Stability Restoration Project site (“demonstration project”), constructed in 2000 and 2001<sup>1&2</sup> (Photo 1).

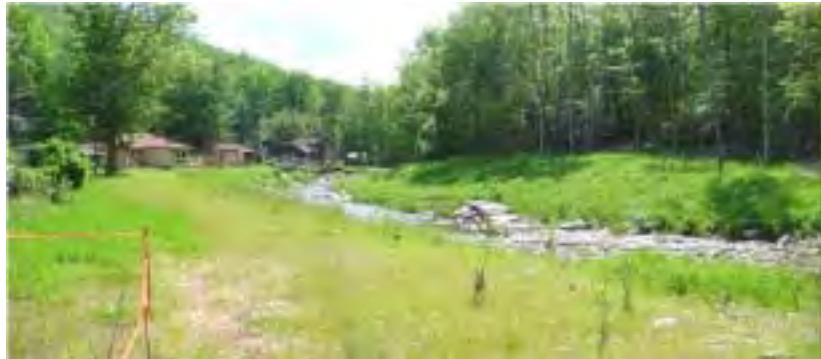
Photo 1. Looking downstream, MU3 , spring 2002.

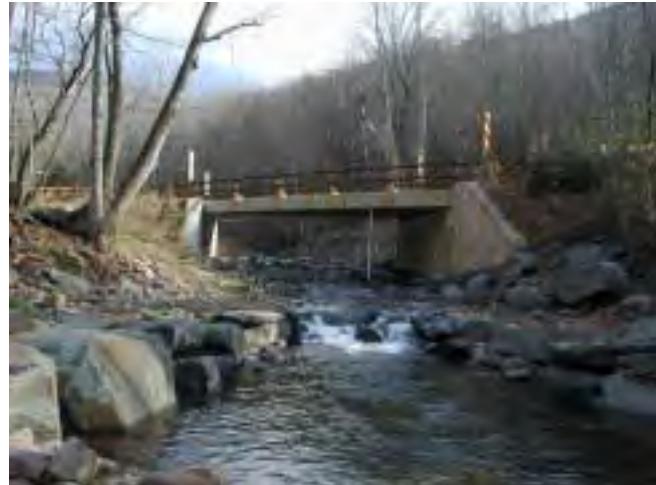
Two County maintained bridges flank the top and bottom of MU3. The upstream bridge is on Broadstreet Hollow Road, just below the intersection with Regina's Way (Photo 7). This bridge was replaced following the flood of 1996, and is wide enough to accommodate both a low flow stream channel and to allow the stream to maintain a generally natural shape consistent with dimensions upstream and downstream.

Photo 7. Looking upstream at County Bridge 3201230, at the top of MU3.

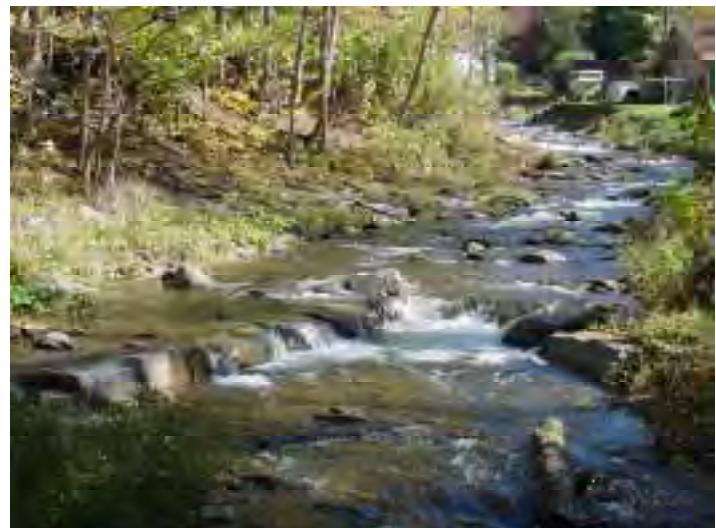
Thirteen boulder structures, or *cross vanes*, were installed in the stream to mimic the natural spacing of small waterfalls, or “steps”, and plunge pools (Photo 9). These features serve multiple functions, including dissipating stream energy (reducing erosion), preventing further down-cutting, providing a variety of fish habitat niches, and aerating the water (providing oxygen).

Photo 9. Looking upstream from the bottom of MU3, Fall, 2002, showing plunge pool below a rock vane structure.

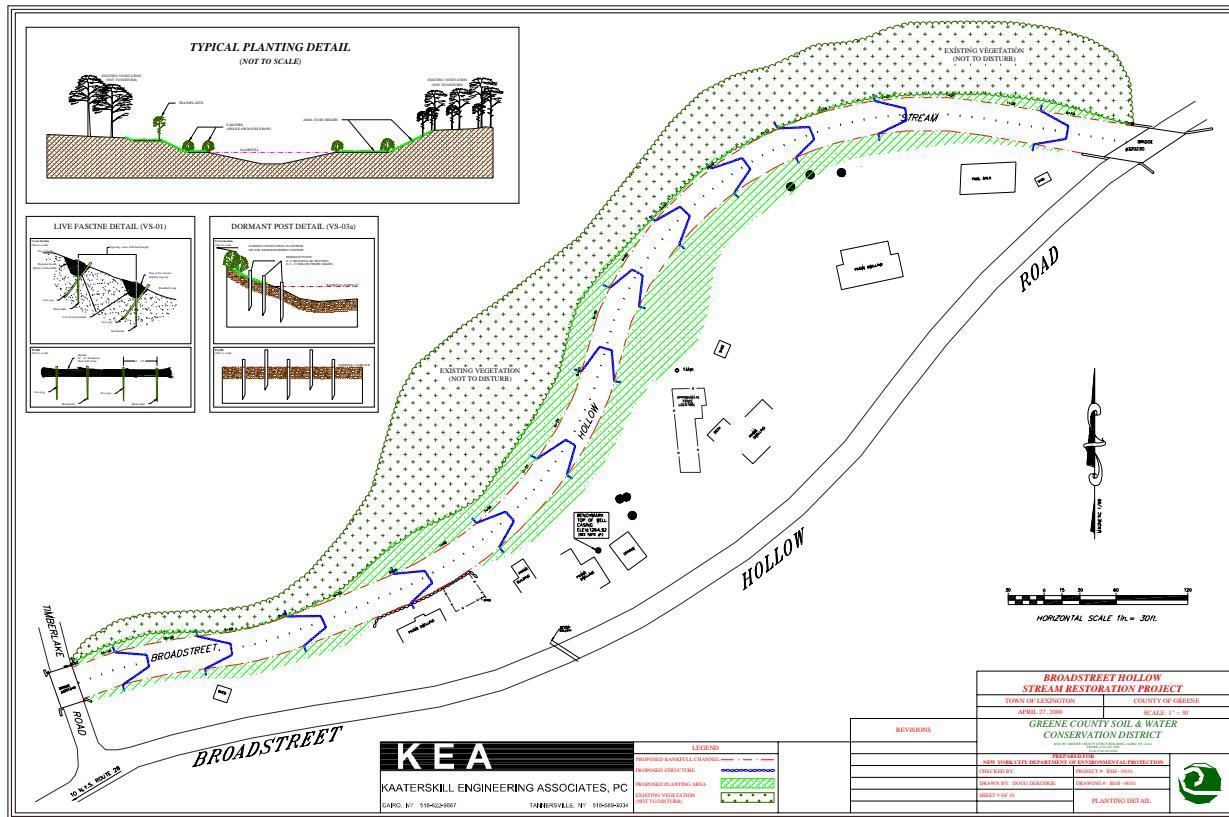
Figure.1 Design plan drawings for demonstration stream stability restoration project for MU3, 2000, showing vegetative planting (bioengineering) plan and spacing of rock vane structures. Drawing courtesy of Greene County Soil and Water Conservation District, NY.

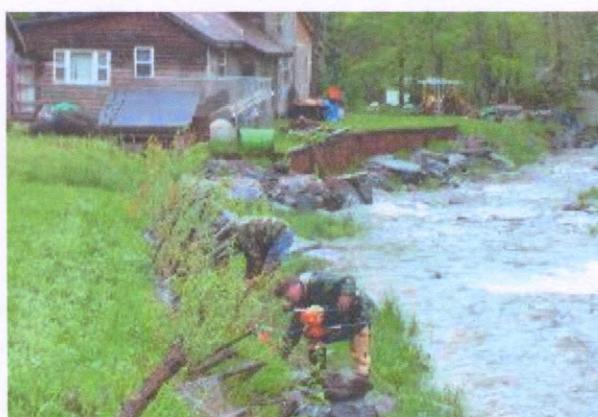
Photo 14. Trout Unlimited volunteers assisting bioengineering efforts along the left bank of MU3, looking downstream, riparian planting day, May 18, 2002.

Establishing a functioning and self-sustaining riparian zone is very difficult, and can require a number of years and ongoing maintenance to achieve success. Under-vegetated areas in MU3 should continue to be vegetated or supplemented with a mixture of native riparian species to improve shade, cover and water temperature conditions for aquatic habitat<sup>9</sup>, as well as to improve bank stability and reduce the need for future restoration work that could cause or increase stream ecosystem
