# BRANDYWINE RESTORATION PROJECT - BATAVIA KILL -

IMPLEMENTATION & MONITORING REPORT

BRANDYWINE PROJECT - BATAVIA KILL  
TOWN OF ASHLAND, GREENE COUNTY, NY

UPDATED  
MARCH 2008

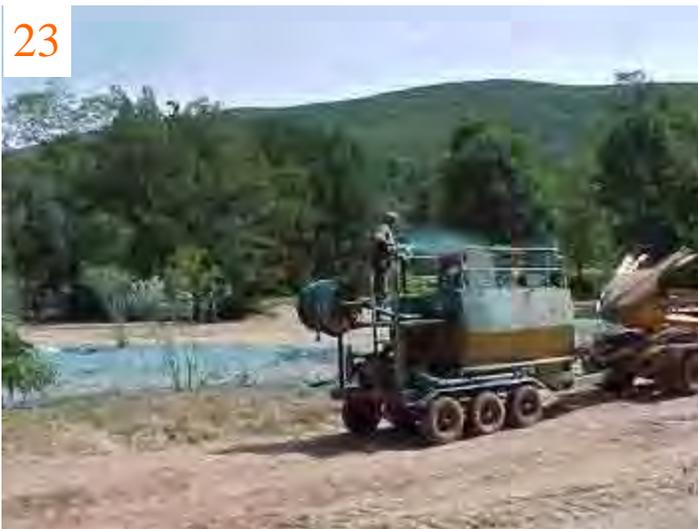
23

Photograph 23: The downstream extent of the project area was also substantially damaged from the event.

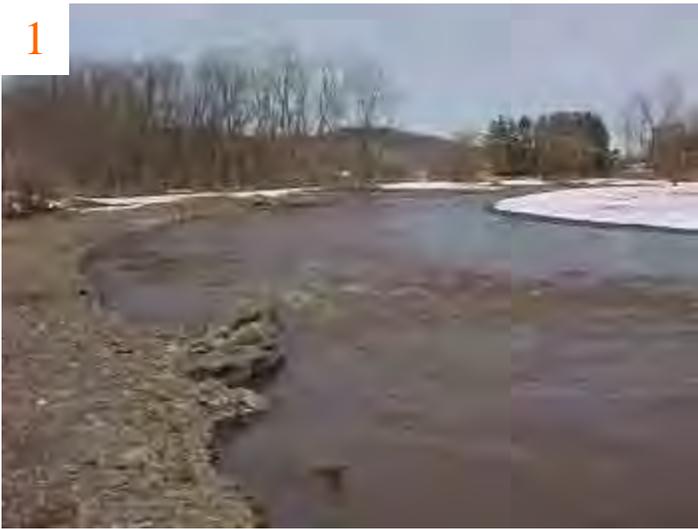
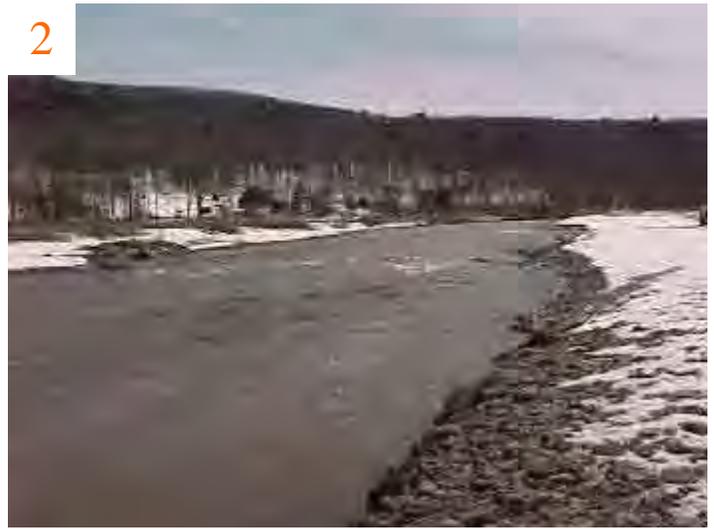
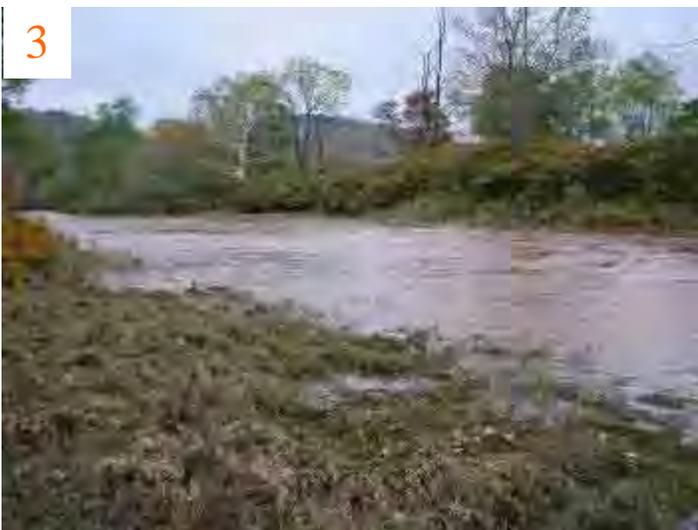
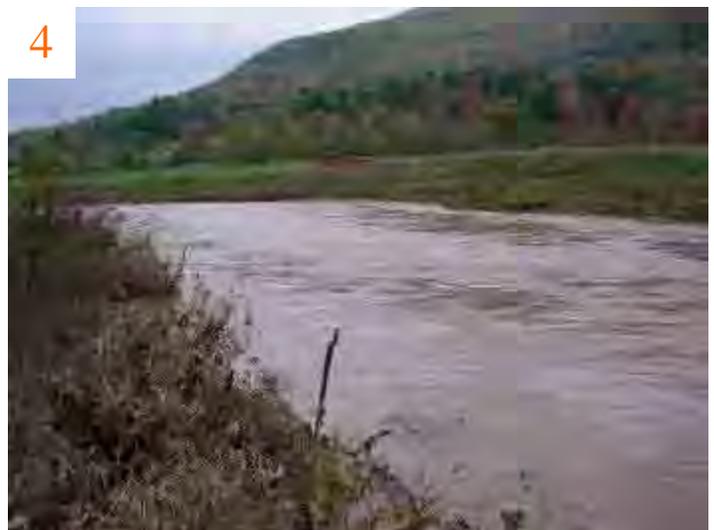
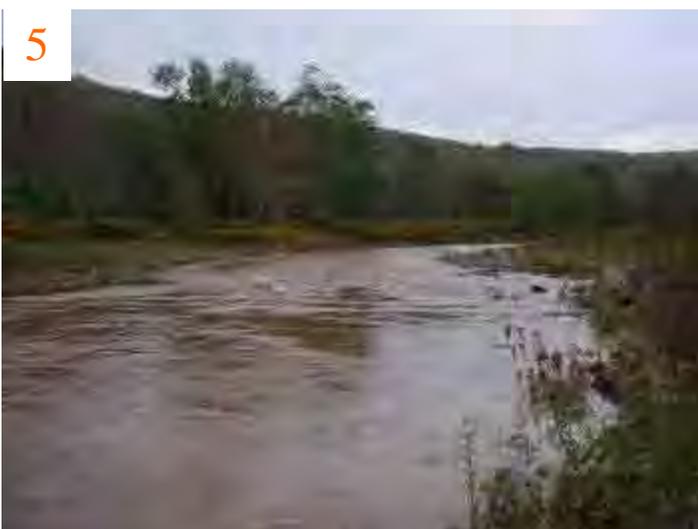
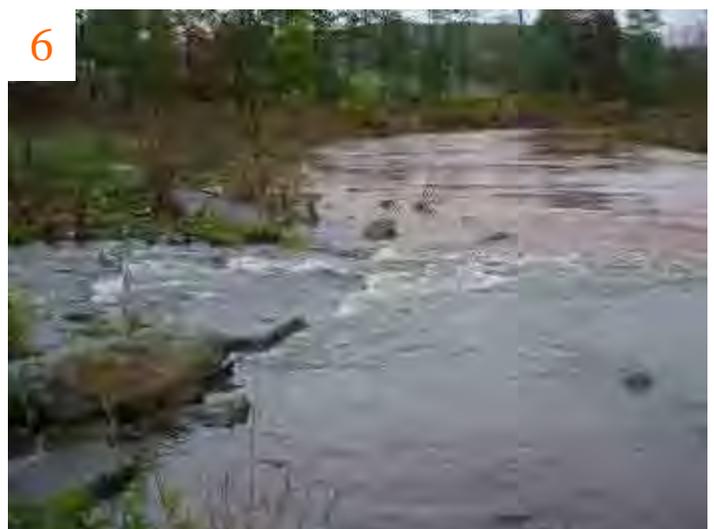
Brandywine Stream Restoration Project  
Project Inspection— 2002

Photograph 5: A functioning cross vane along the second meander

Photograph 6: The confluence of North Settlement Creek over the constructed sill.

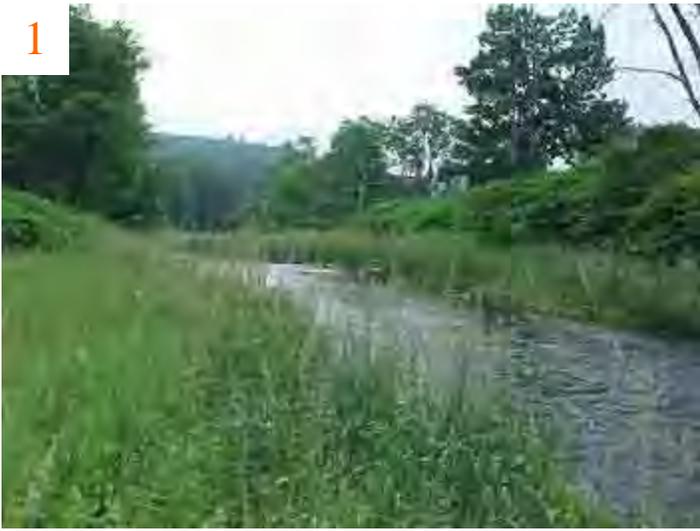
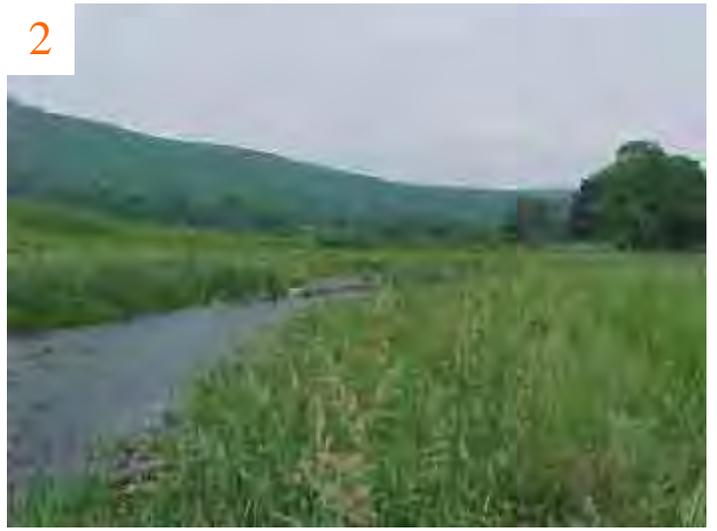
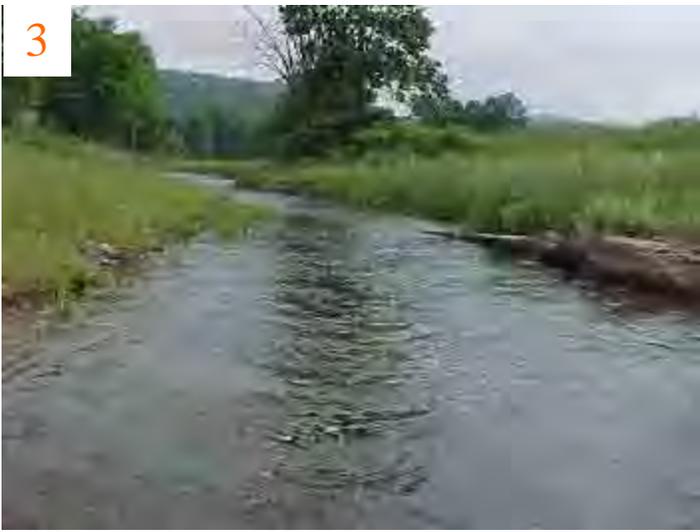
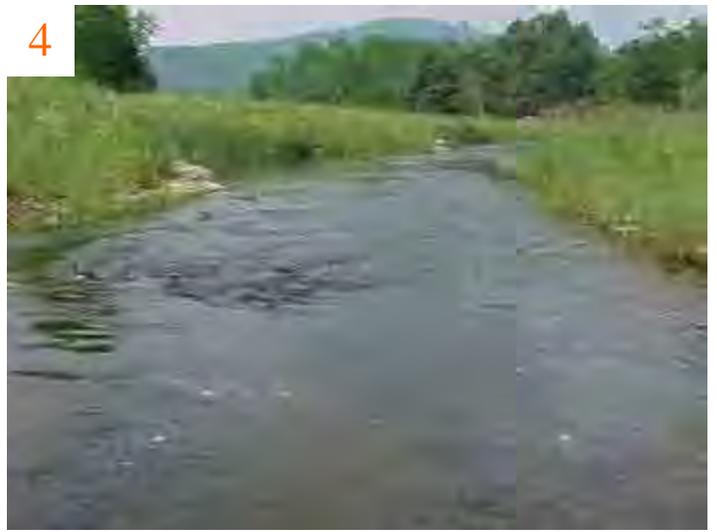
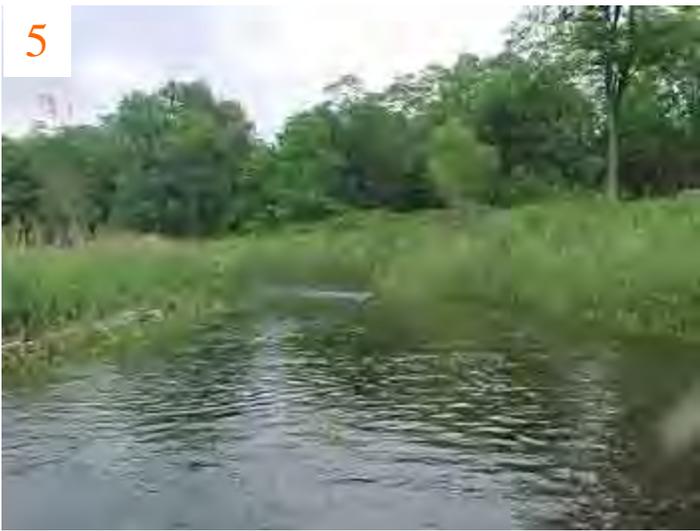
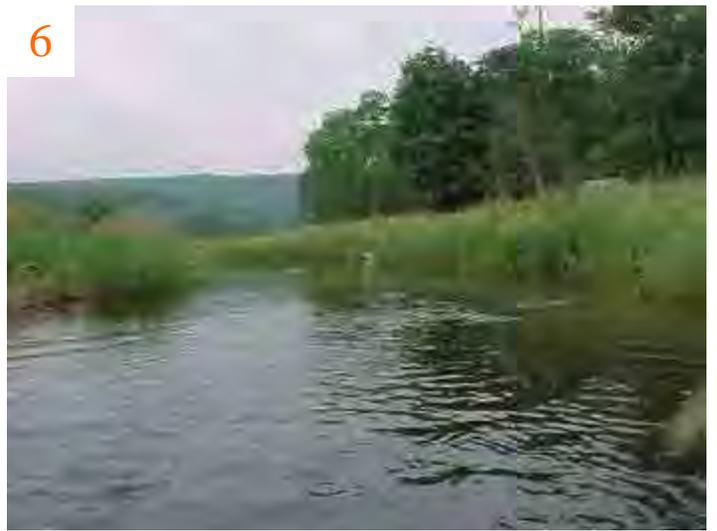
Brandywine Stream Restoration Project  
Project Inspection— 2003

Photograph 5: A rock vane near monitoring cross section 4 and a downstream pool.

Photograph 6: A rock vane near monitoring cross section 4 and a downstream pool.

Photograph 11: The last cross vane on the project site and the downstream scour pool.

Photograph 12: The end of the project site.

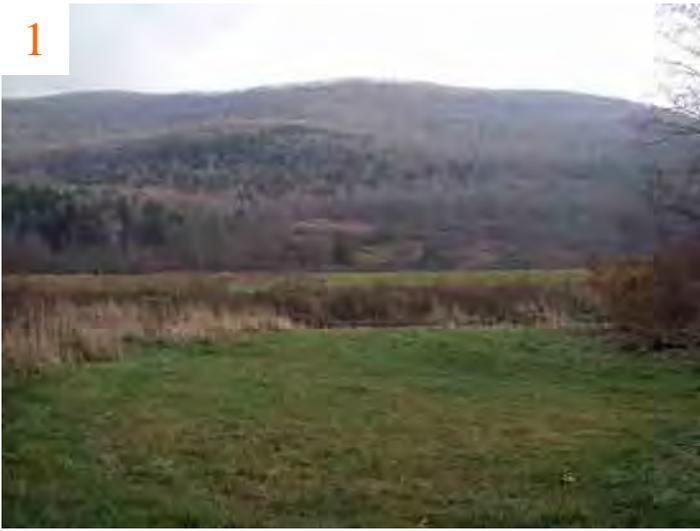
- Photograph 8: View across stream from right bank at cross section 6.
- Photograph 9: Cross vane with bank erosion behind left vane arm located downstream of cross section 6.

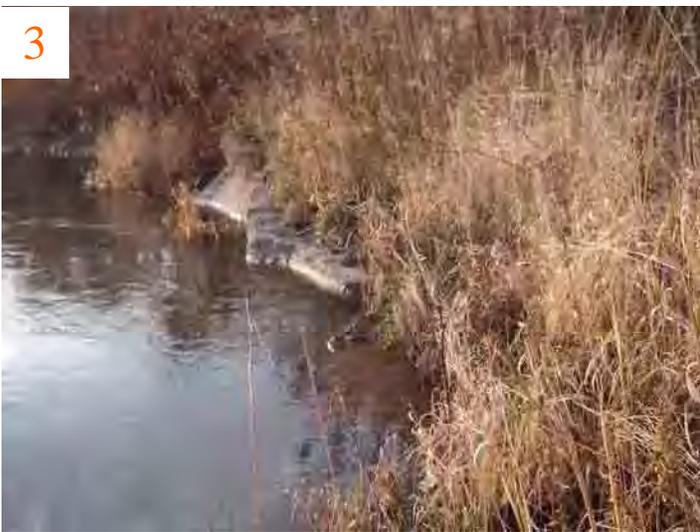
- Photograph 10: Bank erosion on right bank exposing the sand and gravel soil.
- Photograph 11: Rock vane with bank erosion behind vane arm.
- Photograph 12: Cross vane near cross section 6 with substantial bank erosion behind right vane arm.
