The Chestnut Creek Stream Management Plan

Volume I of II

Background, History and Watershed Description

March 2004

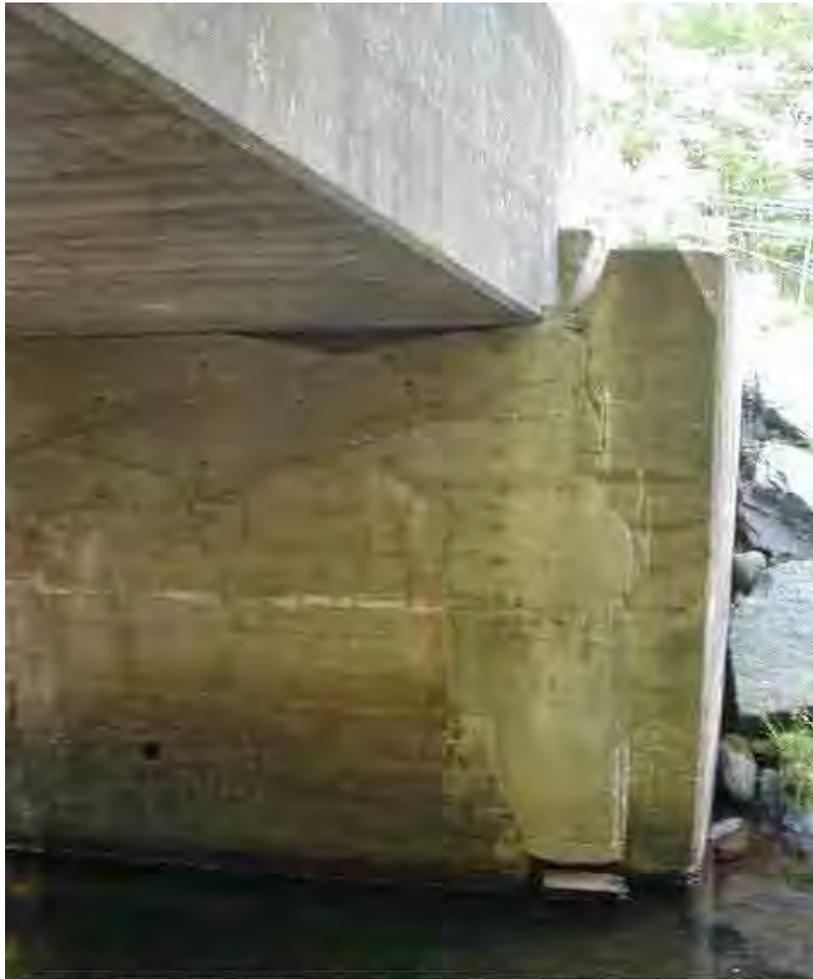
Mohr Bridge. Photo taken by Lori Kerrigan, SCSWCD.

Mohr's Bridge - This bridge is located across from Maschio's Restaurant concerns the Highway Department because the abutment closest to the road is being undercut. If Mohr's Bridge collapses it may cause damage to Route 55 and will be addressed as deemed necessary.

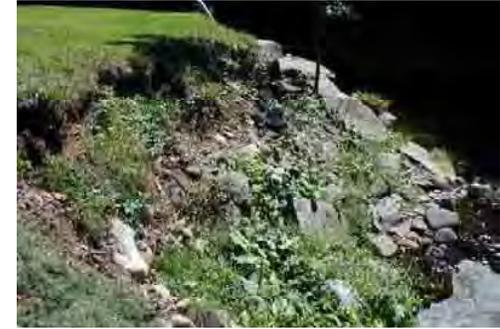
Erosion-left bank behind Town Hall parking lot view looking downstream with dry hydrant visible in the background

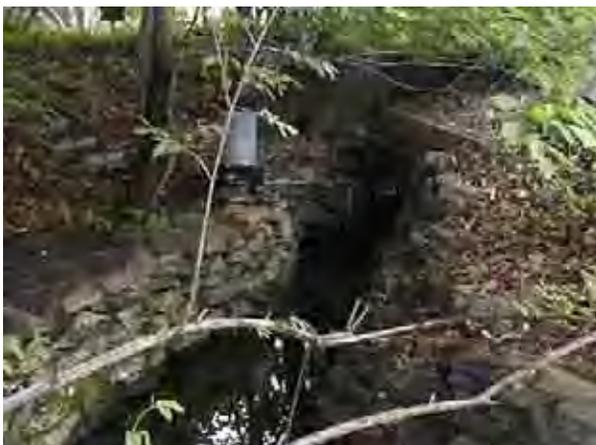
Photo 1. View looking upstream toward culvert under Mutton Hill Road. Laid-up stone walls on both banks, small pump on right bank.

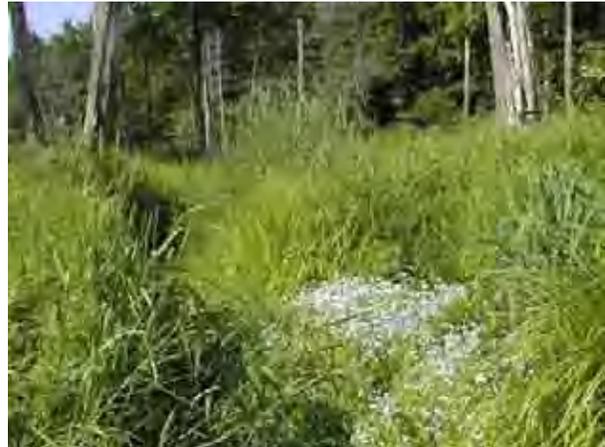
Photo 2. Looking upstream from MU2, trees and grassy flood-plain typical of this type of channel.

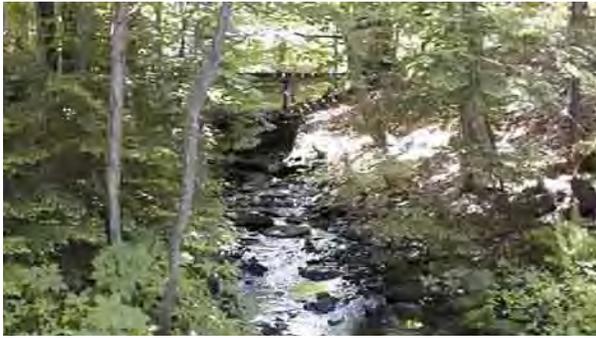
Photo 3. View looking upstream toward private foot bridge and waterfall from below XS-5. As seen here, riparian, or stream side vegetation plays an important role in the health of the stream and aquatic ecosystem.

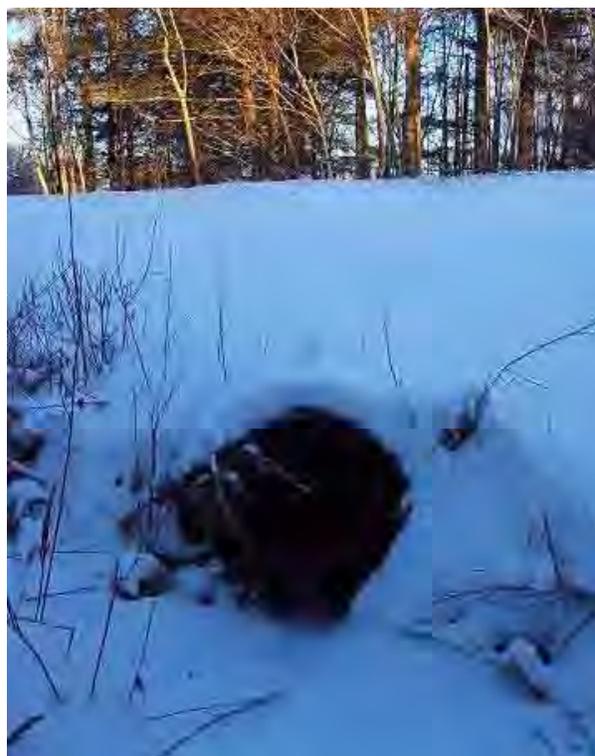
Photo 13. Tributary through culvert, Mutton Hill Rd.

No further information or assessment of these culverts was obtained.

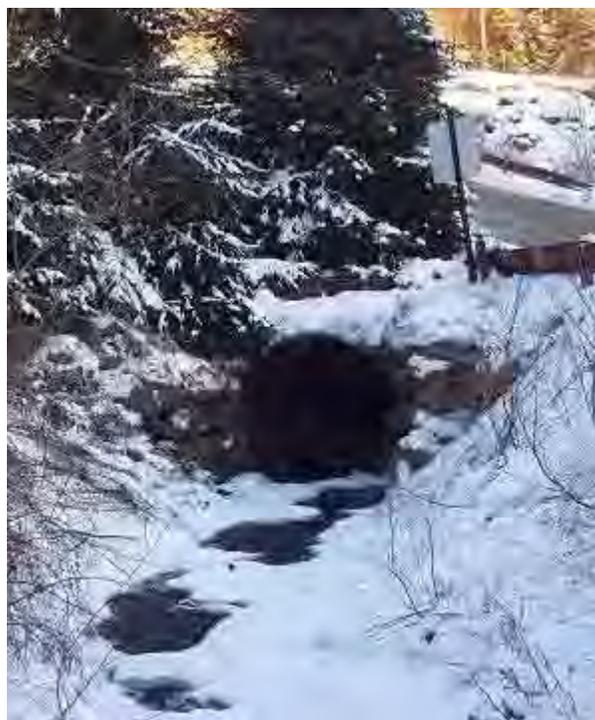
Photo 14. Tributary through culvert under Meyers Rd.

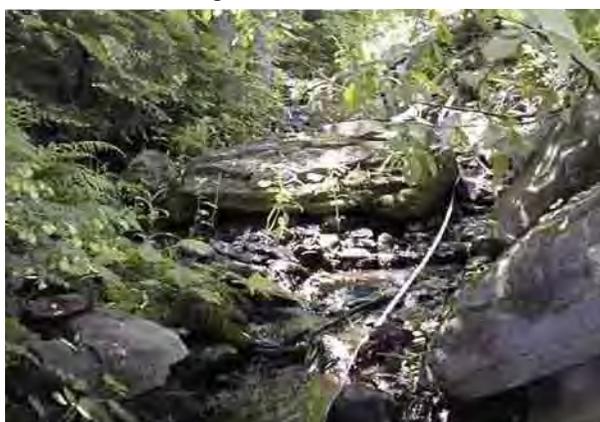
During the 2001 Stream Corridor Survey, MU1 was divided into 9 *reaches* on the basis of the Level II – Morphologic Description (Rosgen, 1996). The largest portion (47%) of this unit includes moderately entrenched channel types B and Ba (MU1 Stream Type & Cross Sections location map, Figure 2). With a low width to depth ratio (i.e., 11 – 16) and mature vegetation on the banks these types of channels tend to be very *stable* and are generally effective at moving *sediment* transported from upstream reaches. Although mature trees and shrubs provide lateral control along much of the management unit, channel maintenance activities in the upstream portion have left all of the reaches in this unit with moderate to low width to depth ratios making them more efficient at moving sediment (Photo 15), though not necessarily prone to severe *downcutting*, especially in reaches with coarser sediment in the lower reaches of the upstream section (Photo 16).

Photo 16. View looking upstream toward XS-9 and large boulder in stream bed.

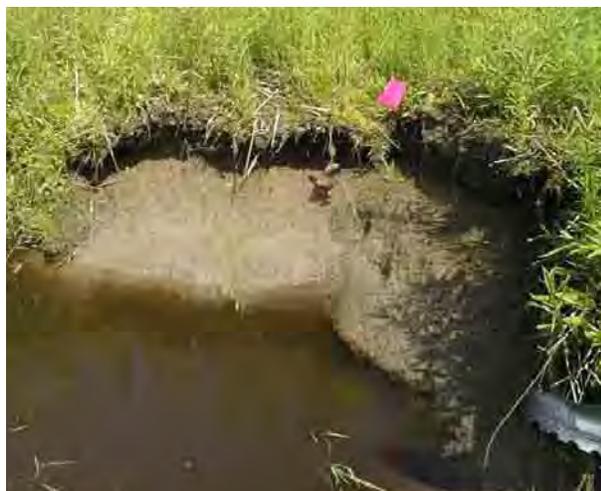
Preliminary observations indicate that the majority of the channel along this management unit is laterally stable (i.e., bank erosion rates are low). Mature grasses and shrubs provide lateral control along the majority of the management unit. There are two small sections of only a few linear feet cut low bank (Photo 9). The erosion appears local and within a natural

Photo 9. View looking upstream at XS-17 towards left bank at outside of meander bend, stream flow left to right.

range for this stream type and should require little or no intervention.

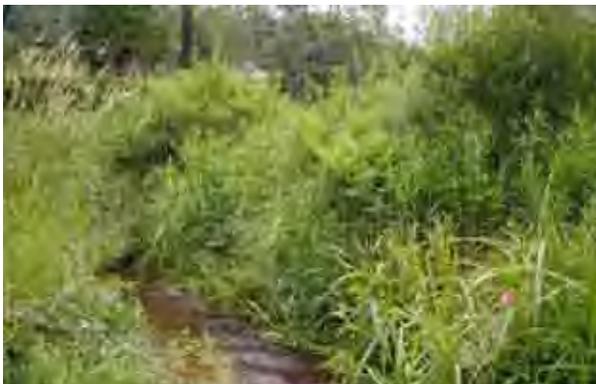
Many of the species seen in this area are native, however reed canary grass, a highly competitive species, was noted. This

Photo 10. View looking downstream at XS-34.5.

species may crowd out native vegetation which have ecological as well as stabilizing benefits. Healthy diverse native plant communities appear to inhibit the growth of the invasive species. Management for the reach should include a more detailed inventory and assessment of the non-native species, and consider methods for eradication (Riparian Vegetation Issues in Stream Management, Volume I, Section IV.B.3, and Riparian Vegetation Management Recommendations, Volume II, Section II. A.1).

6. Continue to assess, inventory and identify invasive plant species within MU2 and consider methods of eradication to prevent future establishment and potential dispersal into downstream areas.

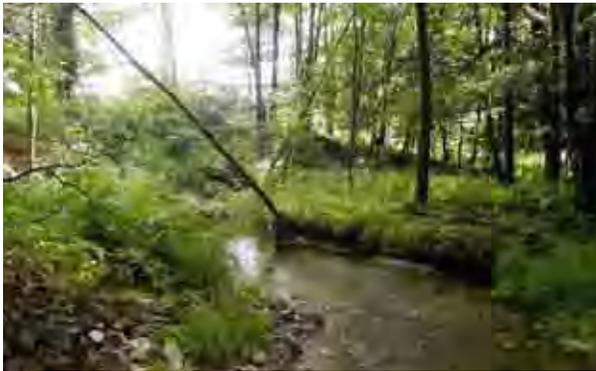
B channel types (Photo 6 shows C-type, Photo 7 shows B-type). Mature trees and shrubs provide lateral control along the majority of these reaches. Slightly and moderately entrenched reaches benefit from the deep-rooted structure and stability of mature vegetation.

Photo 6. View looking downstream at XS-41, C-type stream.

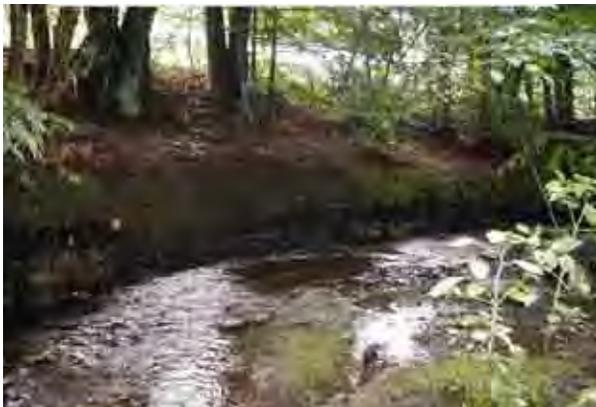
Photo 7. View looking downstream from right bank towards left bank at XS-44, B-type stream.

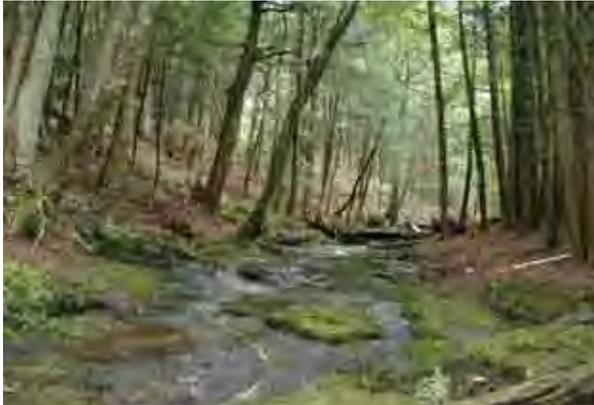
Photo 9. View of bedrock, looking upstream from below XS-48.

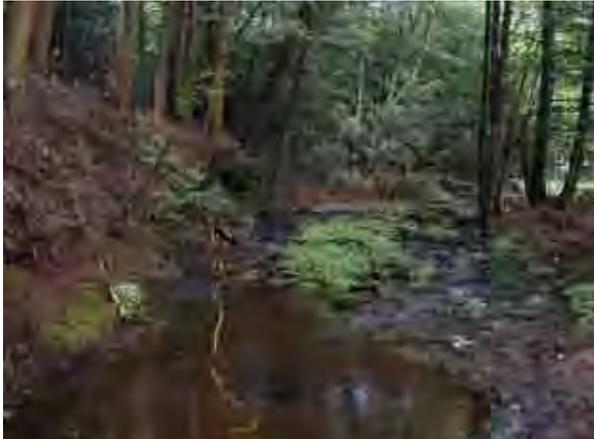
Preliminary observations indicate that most of the channel along this management unit is laterally stable (i.e., bank erosion rates are low) which includes areas along high banks (Photo 10). Mature trees and shrubs also provide lateral control along the majority of the management unit. The 2001 Stream Assessment Survey determined that 117 feet (2.4%) of the streambanks are actively eroding. The erosion occurs in three small sections ranging from 15-50 linear feet and mostly consists of slightly undercut areas along low banks (Photo 11). The erosion appears local in nature, should require little or no intervention, and potentially adds to the fish and wildlife habitat.

Photo 10. View looking upstream towards dam at XS-46.

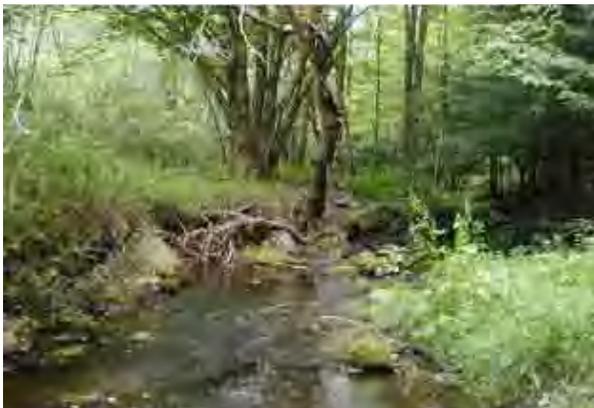
Photo 11. View looking downstream at XS-54.

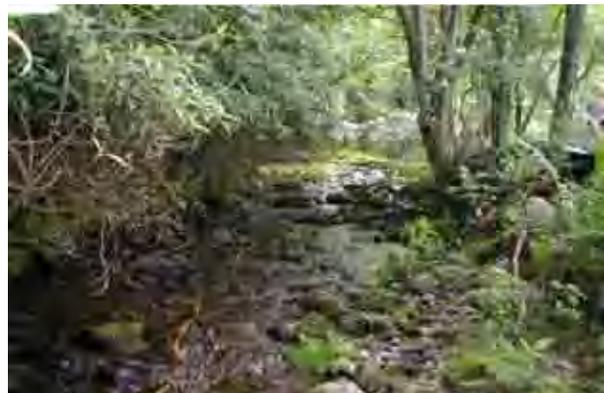
The riparian area in Management Unit 3 is generally stable and consists of mature trees and shrubs (Photo 12). Vegetated riparian zones act as buffers against pollution and are therefore very important in mitigating the adverse impacts of human activities. Forested riparian buffers facilitate stream stability and function by

Photo 12. View looking upstream at XS-53, with cobble bed.

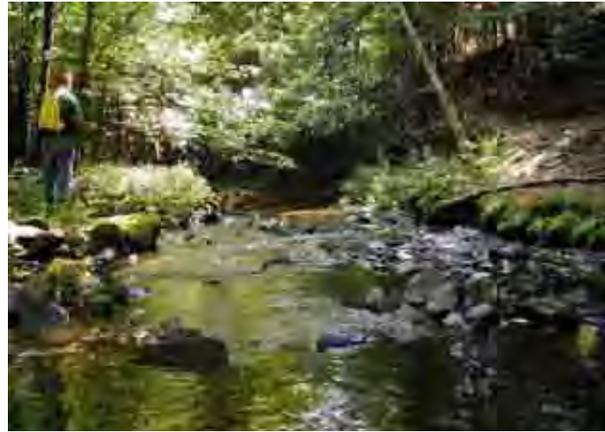
Photo 1. Cross section 58– view looking downstream behind Revolutionary War graveyard.

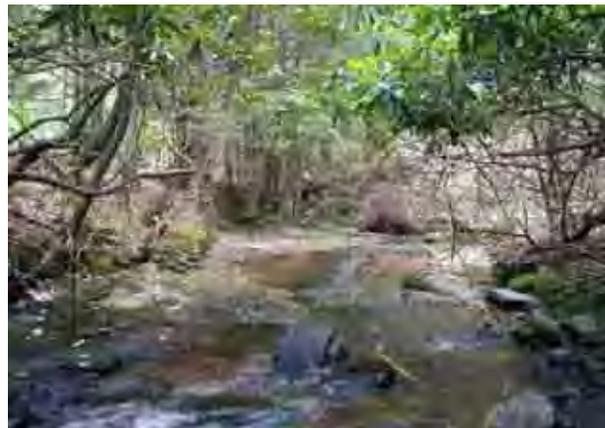
Photo 2. Cross section 63– view looking downstream.

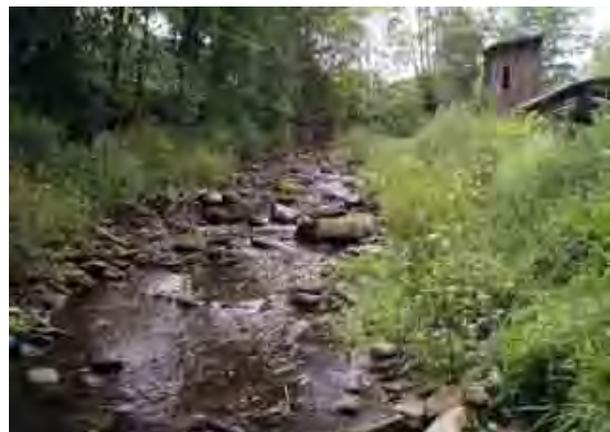
Photo 3. View looking upstream -Rt. 55 to the right of view.

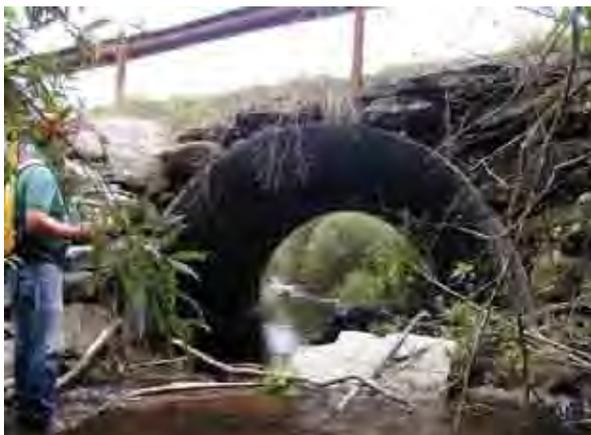
Maintenance of infrastructure is a concern for local municipalities as well as landowners. There are four stream crossings and four drainage culverts in MU4. The stream crossing at Slater Road culvert is a 9 x 15 foot corrugated metal elliptical pipe (Photo 9). The cross-section of the culvert is narrower than the *bankfull* channel upstream and downstream of the culvert. Downstream landowners have reported erosion and maintenance problems. According to residents, an old culvert in the same location had been

Photo 9. View looking downstream at inlet of culvert under Slater Road.

placed to direct streamflow towards the center of the channel. The old culvert was replaced in the mid to late 1980's with a new culvert that was shorter and placed at a skew relative to the stream channel. This skewed position resulted in storm flows being directed against the downstream *meander* bend contributing to *erosion* of the banks. In 1996, the Town repaired the culvert and stabilized 50 feet of banks downstream of the crossing. Subsequently, the landowner placed additional *riprap* along downstream sections.

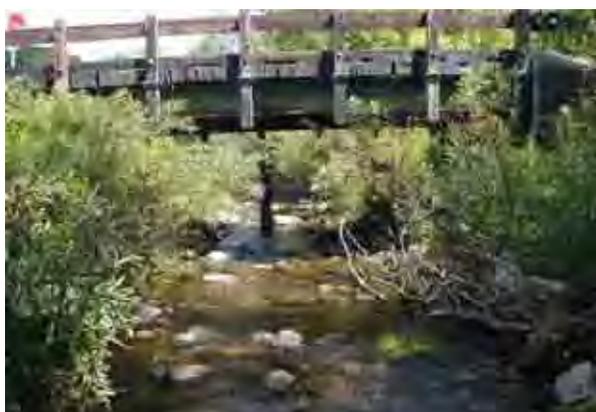
The County bridge at Kelly Road (CBN: 386, BIN: 3229170) was built in 1979 (Photo 11). It appears that the bridge was designed to convey larger, less frequent storm flows, probably the 25-year event. The bridge is subject to a biennial inspection by NYSDOT, which indicates that the decking, abutments, and wing walls are in good condition with no significant changes in scour. The bankfull cross sectional width both upstream and downstream of the bridge are only slightly larger than the span of the bridge itself.

Photo 11. Looking downstream at Kelly Road Bridge.

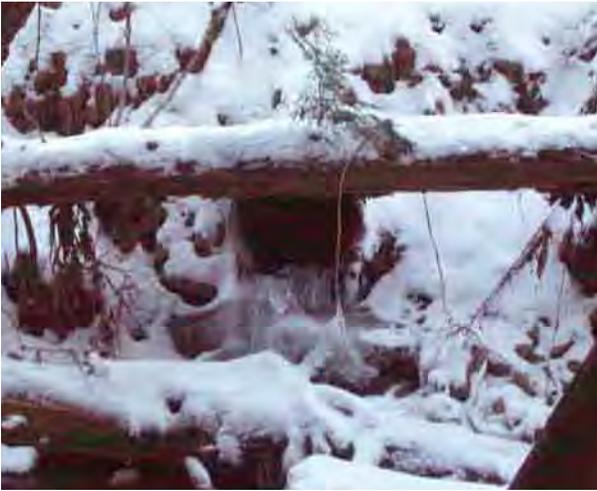
As noted above, storm drainage culverts convey storm water runoff from parking lots and equipment/materials storage areas directly to the creek. Three storm drainage culverts were identified in this management unit during the 2001 Stream Assessment Survey (Photo 12).

Photo 12. Storm drain outfall behind Zanetti's along Route 55.

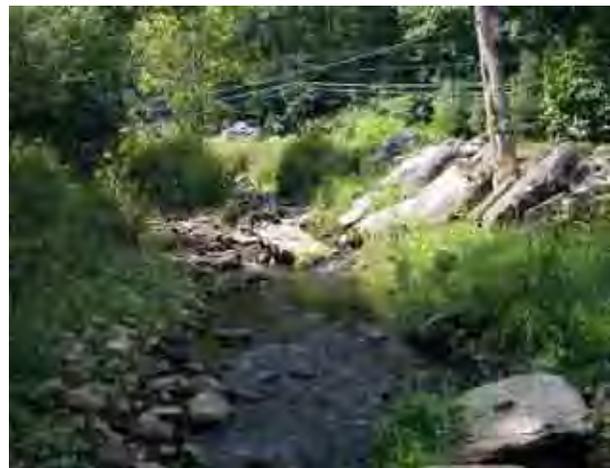
Efforts by the Town, as well as landowners focused on protecting infrastructure and property have involved the installation of *riprap* (Photo 13), stacked rock walls, and a log cribwall along 14% of the channel length through

Photo 13. View looking upstream– rip-rap on left bank– Rt. 55 is on the right side of the picture.

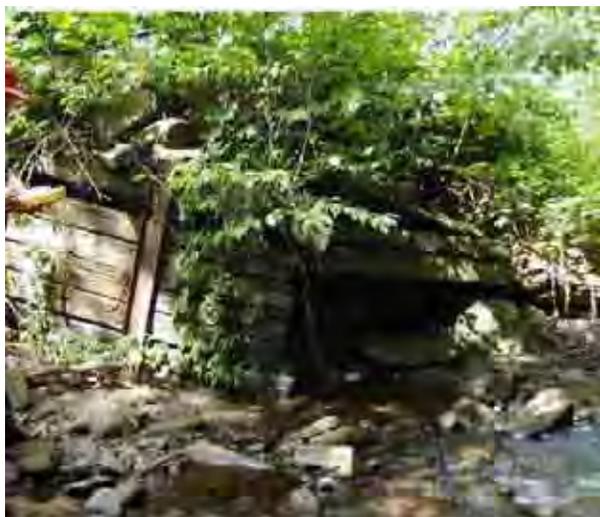
this management unit. These protective measures appear to have been relatively successful in some areas, while less successful in other areas. For example, a section of a log cribwall installed near the downstream end of the unit is failing (Photo 14).

Photo 14. Beginning of log crib wall on left bank view from right bank near bottom of MU4, before the entry of the Claryville Road tributary.

10. Monitor areas with debris jams and channel blockages for changes in channel stability and threat to infrastructure.
11. Evaluate failing revetment for replacement with stabilization structure to maintain naturally functioning channel. Should include bioengineering and/or re-vegetation.

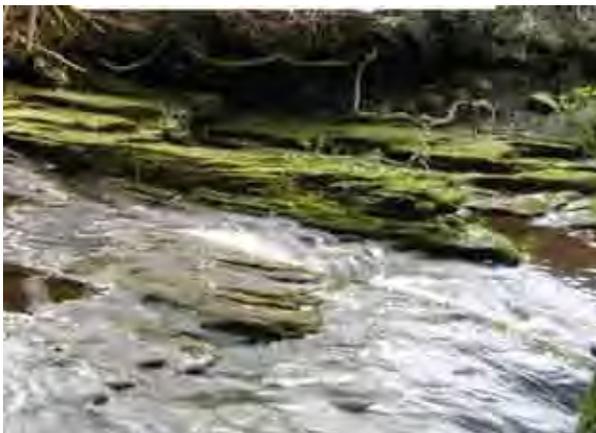
Historic bed *degradation* and floodplain fill contribute to the current entrenched situation along Reaches 1, 4, 6, 7, 9 and 10. Exposed bedrock currently provides grade control along a significant portion of the unit, thereby preventing further widespread channel degradation (Photo 16).

Photo 16. View looking towards left bank at bedrock stream bed MU4.

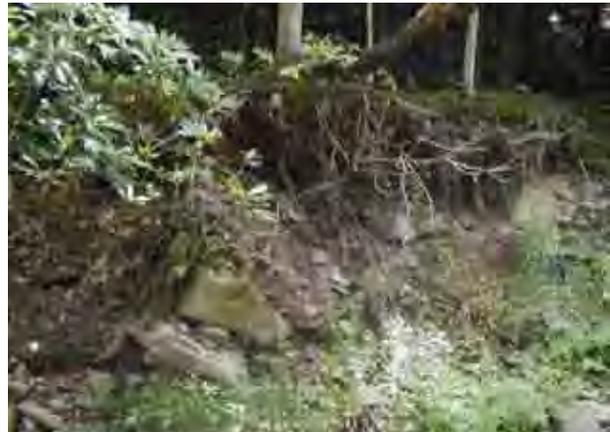
Photo 17. Eroded right bank – view looking upstream near the bottom of MU4.

stability assessment show that the banks along the actively eroding areas have very high bank erosion potential, meaning that the potential for continued bank erosion, loss of trees and channel migration and bank erosion potential is very high compared to other sites. Because the channel is cutting into terraces and fill slopes in some areas they will continue to be a significant source of sediment for downstream reaches.

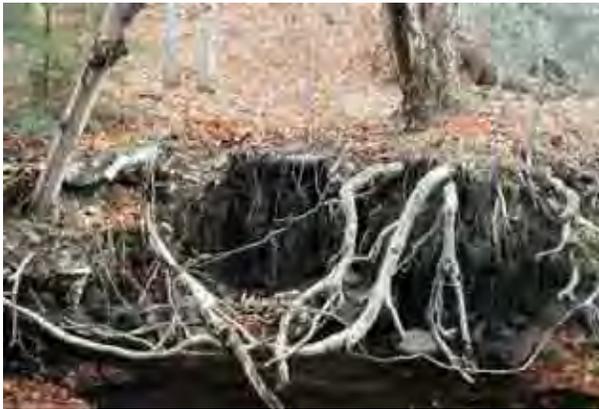
Photo 18. Monitoring cross section 2, left bank above the confluence of Scott Brook with the Mainstem Chestnut Creek. Tree roots and rocks are providing some protection and good habitat.

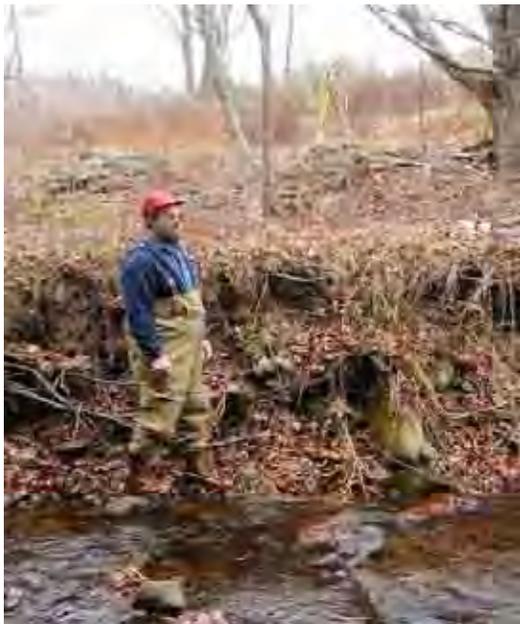
Photo 19. Monitoring cross section 3, below confluence of Scott Brook with the Mainstem Chestnut Creek. Stream flow is from left to right.

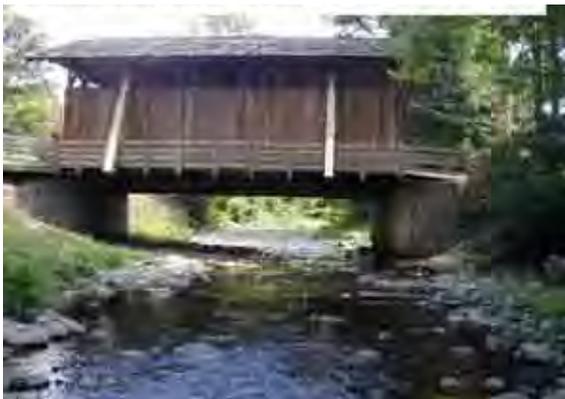
Photo 1. Looking downstream upstream at the historical Covered Bridge at the Town of Neversink, Agricultural Society Fairgrounds along Route 55, at bottom MU 5.

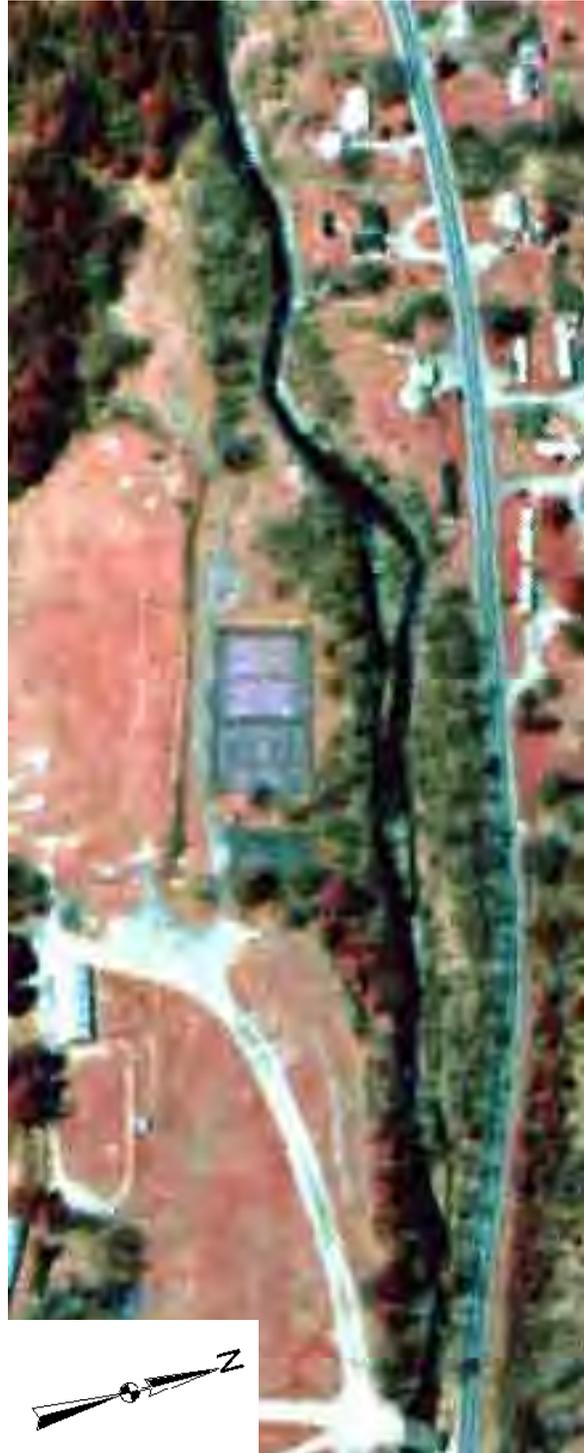
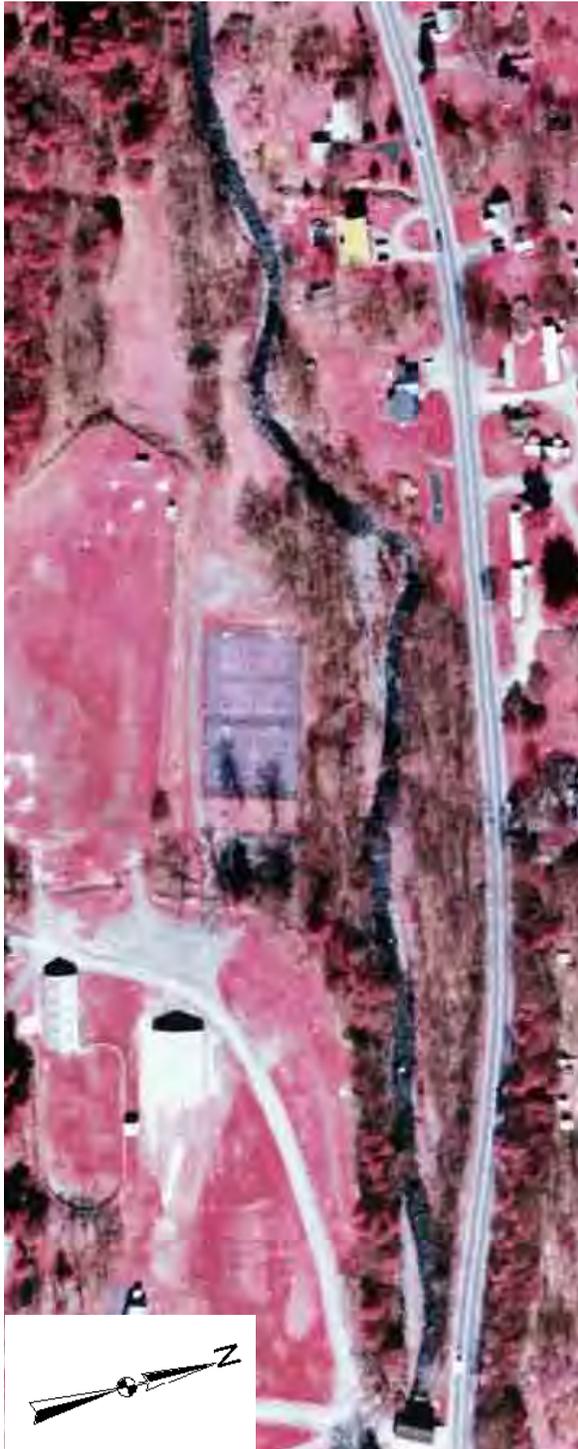
This section of Chestnut Creek appear to have been straightened and *channelized* at some time in the past. An analysis of a series of historic aerial photographs covering the period 1974-2001 indicates that routine channel maintenance occurred until recently (Aerial Photos 2, 3 & 4).

Photo 2. 1974 Aerial Photograph of Management Unit 5.

Photo 3. 1995 Aerial Photograph of Management Unit 5.

Photo 4. 2001 Aerial Photograph of Management Unit 5.

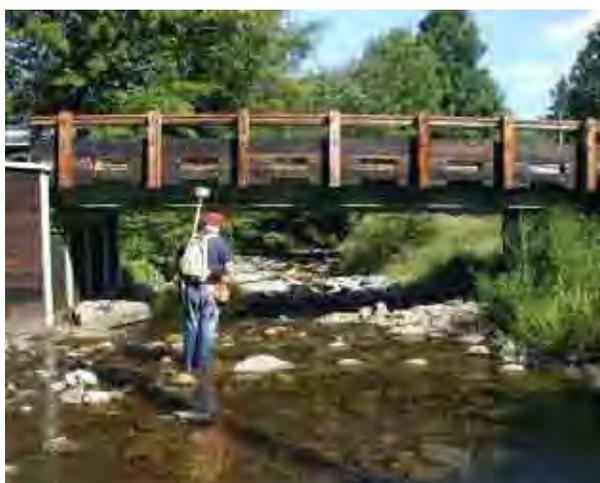
Maintenance of public infrastructure is always a concern for local municipalities. There are two drainage culverts and four bridges in MU5. The bridge names from top of MU5 to the bottom are Clark Road, Mohr's, Hilltop Road, and the Covered Bridge. The County bridge at Clark Road (CBN: 319, BIN: 3357090) was rebuilt in 1995 (Photo 5). The new bridge was designed to convey the 25-year storm flow. Bridge inspections in 2000 and 2001 indicate that the decking, abutments, and wingwalls for this structure are in satisfactory condition.

Photo 5. Looking downstream at Clark Road Bridge.

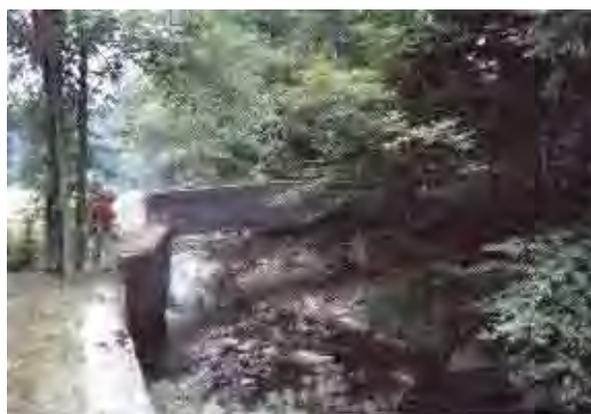
Although privately owned, the bridge at the Mohr Property provides emergency access for several landowners. The bridge was originally used as access for the local school before the present day Tri-Valley School was established in 1950. The bridge is currently in poor condition. The bridge span was measured to be less than the *bankfull width* immediately both up and downstream of the structure. The left abutment (looking downstream) is also located in the *thalweg* or deepest part of the active stream channel which can be seen in Photo 7. This puts significant stress on the structure as well as the stream channel in the vicinity of the bridge as evidenced by the large scour hole that has undermined the left abutment (Photo 6). Approvals were obtained from NYSDEC in 1998 to repair the failing abutment. The concrete wall that runs along the left bank adjacent to Route 55 is attached directly to the failing abutment (Photo 7). If the bridge is not repaired or replaced the factors contributing to its failure may ultimately affect the structural integrity of the concrete wall.

Photo 7. Looking downstream at concrete wall on left bank tied into edge of Route 55 and Mohr's Bridge.

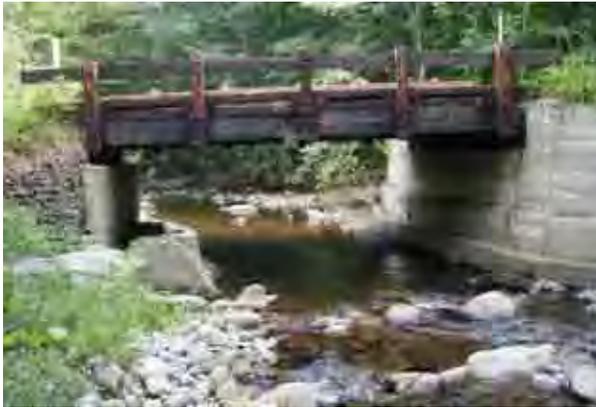
Hilltop Road Bridge also a County bridge (CBN: 340, BIN: 3357180) was built in 1967 (Photo 8). The bridge width from bank to bank, is smaller than the immediate up and downstream cross sections. This narrow span may contribute to backwater conditions and scour through the bridge opening. Flood damage to the foundation and wingwalls occurred during a severe thunderstorm in July 1995. A general permit was issued for repairs that included removal of gravel and debris deposits, replacing riprap, new toe footings and base protection. Bridge inspections in

Photo 8. View looking downstream at Hilltop Road Bridge, gabion revetment can be seen on left of photo.

2000 and 2001 indicate minor scour erosion was evident. However, the decking, abutments, and wingwalls for this structure are in satisfactory condition.

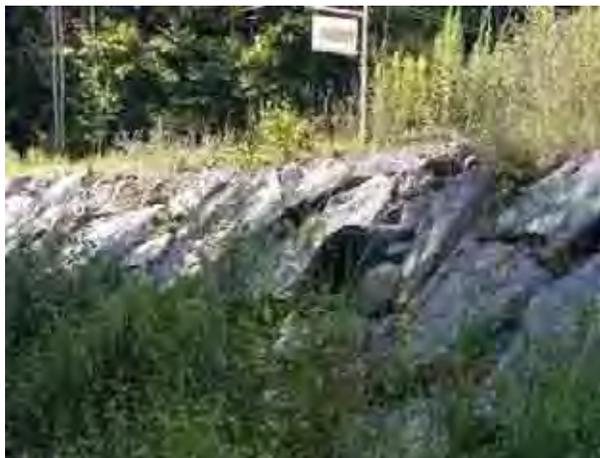
parking lots directly to the creek (Photo 10). Two storm drain outfalls were identified in this management unit during the 2001 Assessment Survey.

Photo 10. rip-rap along left bank and Rt. 55 with 2' diameter culvert from the road – below Mohr's bridge.

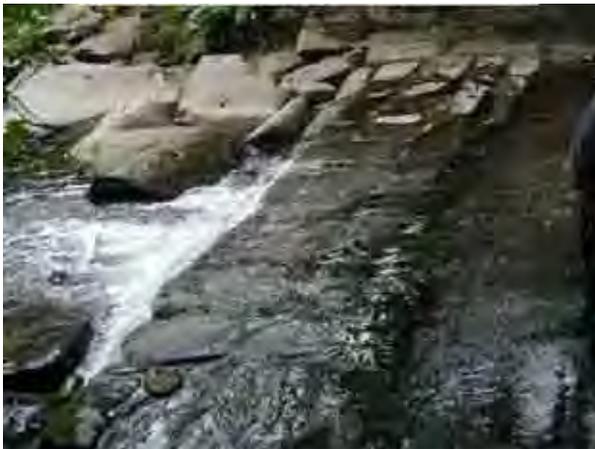
Photo 11. Rock and cement bed/elevation control – looking toward right bank below Clark Road Bridge.

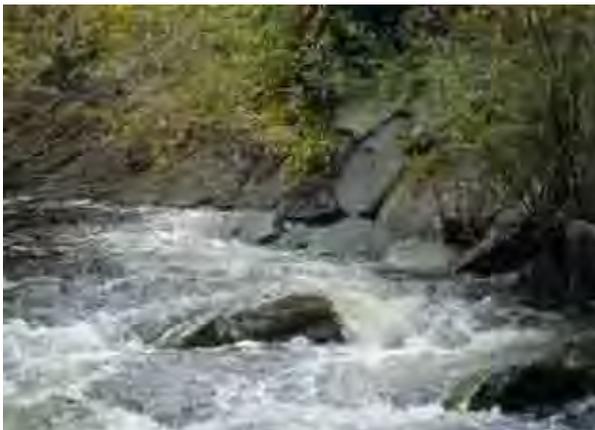
Photo 12. Left channel riprap looking upstream several hundred feet above covered bridge opposite fairgrounds.

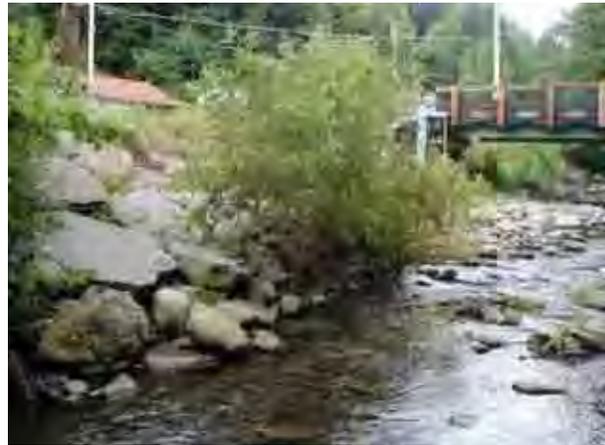
Photo 13. Rip-rap on right bank below Clark Rd. Bridge – view looking upstream at end of bridge opposite from Route 55.

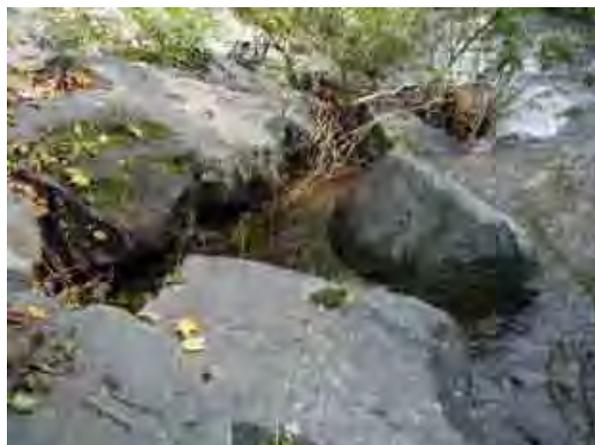
protective measures appear to have been relatively successful in some areas, while less successful in other areas. For example, the banks along the rear of the Black Property in the middle reaches of this unit had been riprapped during previous maintenance attempts. Currently riprap has been dislodged, fallen into the channel and is inappropriately redirecting higher flows and scouring stream banks (Photo 14).

Photo 14. Dislodged riprap in the channel.

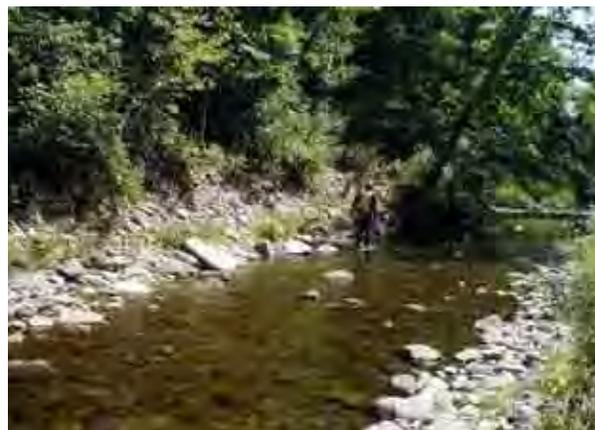
Photo 15. Looking downstream towards eroded left bank and fallen Sycamore trees near Fairground area-monitoring cross section 6.

streambanks are actively eroding (Photo 15). Bank to bankfull height ratios along this unit ranged from 1.1 – 3.6, confirming that a significant length of the channel is *incised*. Rosgen (2002) notes that bank to bankfull height ratio is a good measure of vertical stability, as well as an indicator of sediment supply potential. Stability assessment resulted in banks along the actively eroding areas to be rated very high in terms of bank erosion potential, meaning that the potential for continued bank erosion, loss of trees and channel migration is very high compared to other sites. In fact, as meander bends and bars continue to develop lateral erosion and meander migration will accelerate. Because the channel is cutting into terraces and fill slopes in some areas they may continue to be a significant source of sediment for downstream *reaches*.

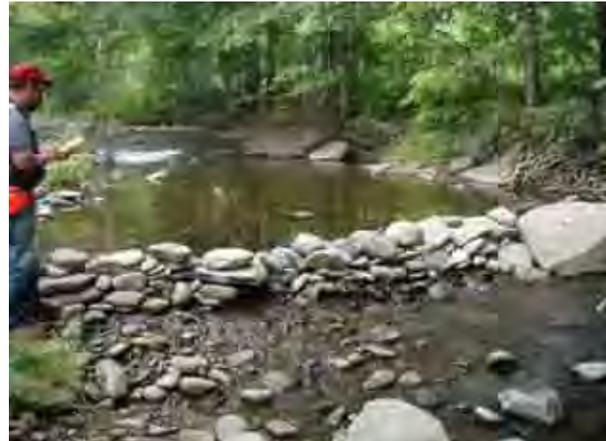
Photo 16. Rock check dam, between Clark Road Bridge and Hilltop Road Bridge.

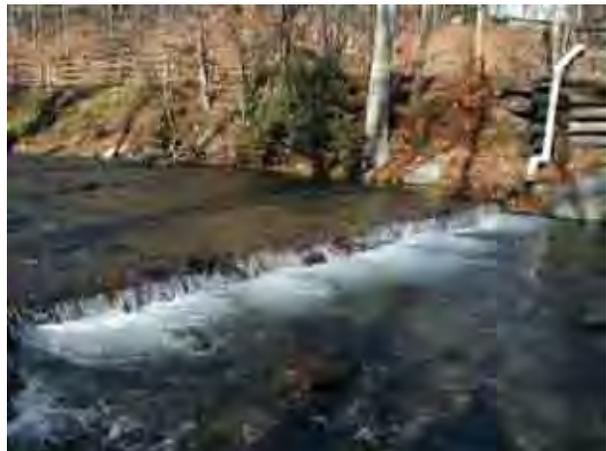
Photo 17. Just below Covered Bridge MU5, Wood Weir serving dry hydrant in downstream MU (see MU6 for more detail).

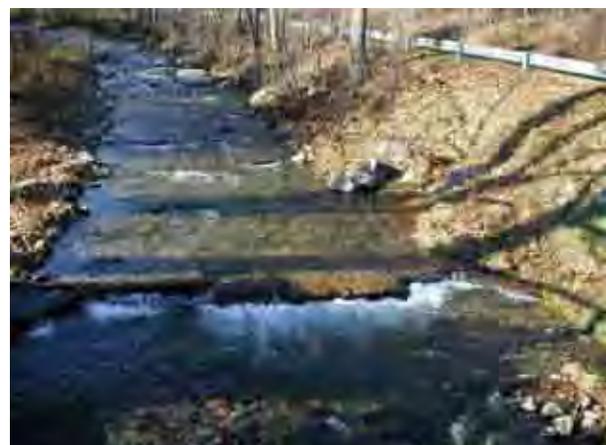
Photo 18. Log sill located just above Covered Bridge.

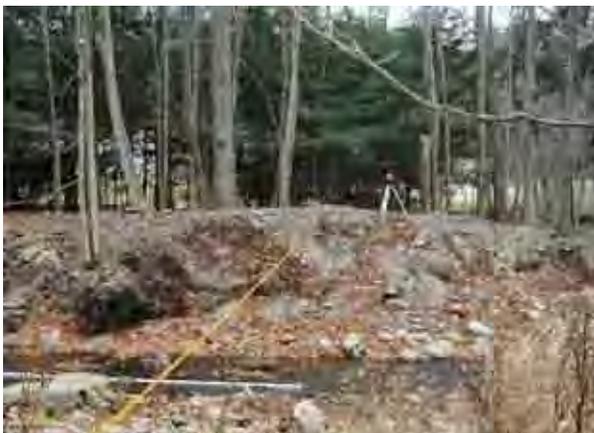
Photo 20. Monitoring cross section 5, view looking at right bank, tennis courts in background beyond tree, approximately 200' downstream of monitoring cross section 4.

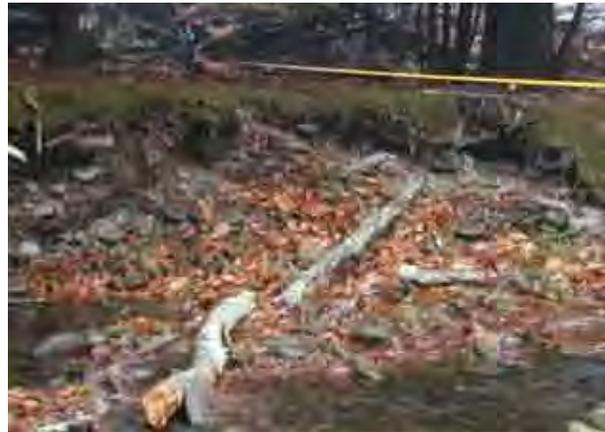
Photo 21. Monitoring cross section 6, approximately 200' eroded right bank, downstream of monitoring cross section 5.

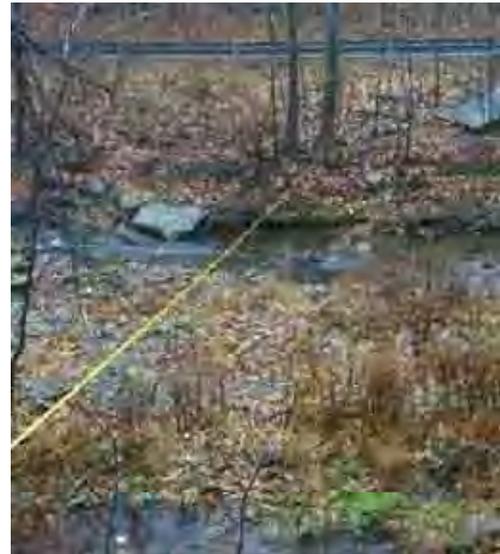
concern (Bank Erosion Hazard Index, BEHI, and Bank Monitoring Cross-section, BMX, to observe aggradation) Accordingly, four cross-sections were established and surveyed in MU5 along the reaches upstream of the Covered Bridge adjacent to the Town Fairgrounds (Photos 19, 20, 21 & 22, MU5 Stream Type Cross Section map, Figure 2). Three of the sites were established to monitor lateral erosion (BEHI 4,5&6) and one along a section that appears to be aggrading (BMX 1). The cross-sections will be resurveyed and compared to the initial surveys to

Photo 22. Aggradation monitoring cross section 1, just upstream Covered Bridge.

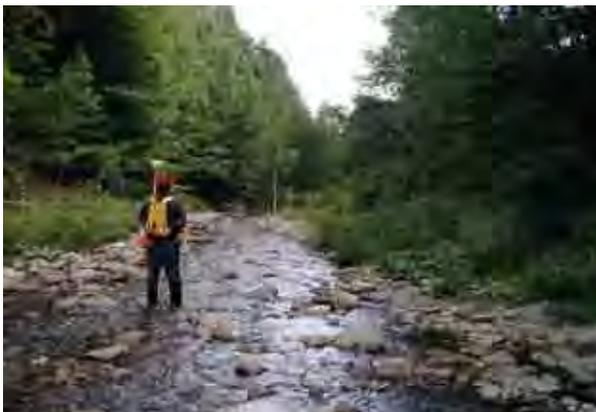
Photo 1. View looking downstream from cross section 136, Fairgrounds on right of photo, several hundred feet below Covered Bridge.

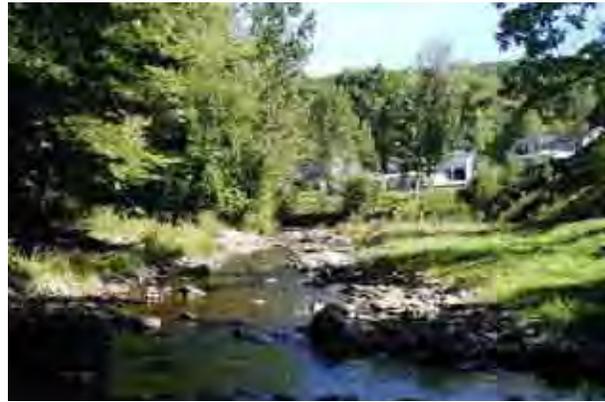
Photo 2. Looking upstream at cross section 151, half-way between Davis Lane and River Road bridges.

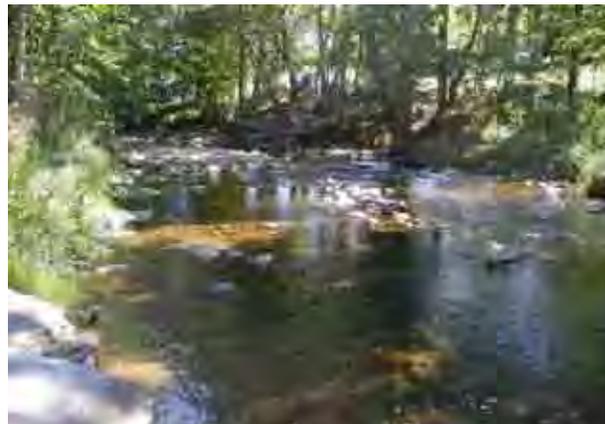
Photo 3. Reach-view looking downstream from left bank at cross section 161 behind fire house.

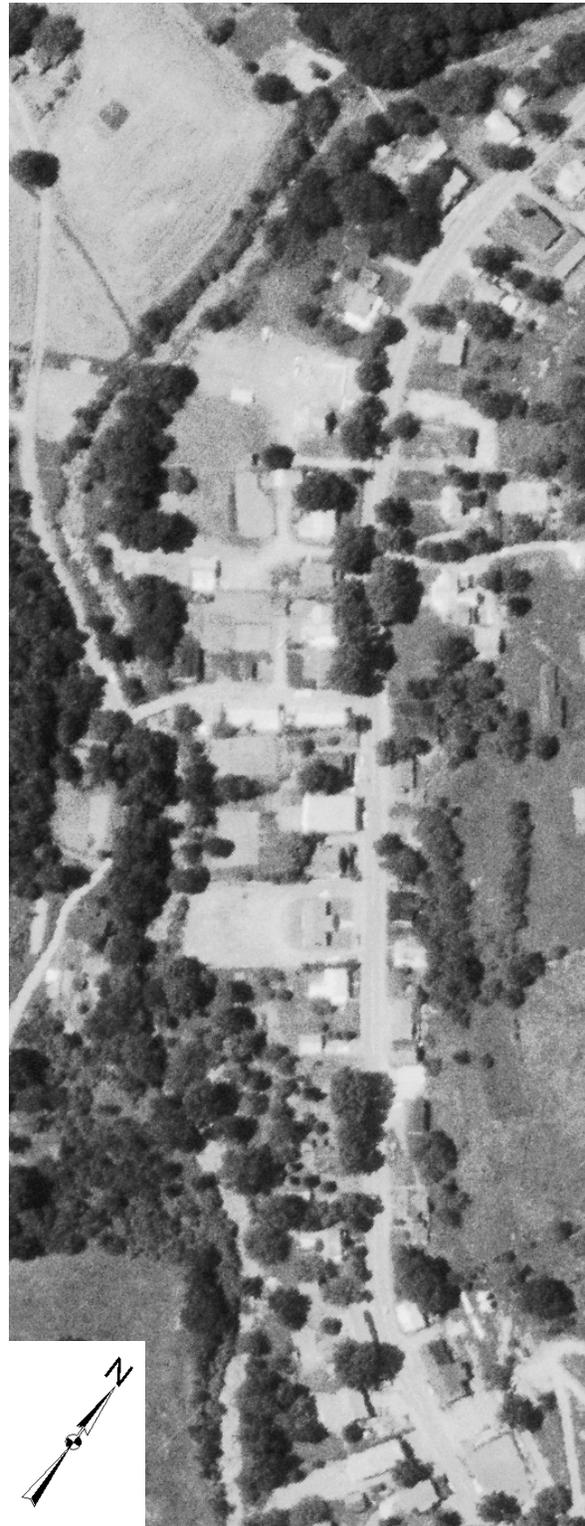
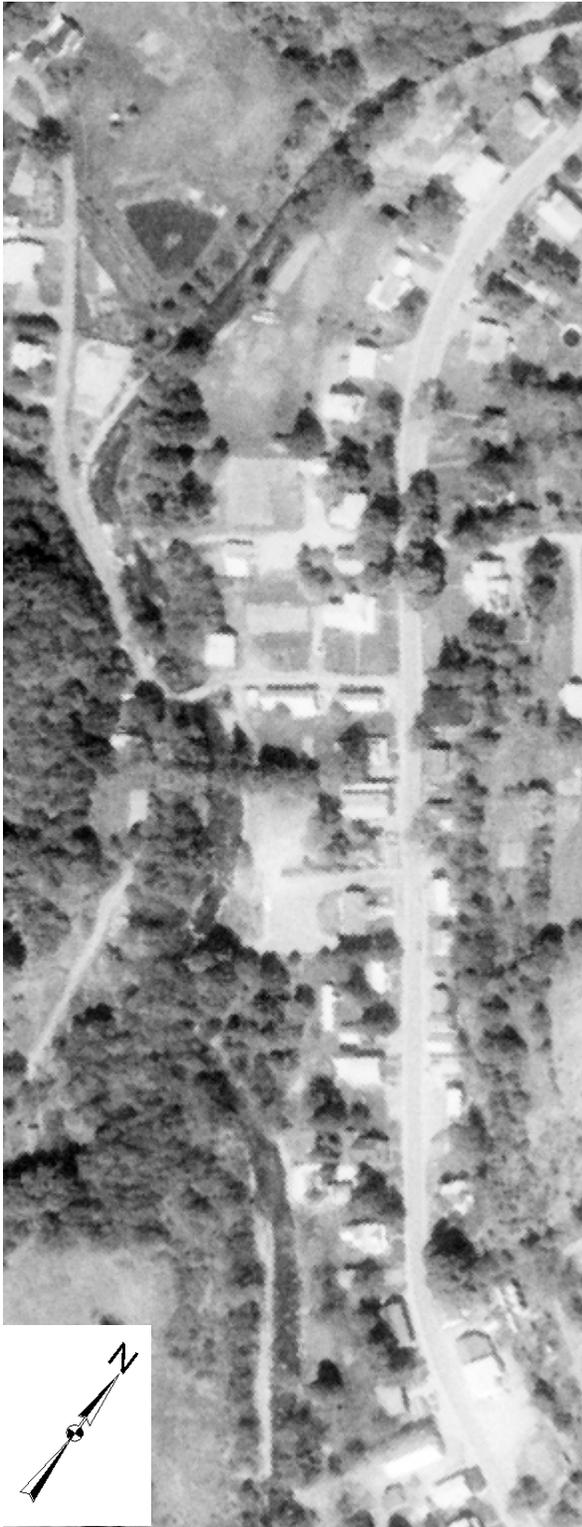
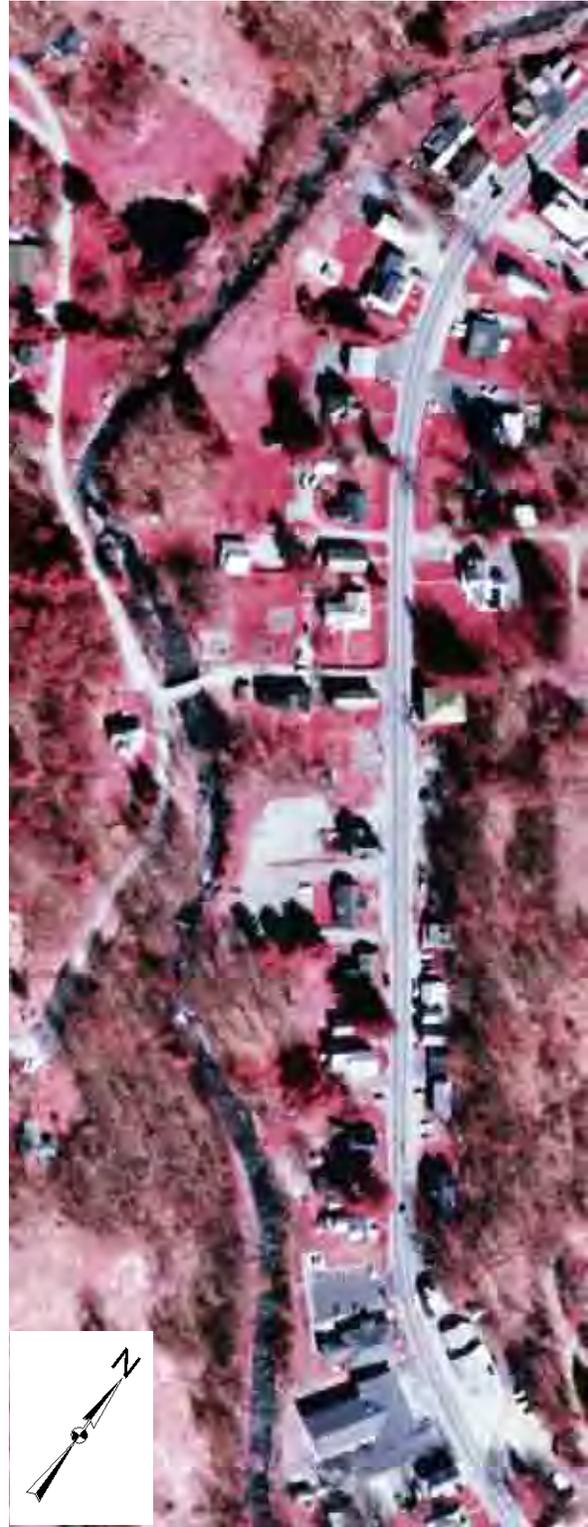
at some time in the past from information obtained from an historic 1929 DOT highway map. An analysis of a series of historic aerial photographs covering the period 1963-2001 verifies that any channel modifications occurred prior to 1963. The aerial photographic record also indicates that routine channel maintenance occurred until recently (Aerial Photos 4, 5 & 6).

Photo 4. 1963 Aerial Photograph of Management Unit 6.

Photo 5. 1977 Aerial Photograph of Management Unit 6.

Photo 6. 2001 Aerial Photograph of Management Unit 6.

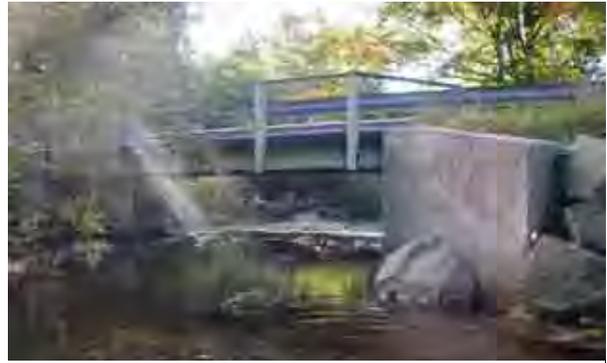
Photo 7. Looking downstream at right span of Davis Lane Bridge.
