The Chestnut Creek Stream Management Plan

Volume I of II

Background, History and Watershed Description

March 2004

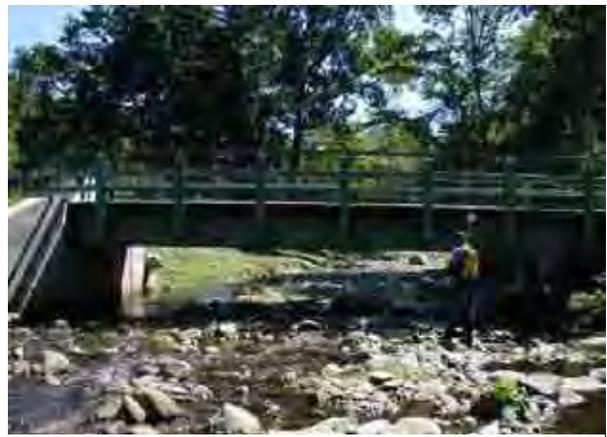
Maintenance of public infrastructure is always a concern for local municipalities. There are two bridges in MU6, one on Davis Lane (CBN: 70, BIN: 3357040) built in 1953 (Photo 7) and the other on River Road (CBN: 92, BIN: 3357080) built originally in 1933 and rebuilt after flooding in 1996 damaged it (Photo 8). Although bridge inspections in 2000 and 2001 indicate that the decking, abutments, and wingwalls for both structures are in satisfactory condition, inspection reports, as well as the historic aerial photographs and information obtained from residents and town officials indicate that the stream reaches in the vicinity of the bridges have had on-going *aggradation* problems. Large gravel bars were observed upstream and downstream of the bridges during the 2001 Assessment Survey (Photos 8 & 9).

Photo 8. Looking downstream at River Road Bridge, just above Town Hall. Note the cobbles that are deposited upstream of the bridge in the foreground of the photo.

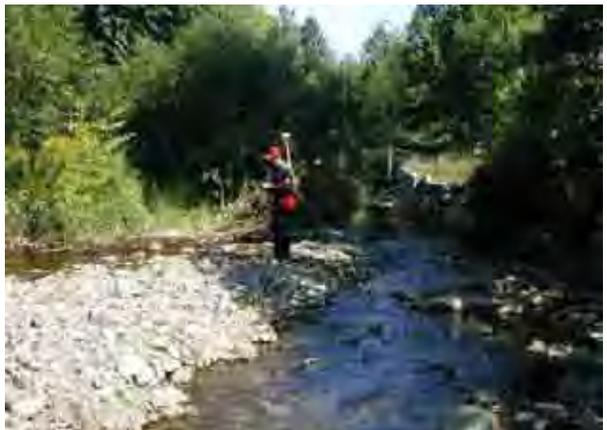
Photo 9. Looking downstream at left bank cross section 141 at end of center bar and split channel upstream of Davis Lane Bridge.

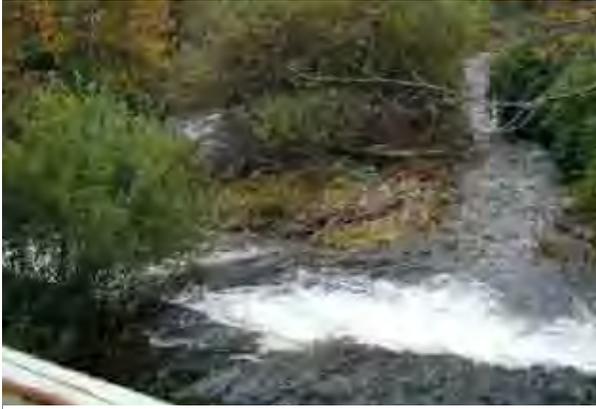
Photo 10. Looking downstream from top of Davis Lane Bridge at split channel below grade control at high flow. Right channel dry in 2001 at low flow. Center bar with cobbles and willow can be seen.

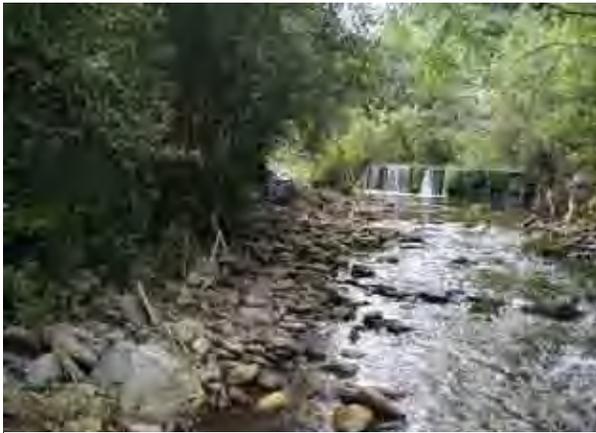
Another significant factor contributing to problems in this area was the effect of the sanitary sewer crossing downstream of the bridge on channel slope through this reach (Photo 11). In the 1950's, a sanitary sewer lateral was installed across Chestnut Creek immediately downstream of the Davis Lane Bridge to serve the Fairgrounds. After the sewer line was exposed by a

Photo 11. Looking upstream towards Davis Lane Bridge concrete grade control structure over sewer line.

storm in the 1960's it was reinforced with a grouted riprap encasement. The elevation of the original sewer line and subsequent encasement significantly raised the streambed in this reach. This resulted in an extremely flat channel gradient in the vicinity of the bridge upstream, which has undoubtedly contributed to the on-going aggradation problems previously mentioned. The combination of the high width to depth ratio, flat gradient, and center pier of the bridge ensures that material transported from upstream will routinely accumulate in this reach.

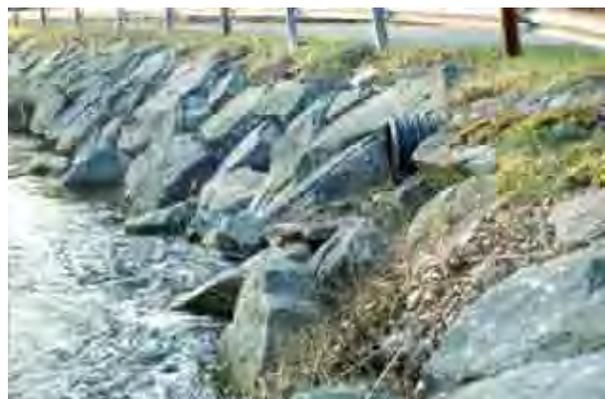
The River Road Bridge is also affected by aggradation. However, in this case the problem appears to be the result of a loss of stream energy due to a sharp (120°) meander bend and overwiden reach upstream of the bridge (Photo 12). In addition, the bridge span is narrower than the width of the channel along the reaches upstream and downstream. These factors cause water to back up on the upstream side of the bridge. Under this *backwater* condition, the flow velocity along the upstream reach drops reducing the stream's ability to transport its sediment load. As a result material accumulates along the upstream reach. Water backed up above the bridge during floods tends to form scouring eddies near the banks as the water rushes under the bridge, contributing to bank erosion and further widening of the channel.

Photo 12. Looking downstream at rip rap along sharp curve and culvert on right bank, along River Road upstream of bridge. Flow hits directly into bank near culvert.

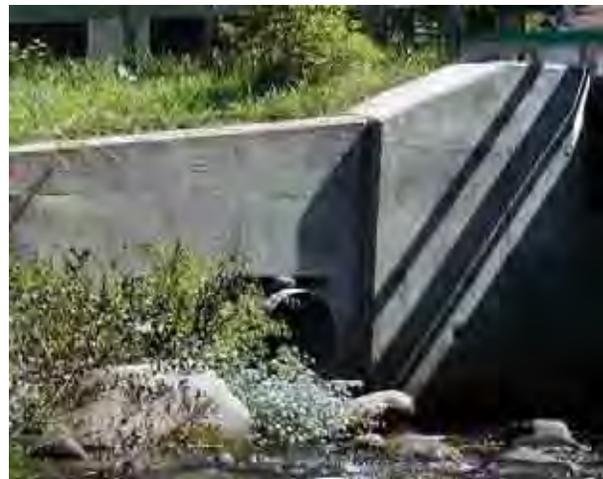
Assessment Survey (Photo 14). The volume as well as the water quality of the runoff is a function of the size and characteristics of the land area each system drains. For example, land areas with a high percentage of impervious surfaces tend to generate considerably more runoff than areas that are predominantly forest or lawn. The size and land use characteristics of the areas draining to the outfalls identified, as well as the potential for storm water retrofit opportunities was not evaluated as part of the initial assessment. However, a review of the aerial photographs indicates that the properties along the corridor with the highest percent impervious surfaces include the Agriculture Center, Bank, Town Hall, Post Office, and Fire Hall. None of these properties have storm water management facilities for controlling runoff.

Photo 14. Culvert in left bank abutment on upstream side of River Road Bridge, view looking downstream from the center of the stream.

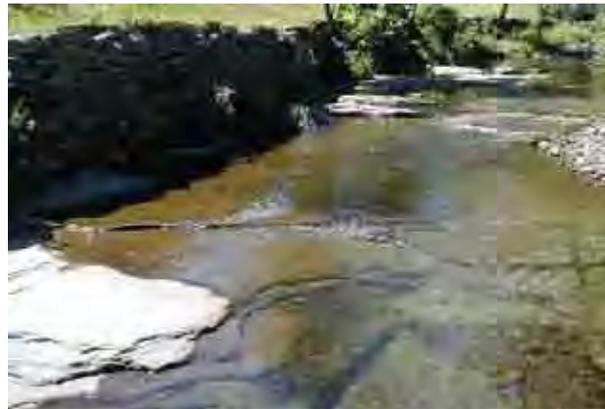
Photo 15. Bedrock streambed, starting approximately 200' upstream from Route 42 Bridge-view looking upstream from center of stream, stacked rock wall on left of photo.

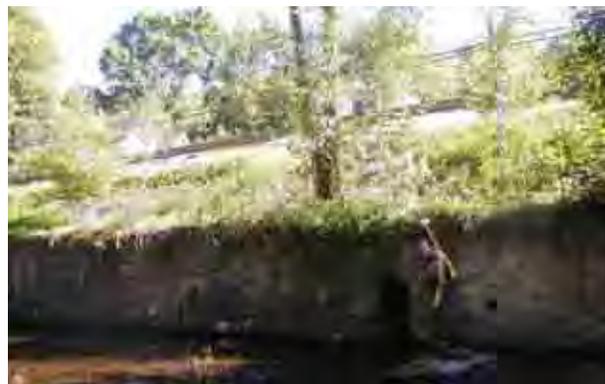
Photo 16. Concrete wall with box culvert along Route 55 between River Road and Fire House.

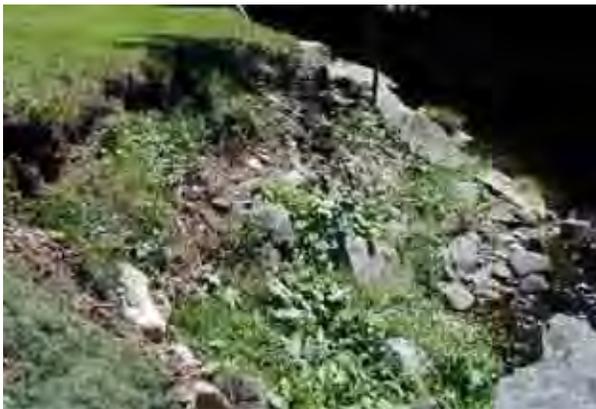
rip-rap, gabions, stacked rock, and concrete revetment. These protective measures appear to have been relatively successful in some areas, while less successful in other areas. For example, the banks along the rear of the Town Hall have been rip-rapped during previous maintenance attempts. Currently rip rap has been dislodged, fallen into the channel and is diverting storm flows (Photo 17). Residents have expressed concerns about the riprap revetment on the sharp bend upstream of the River Road Bridge. The riprap was installed in the 1970's to protect the road along the right floodplain. Some of the riprap has been dislodged and scattered along the channel by storm flows during the intervening years.

Photo 17. Dislodged riprap at left bank behind Town Hall parking lot-view looking downstream with dry hydrant partially visible in the background.

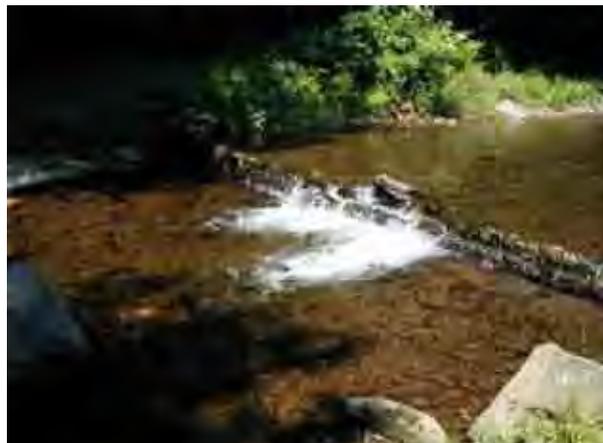
Photo 18. Wood weir behind Town Hall.

11. Reconstruct problematic dry hydrant sites utilizing cross vanes to provide low maintenance facilities.

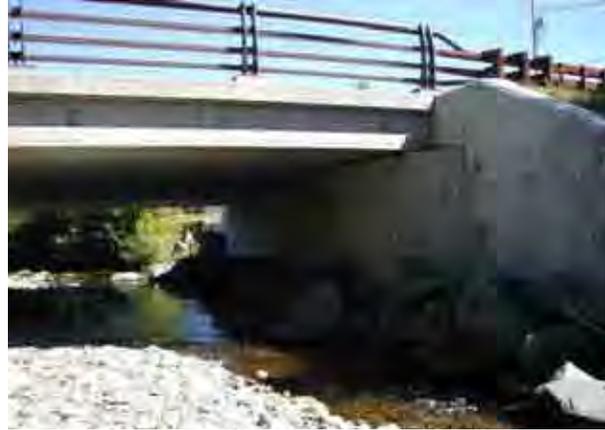
Photo 1. View looking downstream at Route 42 Bridge, cobble bar under bridge with main channel flowing into right abutment armed with riprap.

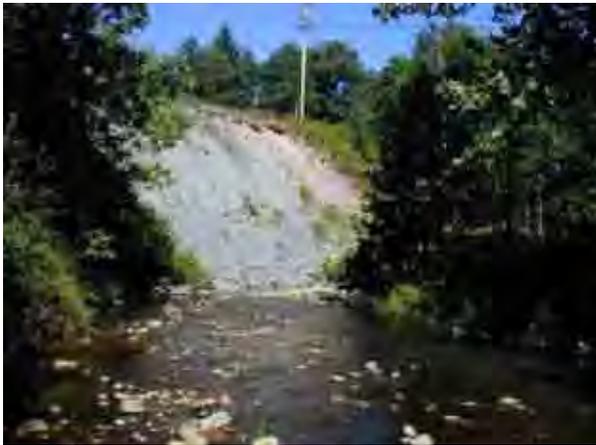
A number of natural constraints and human-made modifications were inventoried within the unit during the 2001 Stream Assessment Survey. These include traditional applications consisting of placed rock revetment, such as *riprap*, floodplain *berms*, and grade control structures such as check dams and weirs, as well as sewer and bridge crossings. Channel alignment has been historically constrained by high terraces, in areas along both banks. In the center of the unit, the stream channel currently impinges along the toe of a high bank along State Route 55, on NYCDEP property, resulting in severe erosion and *mass wasting* (Photo 4 & Appendix Projects Ranking).

Photo 4. Steep eroded left bank on DEP property, along Route 55-view looking downstream toward road & left bank from XS-170.

The Sullivan County SWCD, the Town of Neversink, NYCDEP, NYSDEC, and NYSDOT and should work with consulting engineers trained in geomorphology and natural channel design to evaluate existing high bank instability.

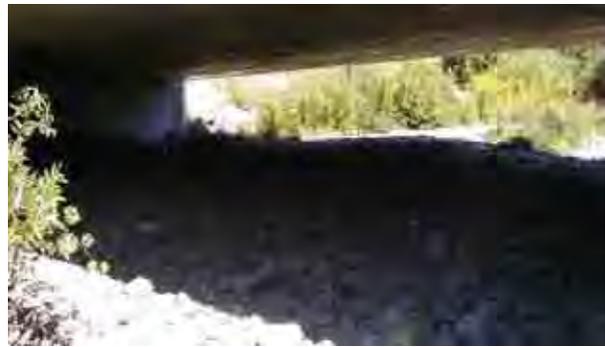
a large gravel bar had formed under the opening of the structure (Photo 8). Gravel deposition can result from inadequate bridge width or location over the bankfull channel width. Reduction of the *hydraulic* opening under a bridge causes ongoing maintenance problems as well as potentially results in higher stress along the bridge abutments. Field surveys verified that the deepest part of the stream channel currently runs directly into and along the right bridge abutment (see Photo 1). Evaluation of the bridge alignment and width over the bankfull channel width would be beneficial to both the longevity of the bridge and the integrity of the stream.

Photo 8. Cobble bar under Route 42 bridge along left abutment.

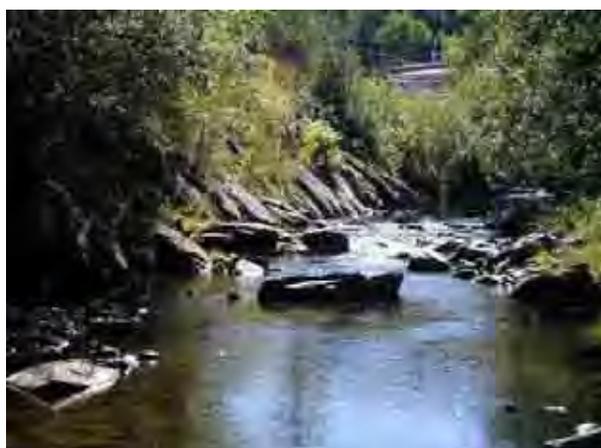
General impacts of traditional approaches to stream management have been addressed in Stream Stewardship Recommendations, Volume II, Section II. Specific impacts and management considerations in relation to the assessment of MU7 are included with this section of the plan as well. Use of riprap around bridges is a common practice and usually is specified in design and construction due to hydraulic considerations and erosive forces created by the bridge opening during storm flows. The Route 42 Bridge has a continuous section of riprap along the right bank of the channel. Riprap begins at the bridge outlet and continues nearly 600 feet downstream (Photo 9). The purpose for the extent of the original installation was not established during the initial site investigation. Several impacts have potentially resulted from revetment placement, which includes redirection of stream flow toward the high bank area and increased entrenchment. Additionally, the stream channel in MU7 seems to be

Photo 9. End of rip-rap on right bank, downstream of Route 42 Bridge – on DEP property – view looking upstream from the center of the stream.

reducing channel slope by increasing belt width through erosion and lateral migration. This process is prevented by riprap, but is potentially amplified or transferred to the downstream areas.

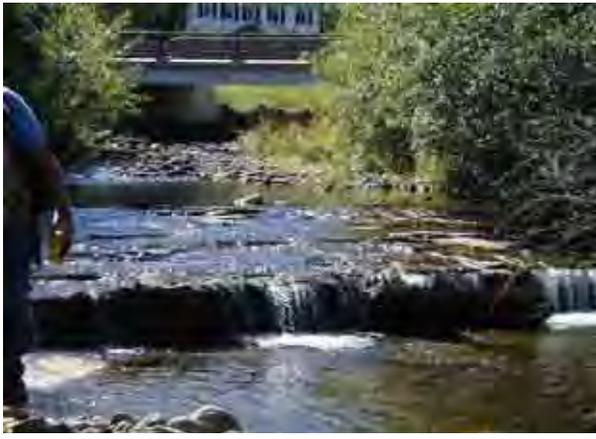
A common practice in the past for controlling erosion of stream beds, is the installation of cross channel check dams constructed of concrete, steel sheet piling, gabion baskets or other materials. MU7 contains two structures acting as check dams with apparently different purposes. Approximately 140 feet downstream of State Route 42 Bridge is a low head check dam structure (Photo 10). This structure generates a one-foot grade drop in channel invert below the structure. The nature of this check dam was not determined during the initial inventory, but these structures are frequently used to address stream channel *incision*, or to raise base stream flow elevation for easier water withdrawal. The structure may contain a sanitary sewer lateral, which were inventoried in upstream units, and should be investigated. Typical impacts of stream channel check dams include a local reduction of stream slope, increased deposition and increased bank erosion. Sediment transport through

Photo 10. Stone and cement bed-grade control-view looking upstream towards Route 42 Bridge.

Route 42 Bridge may be affected by the check dam. Often a stream will migrate around a check dam requiring ongoing maintenance. Use of extensive riprap discussed above may have been implemented to prevent loss of this check dam.

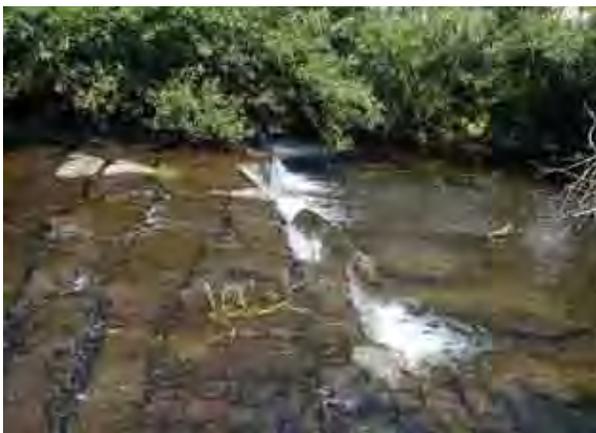
The second structure is a v-notched weir located at the USGS gaging station, 1,400 feet downstream from State Route 42 Bridge (Photo 11). The effects of this structure independently were not evident from the assessment, however the combination of these structures and the

Photo 11. Stone step weir on DEP property at USGS gage.

apparent instability of the high bank between them will need to be incorporated in future analysis, restoration and management of MU7.

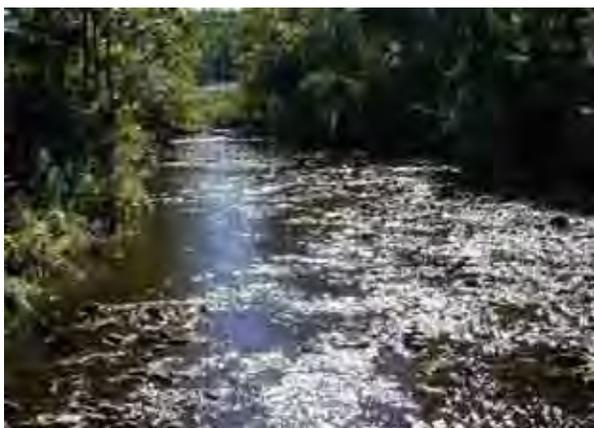
Photo 14. Reach-view looking upstream from XS-170 on DEP property.

densities (Photo 14). A large area containing maintained fields exists along the upper portion of the unit on the right floodplain. The lower section of the unit consists of more dense mature stands of deciduous trees along both floodplains. Although floodplain vegetation was deemed adequate to provide general stability, areas with a relatively low rooting depth to bank height provided minimal vegetative stability. Historical aerial photograph analysis shows an increasing density of riparian vegetation from 1997 to present.

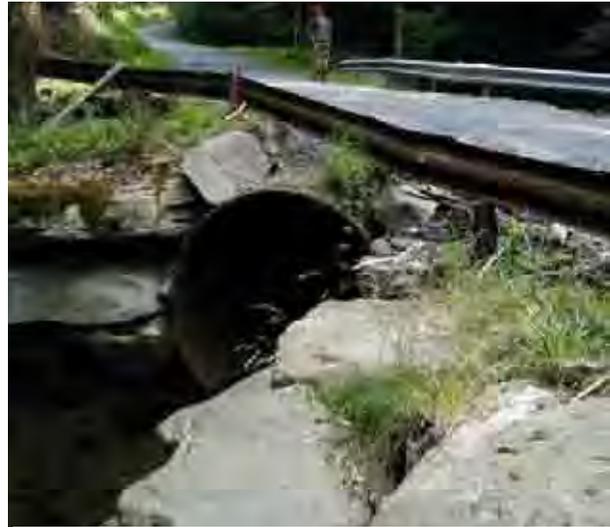
stakeholders regarding the existing 6.5-foot diameter culvert crossing under Pepacton Hollow Road (Photos 7 & 8). Local residents reported on several occasions floodwater crested the road and caused substantial damage throughout the area. Floodwaters kept landowners from their homes and/or landlocked from other access roads. Site inspections and the 2001 Stream Assessment Survey, noted the culvert pipe crossing under the roadway is of insufficient size to pass bankfull discharge. Several problems can directly result from an undersized culvert in this location. A backwater condition

Photo 7. Culvert crossing under Pepacton Hollow Road.

can occur when the culvert pipe is unable to carry the volume of water delivered to it during a storm event. This can cause floodwater to re-route around and over the culvert pipe causing damage to the roadway and erosion at its re-entrance point with the stream channel. Backwater conditions can also cause sedimentation upstream of the culvert and lead to streambank erosion as lateral forces on the bank are increased (Landowner Concerns and Interests, Volume I, Section IV.B.6).

Undersized culverts are more susceptible to upstream debris blockages, increasing potential for the stream to divert around the culvert during high flow events. Constriction that an undersized culvert can place on the stream channel can cause an increase in stream velocities through the culvert, causing stream bank erosion downstream of the culvert.

11. The culvert under Pepacton Hollow Road should be replaced with a suitable size crossing capable of providing adequate passage of base flow, bankfull flow and flood flow. Effort should be made to enhance the stability of the upstream and downstream reaches using adequate stabilization structure which will maintain and promote a naturally function stream channel.

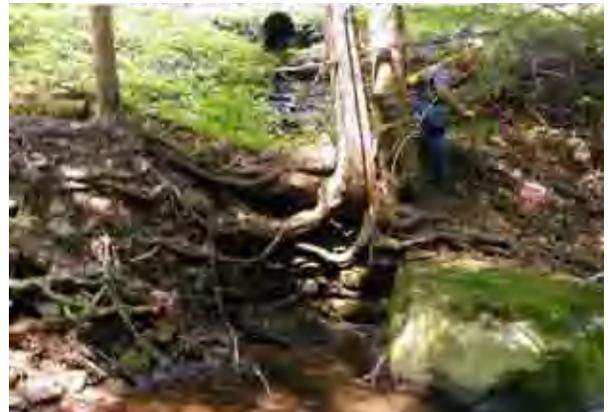
Photo 8. Looking at culvert (top of photo) under Pepacton Hollow Rd. right stream bank, stream flow right to left.

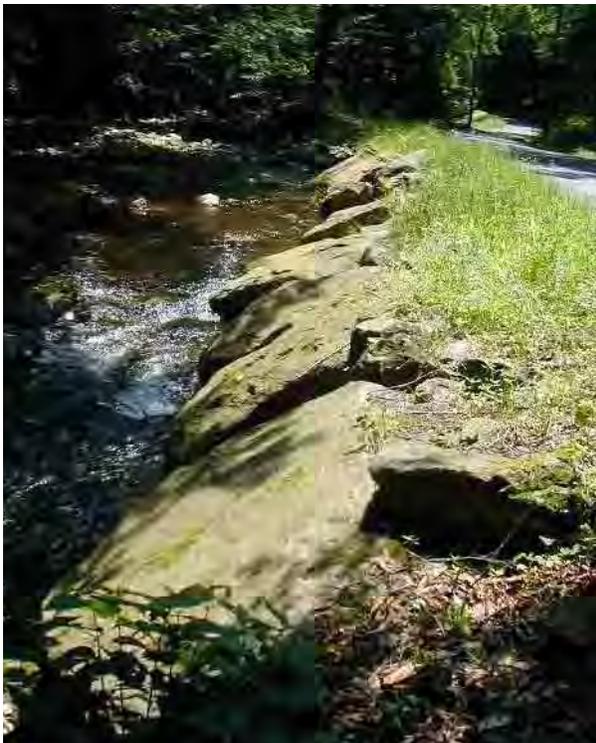
Three types of revetment were found in MU8. Riprap was found in two locations (Photo 9), totaling 90 feet, and a stacked rock wall measuring 160 feet was also inventoried. Berms made of side-cast channel material totaling 830 feet were found in five locations along Pepacton Hollow (Photo 10). The purpose of the berms was not determined, but seem to be a historic remnant of management for flooding. These berms have kept the stream from utilizing its natural floodplain.

Photo 9. View looking downstream at riprap on right bank.

4. Evaluate the existing revetment for replacement with an adequate stabilization structure which will maintain and promote a naturally function stream channel. Any stabilization technique should include bioengineering and/or re-vegetation.

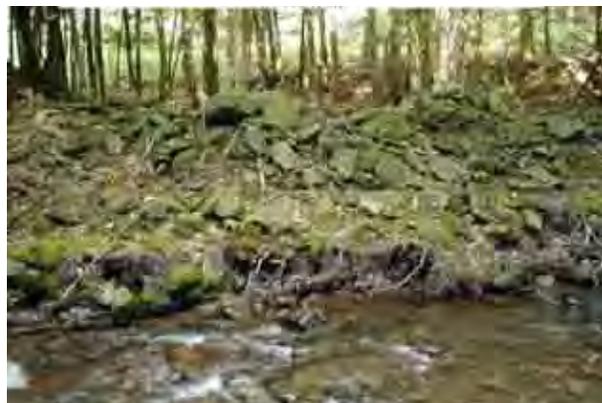
Floodplain berms such as these generally do not offer much, if any, protection from flooding, and can result in higher flood stages by preventing floodwaters from flowing over the floodplain. In situations where berms create higher flow velocities and channel stresses, channel erosion and down cutting can occur. Floodplains function to reduce flood velocity, increase absorption of floodwaters, encourage deposition of silt and fine sediments (keeping them from being washed further downstream) and decrease flood stage, in downstream areas.

Photo 10. Looking at undercut right bank and berm, stream flow left to right.

Small, low, *discontinuous floodplain* benches perform an important floodplain functions in small mountain streams. Removal or restructuring of some of these bermed areas should be considered to add floodplain function to this area and reduce potential erosion and instability problems. Setting berms back away from the active stream can provide a compromise solution, if flood protection is required. Further assessment should be performed in the area of the berm as well as upstream and downstream. Assessment should quantify the degree of disconnection of the stream from its floodplain to determine impacts of the berm to the channel and quantify the benefits of removal or redesign.

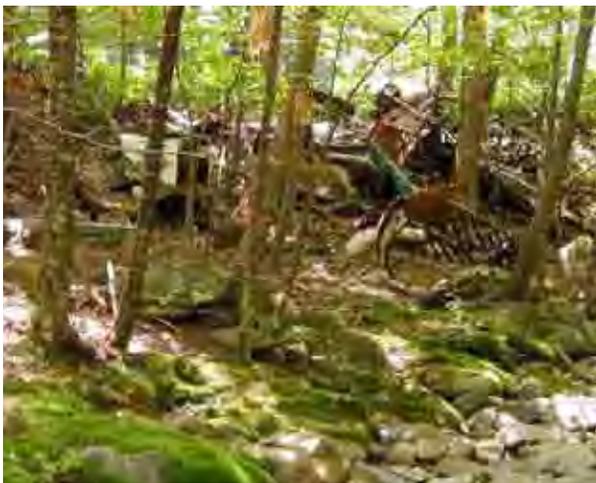
The Stream Assessment along Pepacton Hollow identified an area of floodplain which contains a 500-foot long section of dumped refuse and discarded litter. The area contains a mix of glass and metal waste and is located immediately adjacent to the active stream channel (Photo 11). There are large trees growing through the debris, indicating that it has remained relatively stable and has been present for some time. Several site inspections have been made by SCSWCD, the Town and NYC DEP, but have not revealed any contaminants leaching from the site. Although the area may not currently contribute to impaired water quality, it does remain an aesthetic concern.

Photo 11. View showing old dumping site along Pepacton Hollow stream bank. Stream flow is left to right.

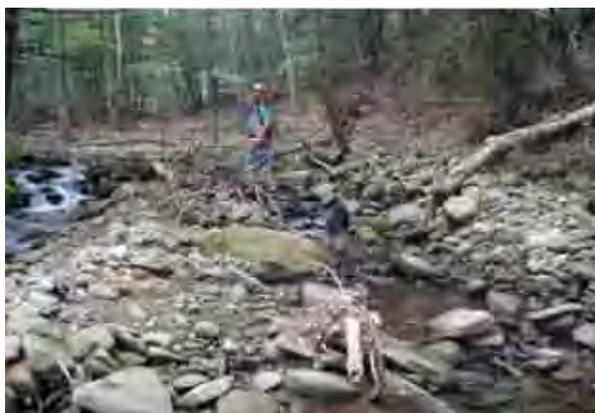
Channel materials such as large cobble and gravels were identified as the dominant sediment size, with isolated areas of bedrock totaling 240 feet. *Bar* formations were frequently noted and consisted of predominantly small side channel formations. Several sections containing recently deposited central bars indicated potential for localized channel aggradation (Photo 12 & 13). Aggradation is caused by the stream flow not having force to move the available sediment through the system, allowing it to deposit along the channel bottom. If total stream energy is less than the energy required to transport the sediment provided, the streambed will aggrade. Several areas were inventoried where the active channel had recently aggraded to nearly the elevation of the active floodplain, completely reducing channel capacity (Photo 13). Sand and fine gravel were

Photo 13. Looking upstream at mid-channel bar in left branch of split channel.

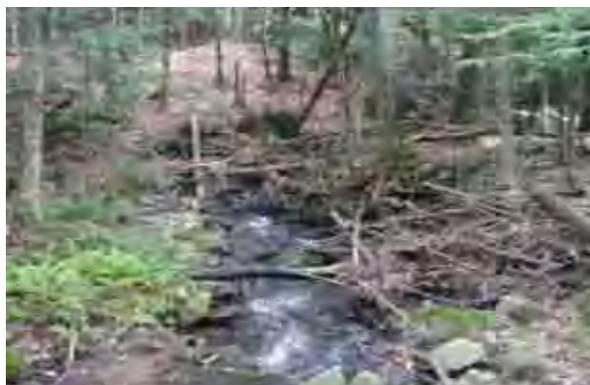
Photo 15. Looking downstream at major debris jam on right branch of split channel.

16. Monitor the areas containing debris jams and channel blockages for changes in channel stability and threat to infrastructure. Initiate an assessment to document the source and magnitude of the large woody debris to include the effects from localized erosion. Treatment recommendations should target the reduction of debris at its source.

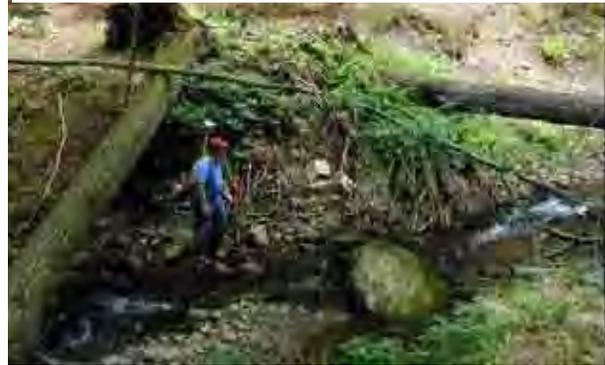
The lower reaches of Management Unit 8 contain five primary areas of erosion totaling 9,340 square feet of exposed streambank. Severe mass wasting was observed along a 40 ft. tall, 150 ft. long section of streambank. A number of smaller eroding banks were identified where undercutting of the banks have

caused large trees to fall into the stream channel (Photo 17).

Photo 17. Eroding right bank and fallen trees, incised section, along Camp Road.

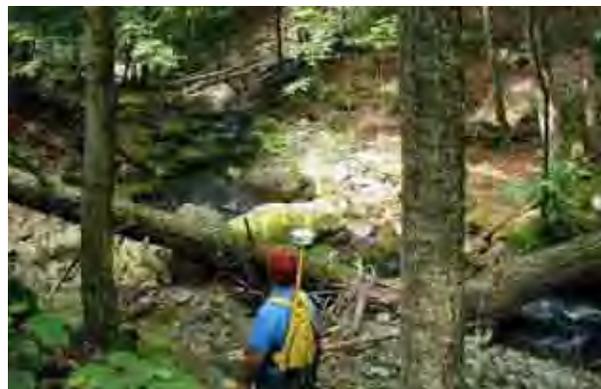
The 2002 Stream Assessment documented a number of areas containing debris jams and channel blockages. Although wood recruitment is a natural and necessary process for mountain stream stability, current volume likely exceeds natural rates. Some areas were documented with debris jams spanning the entire active channel. These blockages are seemingly affecting the capacity to move the water, sediment and smaller debris (Photo 18).

Photo 18. View looking downstream from left bank at steam wide debris jam.

20. Monitor the areas containing debris jams and channel blockages for changes in channel stability and threat to infrastructure.

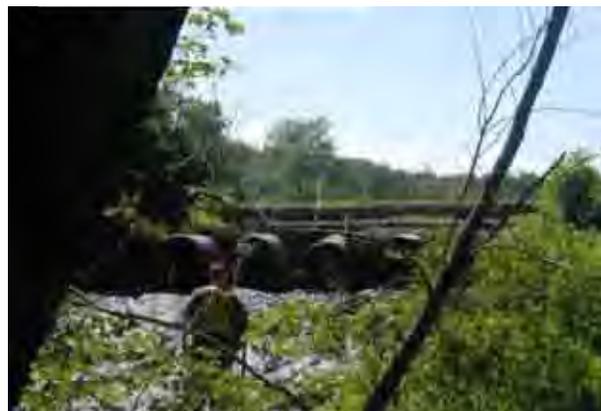
Photo 2. Beaver Dam Pond outfall. Six Culverts, looking upstream.

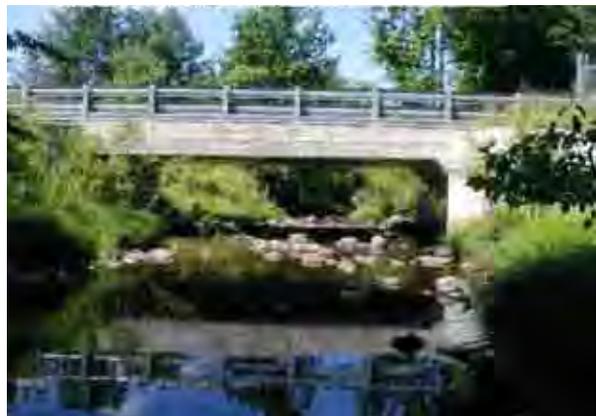
Photo 3. DEP bridge over Red Brook.

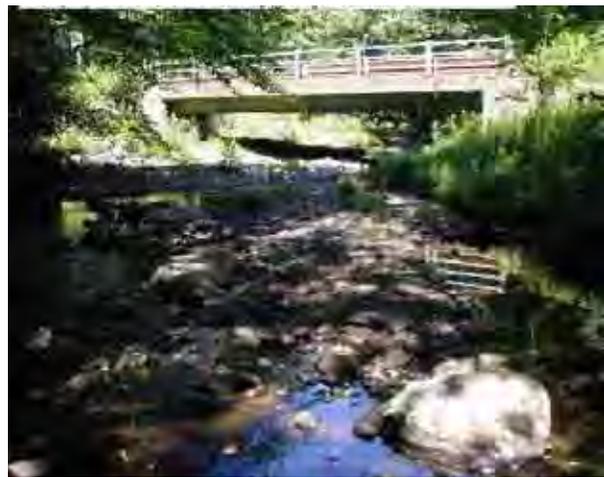
Photo 4. View looking at South Hill Road Bridge.

Hill Road bridge has settled over time, causing some cracking. Debris along the deck exhibits longitudinal, transverse cracking and fatigue prone welds. The report also indicated that the waterway opening was undersized to pass higher *stream flows*.

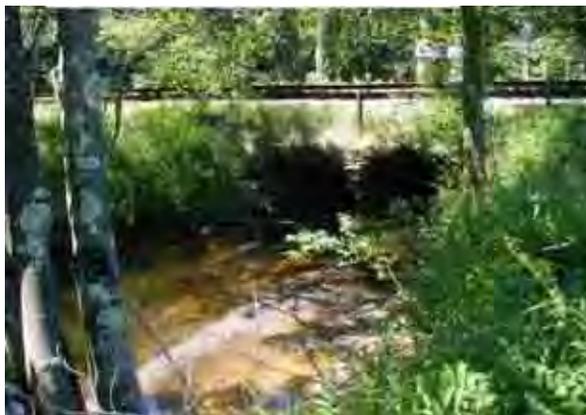
There is a private farm culvert crossing, two double culverts, one on Beaver Dam Road which appears to be having difficulty transporting sediment indicated by the presence of sand bars, however, no further studies have been conducted at this site (Photo 5). There is also another double culvert at a private crossing in which one of the culvert pipes is smaller and elevated to an overflow height seemingly to assist the larger culvert at higher flows (Photo 6). There is a six culvert outlet crossing at the mouth of the Beaver Dam pond (see Photo 2) and one small culvert that feeds an intermittent spring.

Photo 5. Looking upstream at twin culvert Beaver Dam Road crossing.

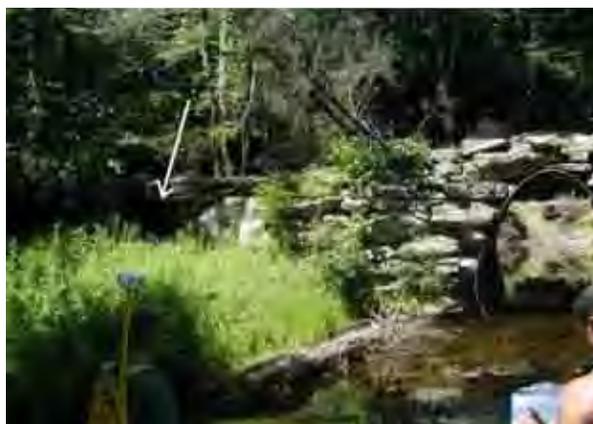
Photo 6. Looking downstream at double culvert Overflow culvert is indicated by white arrow.

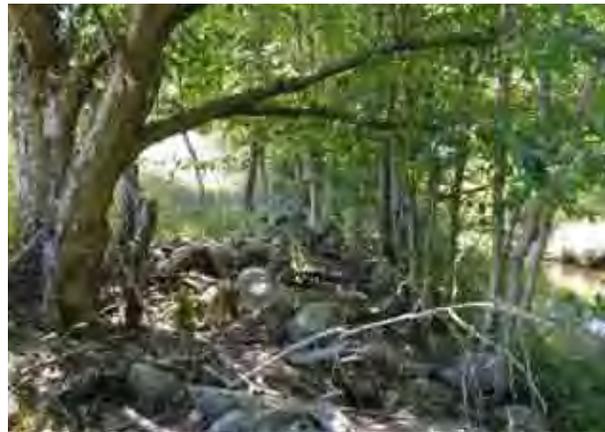
Two types of revetment were found in MU 9. Several *stacked rock walls* totaling approximately 340 feet we inventoried as well as a stone berm comprised of dumped fieldstone (Photo 8), which measured 1340

Photo 8. View looking upstream at dumped field stone on right bank.

feet. The purpose of the berm was not investigated, but it is suspected to be a historic remnant of land clearing for agricultural production and a protective measure from flooding (Community History and Current Conditions, Volume 1, Section IV.A). The berm is currently well vegetated with a large number of deciduous trees growing through the stones. The continuous makeup of the berm prevents flood flow from utilizing the undeveloped natural floodplain.

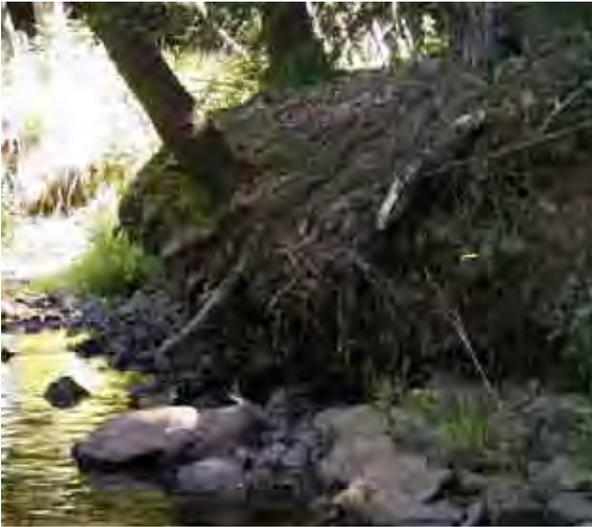
Photo 10. View looking at erosion and undercut trees on right bank.

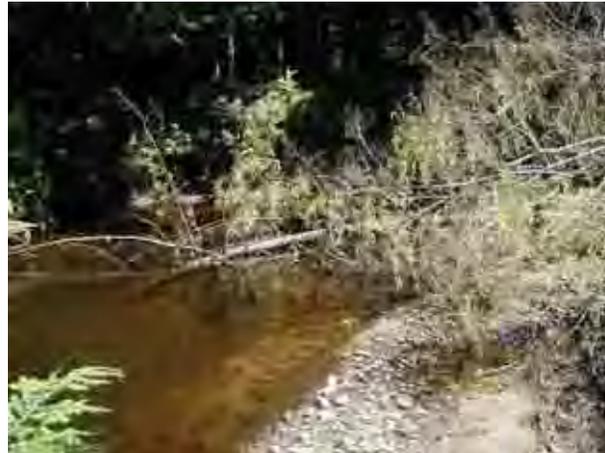
outfall. These debris jams and other channel obstructions cause problems by trapping sediment, which initiates and/or accelerates the development of gravel bars and reduces channel capacity. Subsequent bed erosion and removal of the deposited gravels contributes sediment to downstream reaches. Alternately, small blockages can create and maintain beneficial physical habitat (Photo 12), as well as assist in controlling stream channel

Photo 12. View looking at smaller debris jam on Red Brook, can add to habitat.

incision and *degradation*. Extent of wood debris should be quantified and compared to standards that provide information on quantity and include the association of the *stream types* present. Annual *monitoring* of the area for additional debris and potential impact would be effective management strategy woody debris, jams and channel impacts.

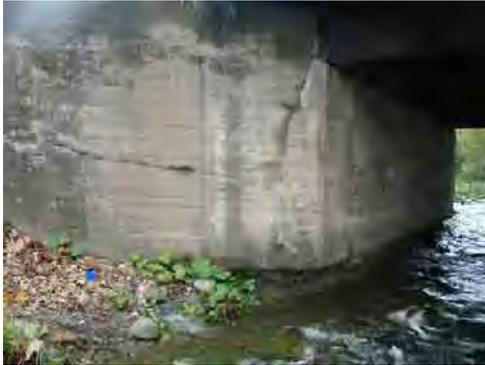
Crack in downstream right wing wall of Covered Bridge

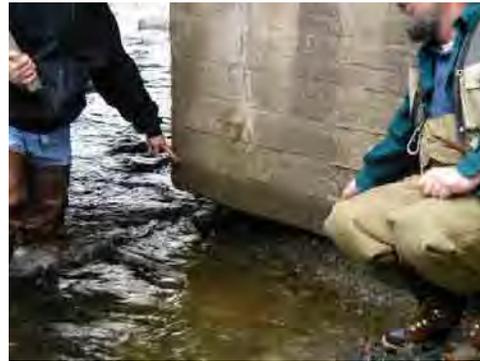
Crack in upstream right wing wall of Covered Bridge and 14 inch undercut

Built as 1976 bicentennial, historically significant, provides access to Fair Grounds, Scour and erosion along bridge abutment and wingwall (14" undercut)—is this a threat? 1929 map-channel straightened (uncertain when), “cleaned”, moved away from road Upstream trees falling into stream as channel migrates, providing material to constriction flow 1963 aerial photograph shows more sinuous channel than currently 1991 Neversink Agricultural Society gained a permit to repair failed abutment NYSDOT conducts Biennial bridge inspection and Scour report, 2001 bridge failed scour report Runoff from parking lot scouring behind wooden wingwall

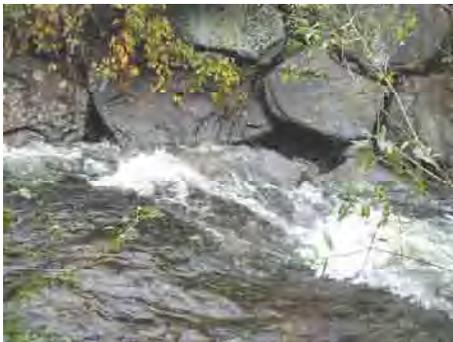
Split channel with riprap on right bank being undermined upstream of covered bridge, within 20' of Route 55

Complete historical aerial overlay to assess erosion rate and direction, as well as changes in plan form geometry at Covered Bridge, upstream to riprap near tennis courts.
Begin assessment of the bridge and upstream area to determine changes in meander patterns
Potential for “assisted” restoration
Review of existing reports and designs as provided by Town
A W-weir structure could redirect the stream and protect the bridge from future repairs as well as reduce gravel build-up

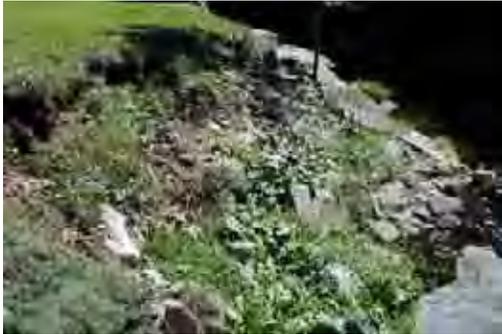
Dislodged riprap behind Town Hall

Add bioengineering to increase riparian buffer and anchor existing or replaced riprap

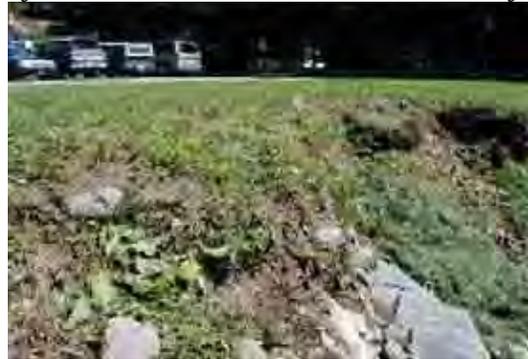
Eroded left bank and lack of vegetation behind Town Hall

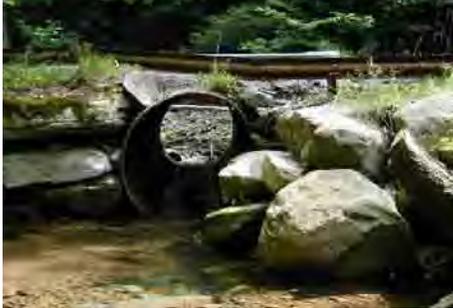
Looking upstream at culvert under Pepacton Hollow Rd.

Replace culvert with properly sized and angled culvert to fit the bankfull stage height and direction of stream flow. This could avert future rebuilding and maintenance after every high flow event

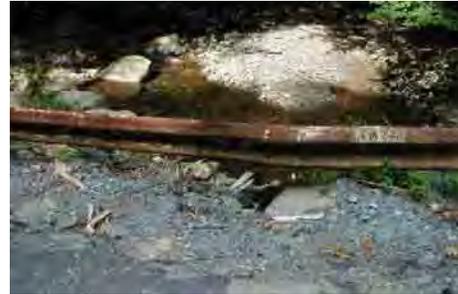
Erosion under guardrail above outlet end of culvert (2001)

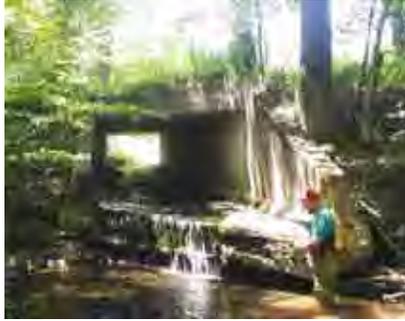
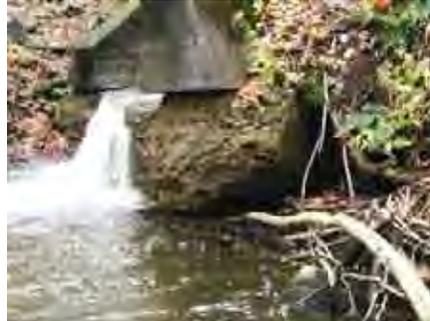
There is single “hanging” box culvert, located on an unnamed tributary crossing State Route 42, just upstream of the tributary’s confluence with Red Brook upstream of the South Hill Road Bridge (Figure 2). The base of the culvert is severely scoured and weathering, as the stream flow passing through its narrow confines has created a scour pool at the outlet (Photo 7). Project stakeholders voiced concern regarding the current condition of the channel at the outlet as well as the potential barrier to fish migration. Local anglers have expressed that Brown trout exist both upstream and downstream of the structure, though whether upstream fish are resident is unknown. The stream channel below the outlet has developed a large scour *pool* resulting in a three to four foot elevation

difference in grade between the outlet invert and *base flow* of Red Brook. A potential cause for the elevation difference is excess channel scour produced by the *hydraulic* condition developed through the culvert. The steep slope of the culvert, lining and geometry are the suspected causes of this condition. Another potential cause of the grade difference is channel *incision* along the main stem of Red Brook leaving a perched condition, possibly a *headcut*, or downcutting, upstream migration, at the culvert. This scenario should be evaluated both for the immediate migration issue, as well as a possible indicator of local channel processes of Red Brook. The culvert bottom has begun to deteriorate revealing rebar supports along the bottom of the culvert and stress cracks in State Route 42 from culvert instability.

Undercut box culvert and scour pool under Rte 42, on tributary of Red Brook

10. Evaluate the existing bridge and culvert crossings for the ability to facilitate fish passage during varying flow periods. Specific attention should be placed on the Route 42 box culvert, on the tributary to Red Brook, where it is recommended that fisheries biologists examine potential migration barrier and assist with project designers to recommend potential enhancements.

Determine natural slope of stream without structure present and the change caused by the hanging culvert

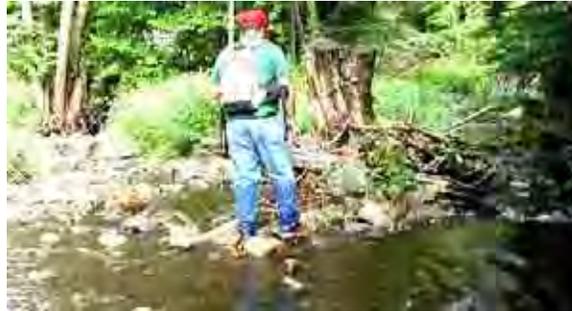
Head cutting erosion, center island, debris jam near back lot of Grey's Lumber

Begin monitoring the site
Potential removal of blockage and regrading the slope.

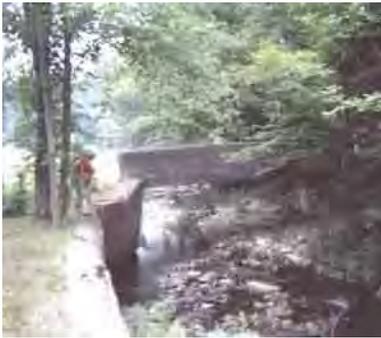
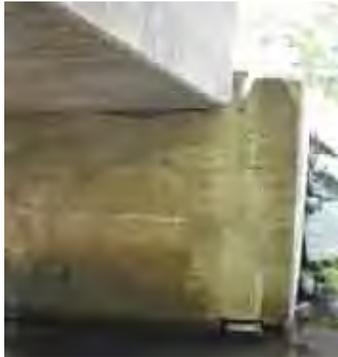
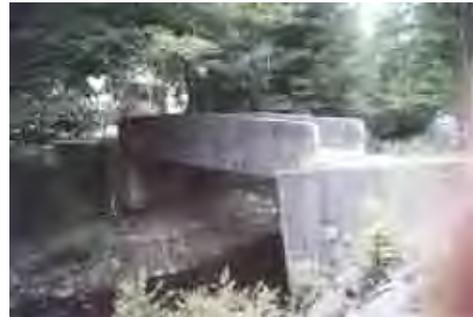
Concrete crib wall along Rte. 55 attached to failing abutment

View looking upstream at Miller's Bridge

An inspection of the structure by the bridge engineer
to determine its safety and anticipated design life.
Possible replacement of structure designed and
built to accommodate the stream flow and protect the road.

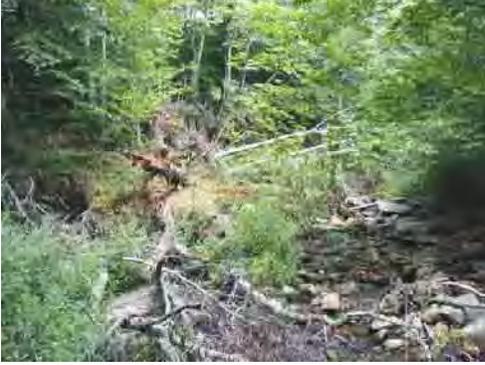
Scott Brook failing bank with fallen trees at Chestnut confluence

Determine cause of erosion

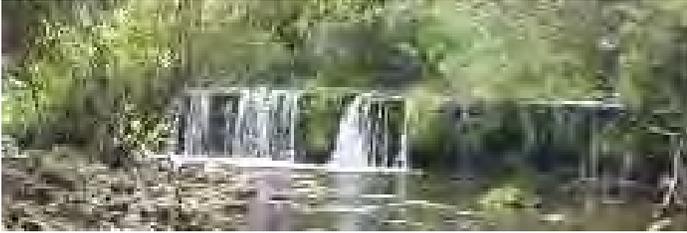
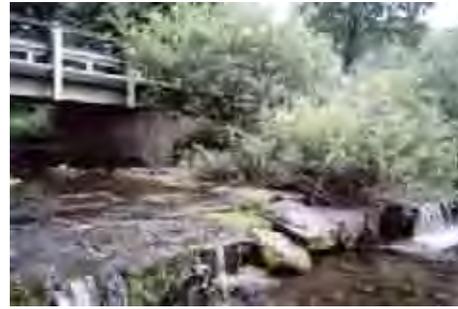
Looking upstream at eroded sewer line structure below Davis Lane Bridge

A W-weir could be used to aid in directing stream flow properly through the double chambered bridge during high flow events

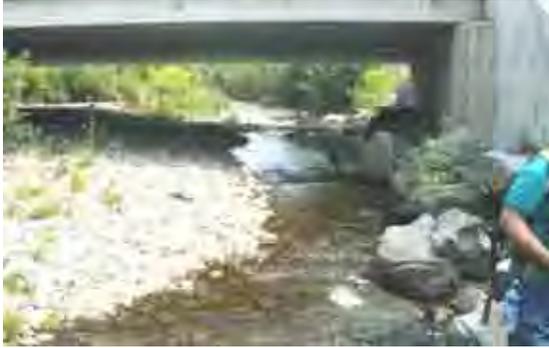
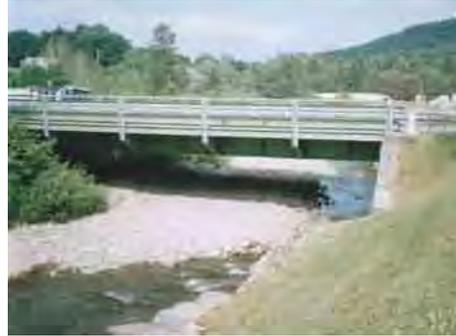
Route 42 bridge Grahamsville, overwidened channel with cobble filling in (right bank) / bridge abutment in main flow of water (left bank).

Model bridge opening with gravel bar for flood risk/damage when maintenance is needed.

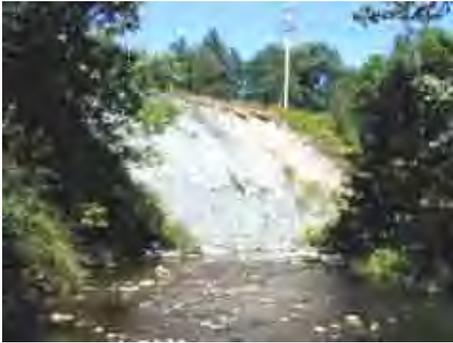
Looking downstream at high eroding bank DEP property

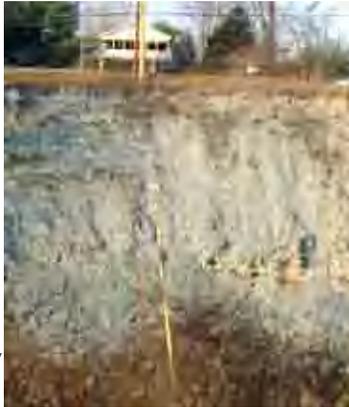
Looking at eroding bank with BEHI XS

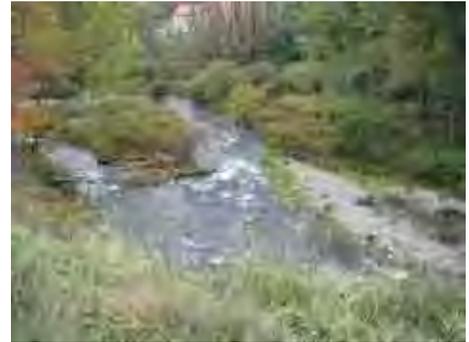
View from Route 55 top of RB looking Downstream

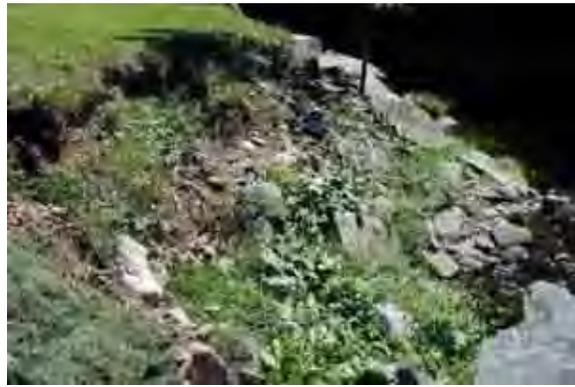
Photo 1. Erosion – left bank behind Town Hall. View looking downstream, dislodged riprap visible in right front corner of photo.

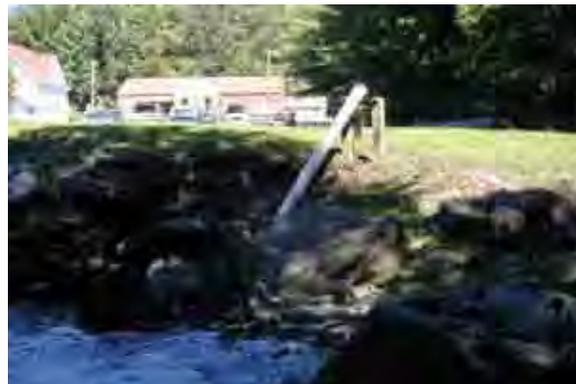
Photo 3. Dry hydrant behind Town Hall parking lot. View looking toward left bank from center of stream.

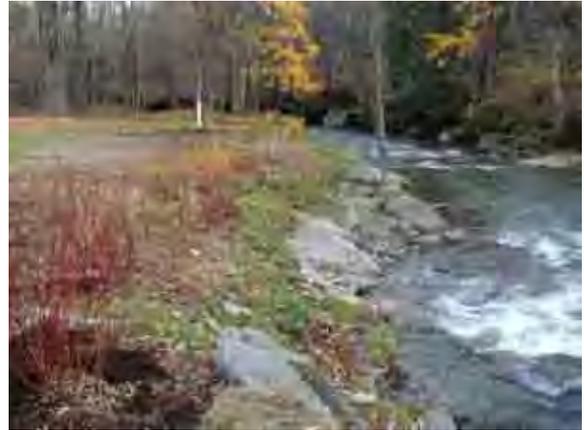
Photo 5. View looking downstream from swale towards stacked rock bankfull bench with new shrubs and native plants.

- 1.) A stacked rock wall was constructed of medium sized flat native stones as support under the dislodged rip rap that was relocated.
- 2.) The dislodged riprap was removed from the creek and keyed into the stream bank horizontally over the stacked

rock wall (Photo 4&5). Soil was placed to build a bankfull bench modeled on the upstream bench at reference monitoring cross-section XS 03-01.

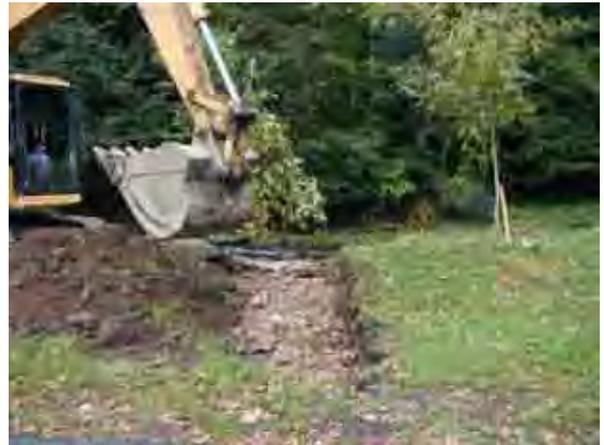
Photo 6. Swale expanded and filled with cobble; September 26, 2003.

- 3.) The non-functioning dry hydrant was removed and the bank was graded. An area of about 25' in width was left unplanted for emergency access to the stream at this location.
- 4.) The existing runoff swale from the parking lot was expanded and filled with cobble four feet in depth to improve percolation from parking area runoff (Photos 6&7).

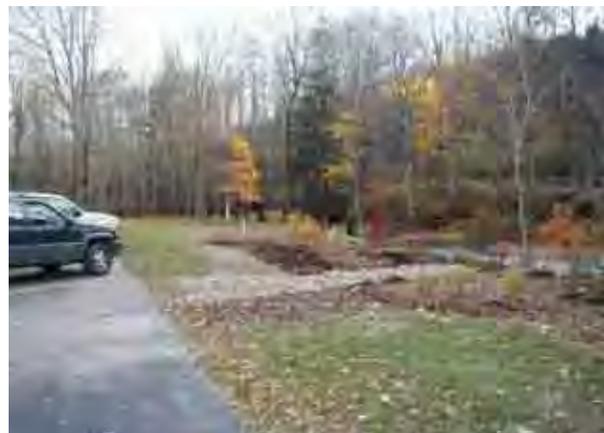
Photo 7. View looking downstream from parking lot. Shows completed swale and planted buffer.

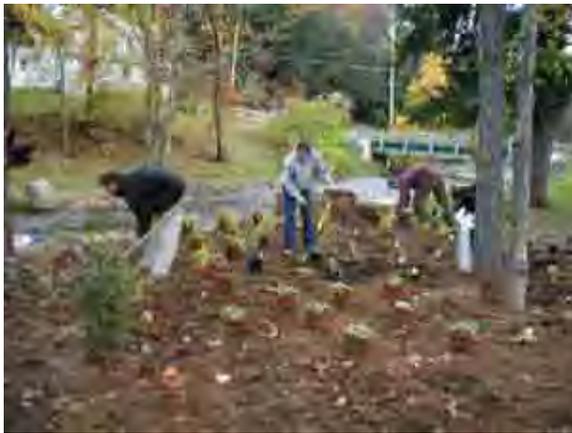
Photo 9. October 16, SCSWCD and DEP volunteers planting at Town Hall Demonstration

Restaino. Native trees, shrubs and herbaceous materials were planted on the left bank, adjacent to the Town Hall parking lot, over approximately a 300' x 10' to 15' area, as a riparian buffer (Photo 9). Many volunteers helped prepare this project including AmeriCorps, Natural Resource Conservation Service, Watershed Agricultural Council, SCSWCD, Neversink residents, Catskill Watershed Association, Cornell Cooperative Extension.

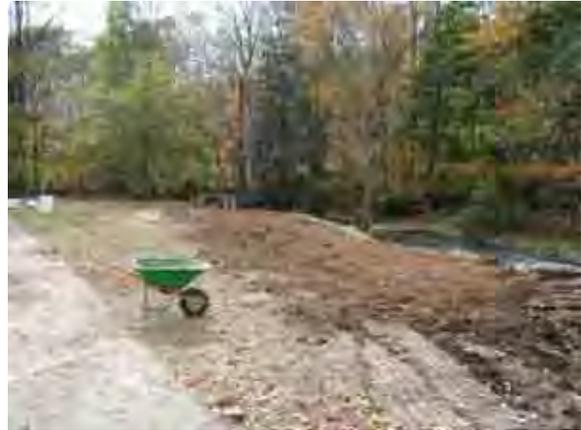
Photo 8. Topsoil/compost distributed at site. View looking downstream from parking lot; October 15, 2003.

- 5.) The sod layer along top of bank where the riparian buffer would be planted was removed with the excavator.
- 6.) On October 14 & 15, 2003 top soil and peat moss was imported to the site as a soil test revealed organic matter at the site was only 1 percent. The remaining vegetation was weeded from the

bed and the topsoil/compost was spread and graded (Photo 8).

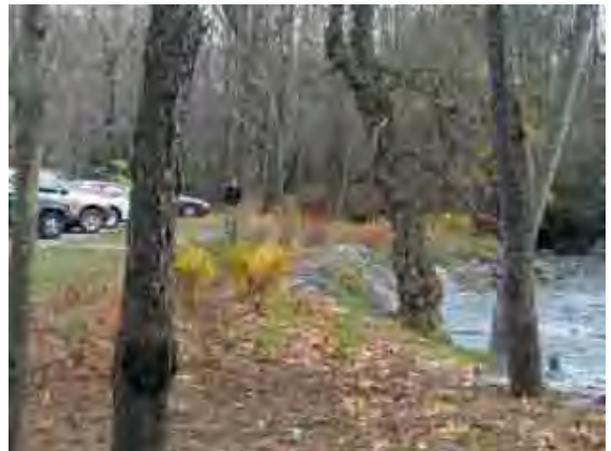
Photo 10. Looking downstream at extent of completed riparian buffer, from just above willow tree. Project ends at tree line property boundary in background.
