The Chestnut Creek Stream Management Plan

Volume I of II

Background, History and Watershed Description

March 2004

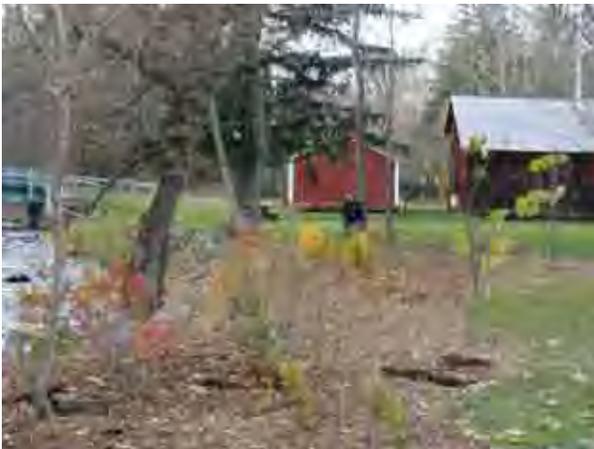
Photo 11. Looking upstream towards River Road Bridge at extend of completed riparian buffer, from just below willow tree. Project ends by Norway Spruce before picnic table in background.

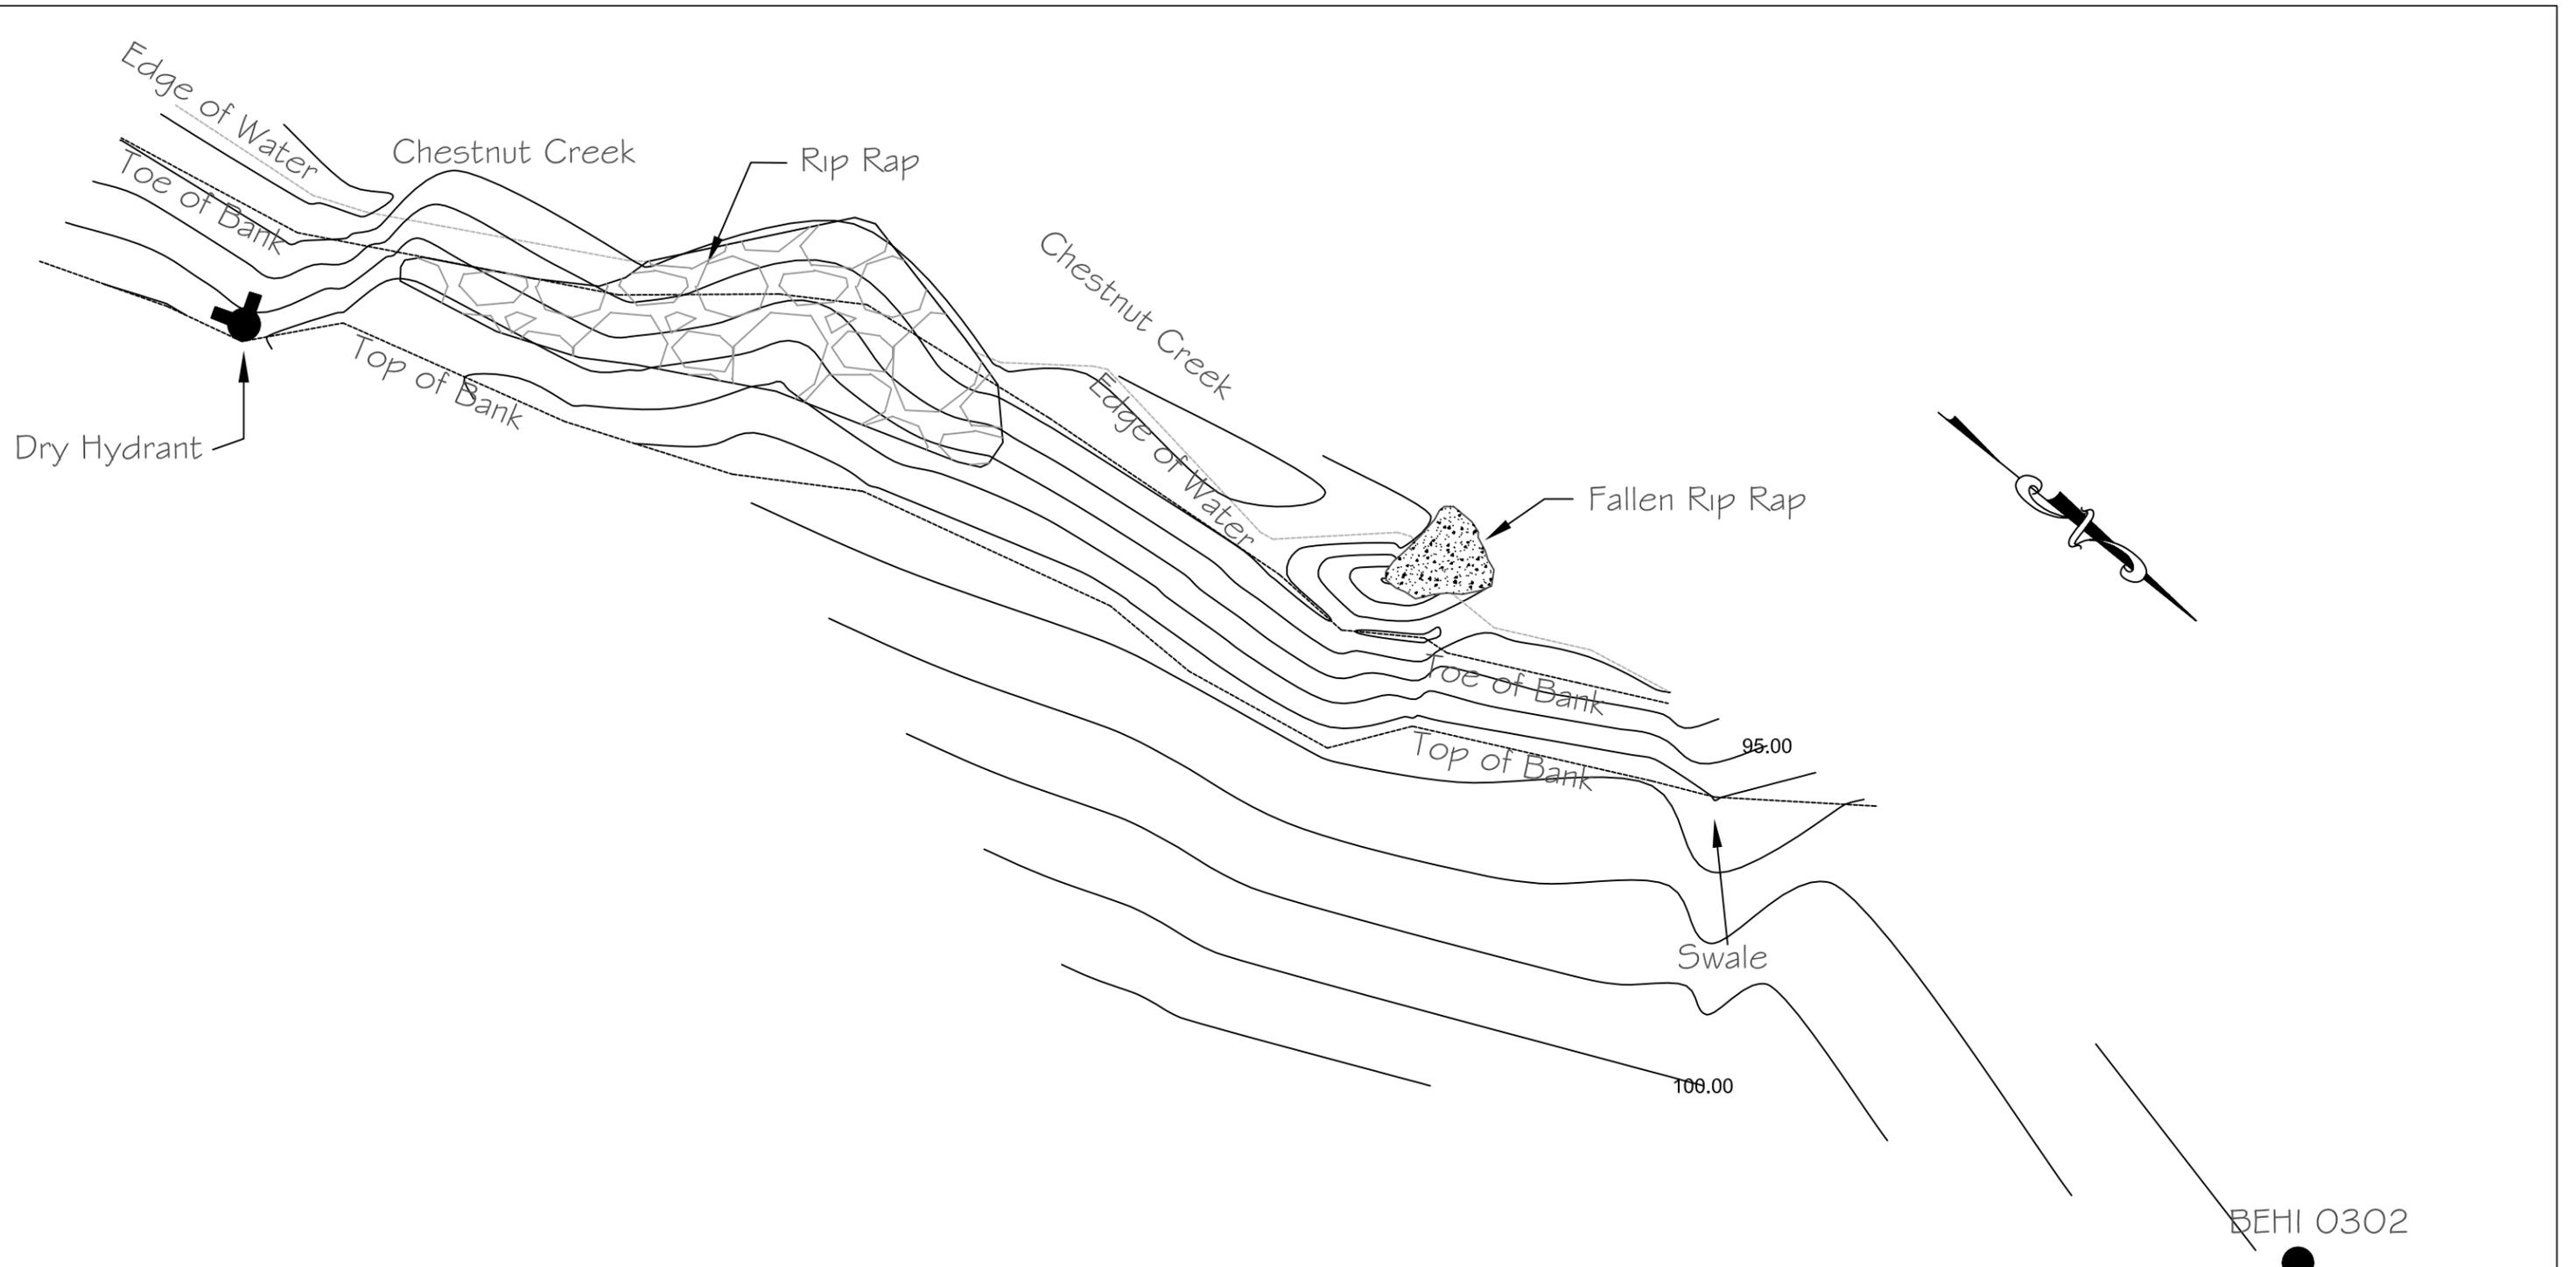
BEHI 0302

The left bank of Chestnut Creek located behind the Town Hall suffers from erosion and failed riprap. The Creek has scoured an area around a large piece of riprap located near the left bank and continues to erode the property. The town uses the area to hold fishing lessons and other leisure activities. A project has been designed to meet the needs of the town as well as preserve the bank from further erosion. The total length of the project is almost 400 feet. A bench will be built on approximately 45 feet of bank

The bank stabilization project, approximately 20'+/- length, would involve the building of a bench to repair the eroded area described above. The low, bankful bench will be modeled on the upstream reference XS 03-1, just below River Road Bridge. The existing dislodged rip rap would be used to create a stacked rock wall type structure infiltrated with topsoil. The channel shape and slope would match the adjacent cross sections for bankfull width and area. A quick-growing annual cover grass will be used on the new bank to help stabilize and protect it over the winter and until spring floods recede and the bank can be planted with more permanent vegetation.
