E. Chestnut Creek Management Unit 5

Chestnut Creek Stream Management Plan

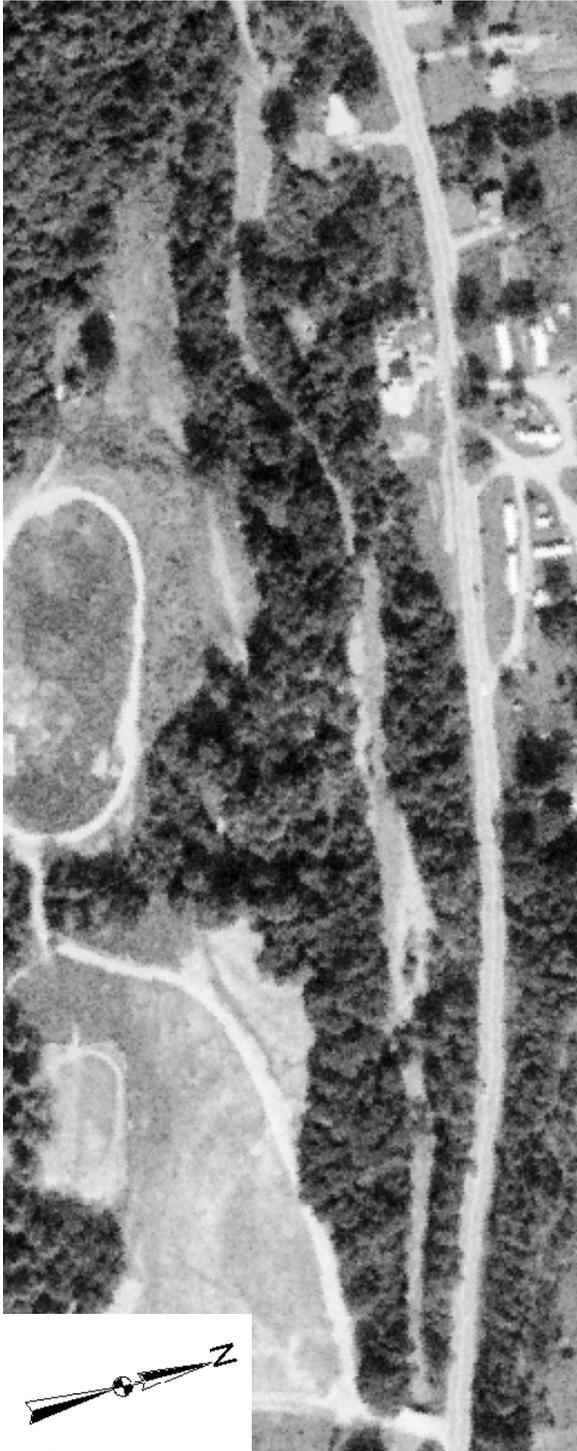
Photo 2. 1974 Aerial Photograph of Management Unit 5.

This section of Chestnut Creek appear to have been straightened and *channelized* at some time in the past. An analysis of a series of historic aerial photographs covering the period 1974-2001 indicates that routine channel maintenance occurred until recently (Aerial Photos 2, 3 & 4).

and floodplain modifications have resulted in a confined channel with a moderate to high *width/depth ratio*, low *sinuosity* and a relatively steep gradient. As such the creek and adjacent floodplain are more susceptible to stability and flooding problems.

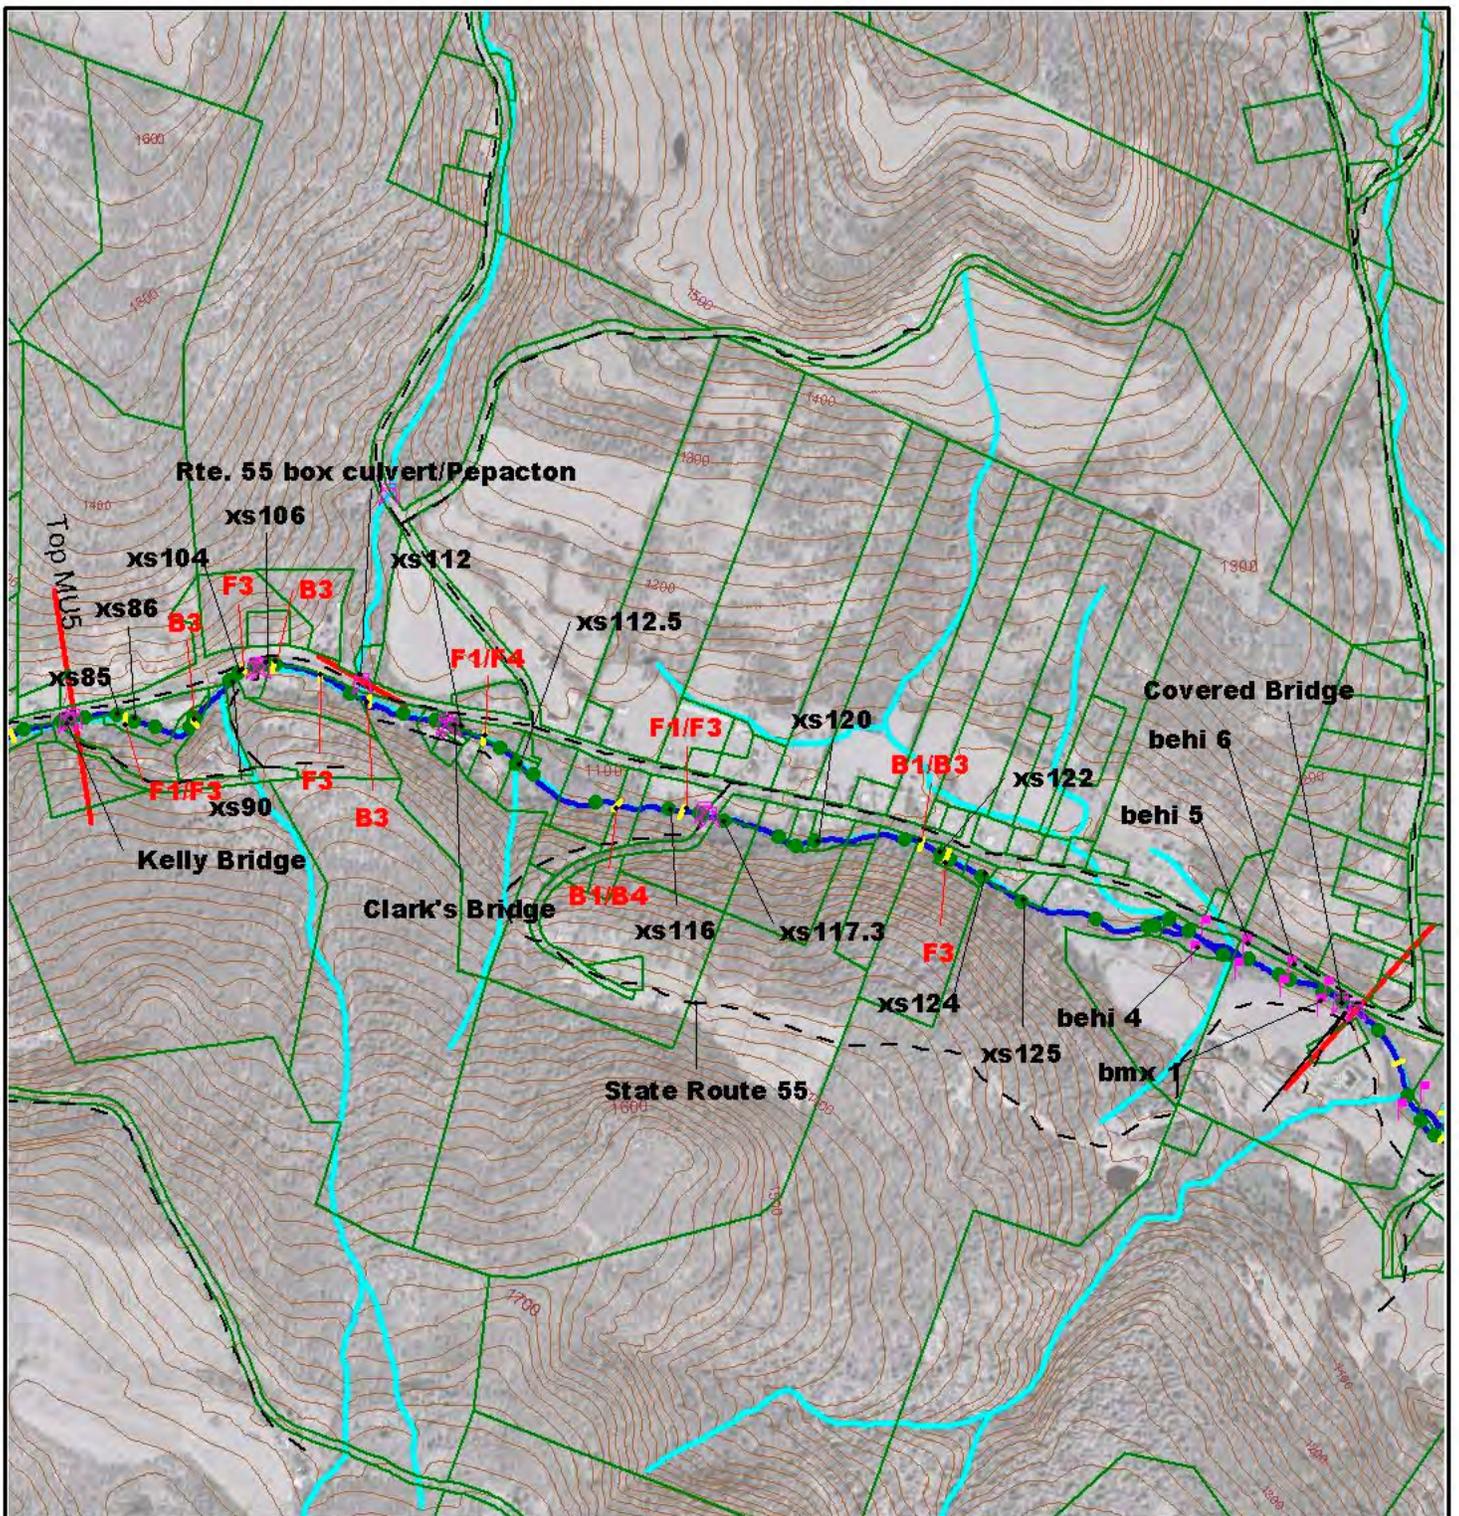
Figure 2. Chestnut Creek MU5 Stream types & Cross Sections

quickly to downstream reaches where they can contribute to channel instability and flooding. The morphological data collected along the reaches is summarized in Table 1 and illustrated in Figure 2.

concern (Bank Erosion Hazard Index, BEHI, and Bank Monitoring Cross-section, BMX, to observe aggradation) Accordingly, four cross-sections were established and surveyed in MU5 along the reaches upstream of the Covered Bridge adjacent to the Town Fairgrounds (Photos 19, 20, 21 & 22, MU5 Stream Type Cross Section map, Figure 2). Three of the sites were established to monitor lateral erosion (BEHI 4,5&6) and one along a section that appears to be aggrading (BMX 1). The cross-sections will be resurveyed and compared to the initial surveys to
