G. Chestnut Creek Management Unit 7

1. Summary Description

Chestnut Creek Stream Management Plan

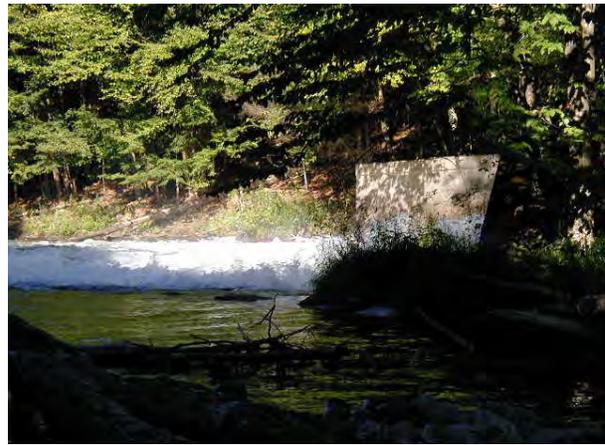
Photo 2. NYC DEP water portal from the Neversink Reservoir, emptying into the Chestnut Creek on the outskirts of Grahamsville, NY.

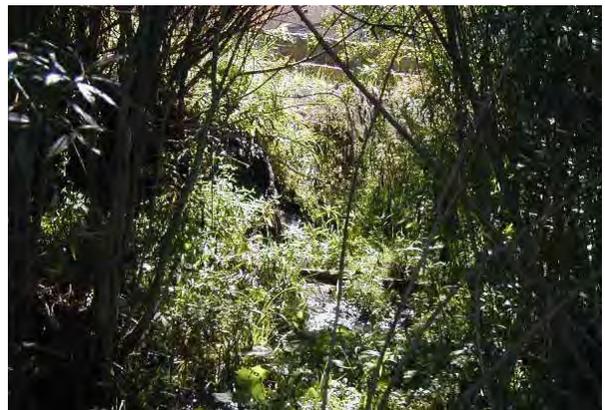
Photo 3. Tributary from sewer plant outfall on NYC DEP property above USGS gaging station, Grahamsville, NY.

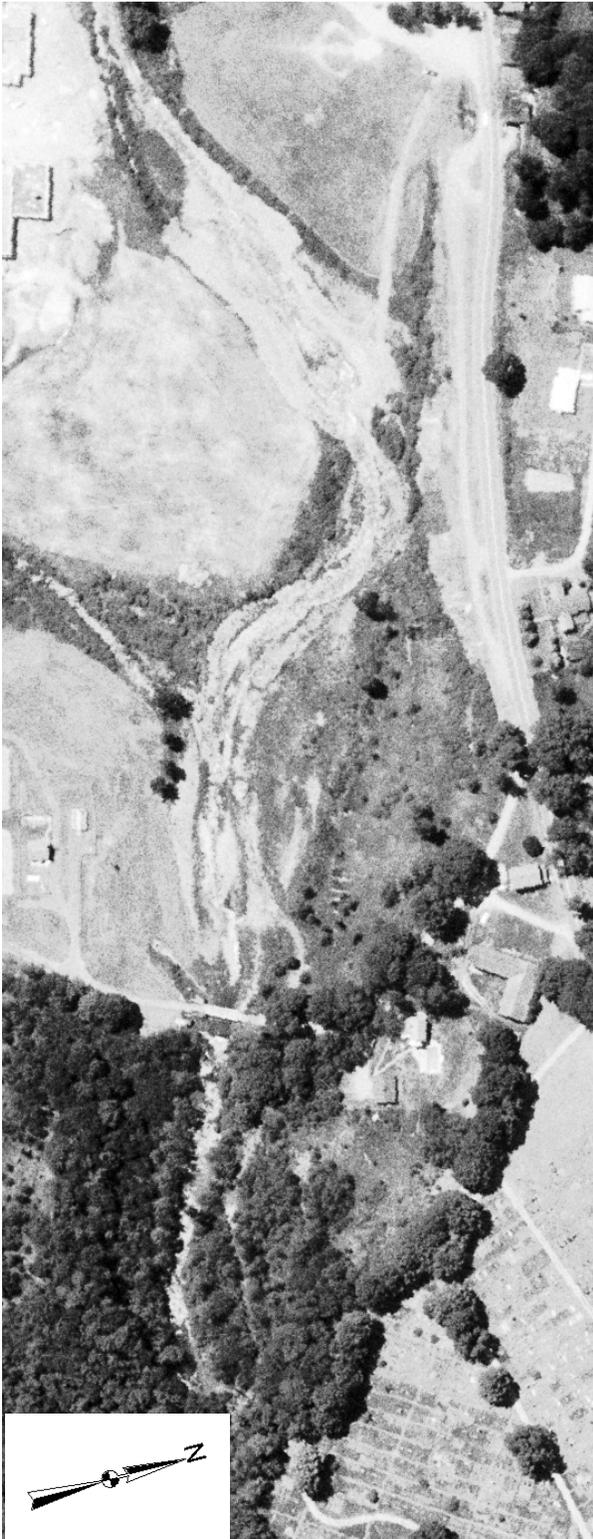
Photo 5. 1963 Aerial Photograph of Management Unit 7.

Channel modifications appear to have occurred in MU 7 prior to 1963, associated with unstable areas. The channel was braided throughout many sections along the length of MU 7, particularly upstream of the failing DEP bank. Braiding could be a direct result of previous channel maintenance or in combination with prior flood events. Historic peak flow data shows several large flood events occurring in the 1950's, with the largest flow of 4,640 cfs recorded on October 15, 1955. The riparian corridor consisted of a thin strip of vegetation along MU 7 channel banks and floodplain from State Route 42 Bridge to the sewer outfall. Below the outfall the buffer looks to be continuous through the end of the unit (see Hydrology and Flood History, Volume I, Section IV. B.2, & Aerial Photos 5, 6 & 7).

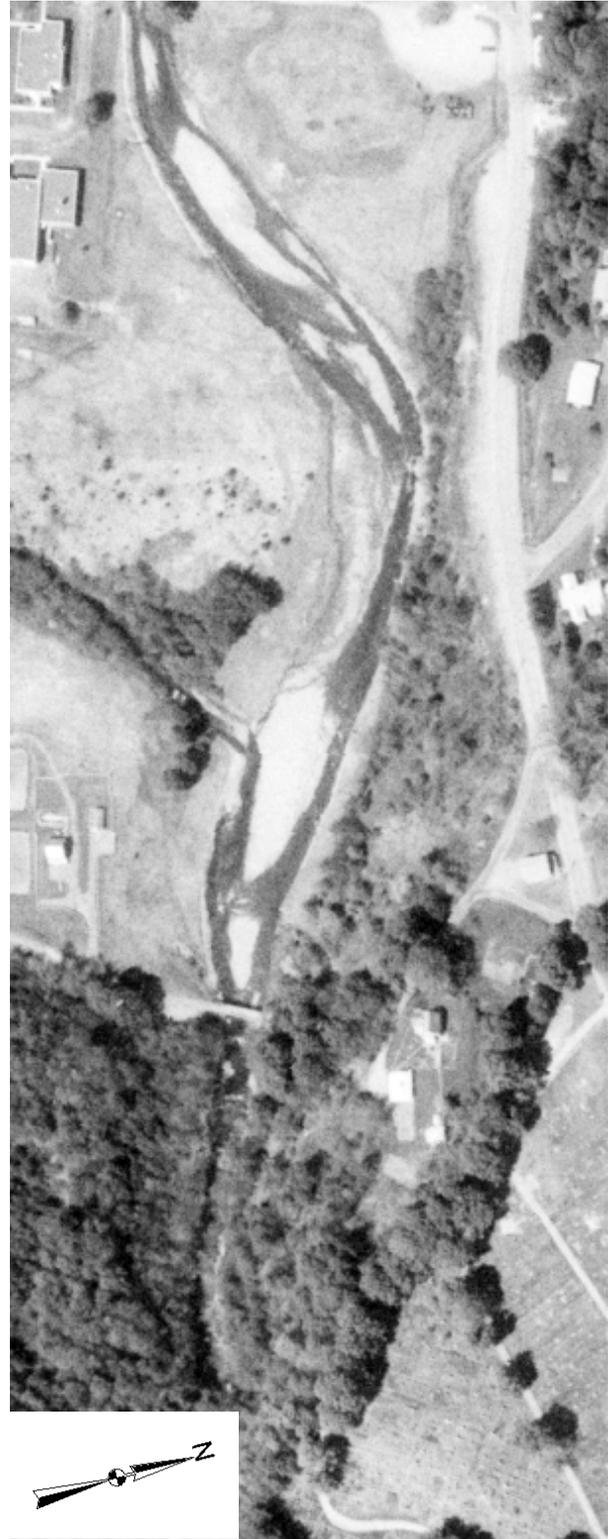
Photo 6. 1977 Aerial Photograph of Management Unit 7.

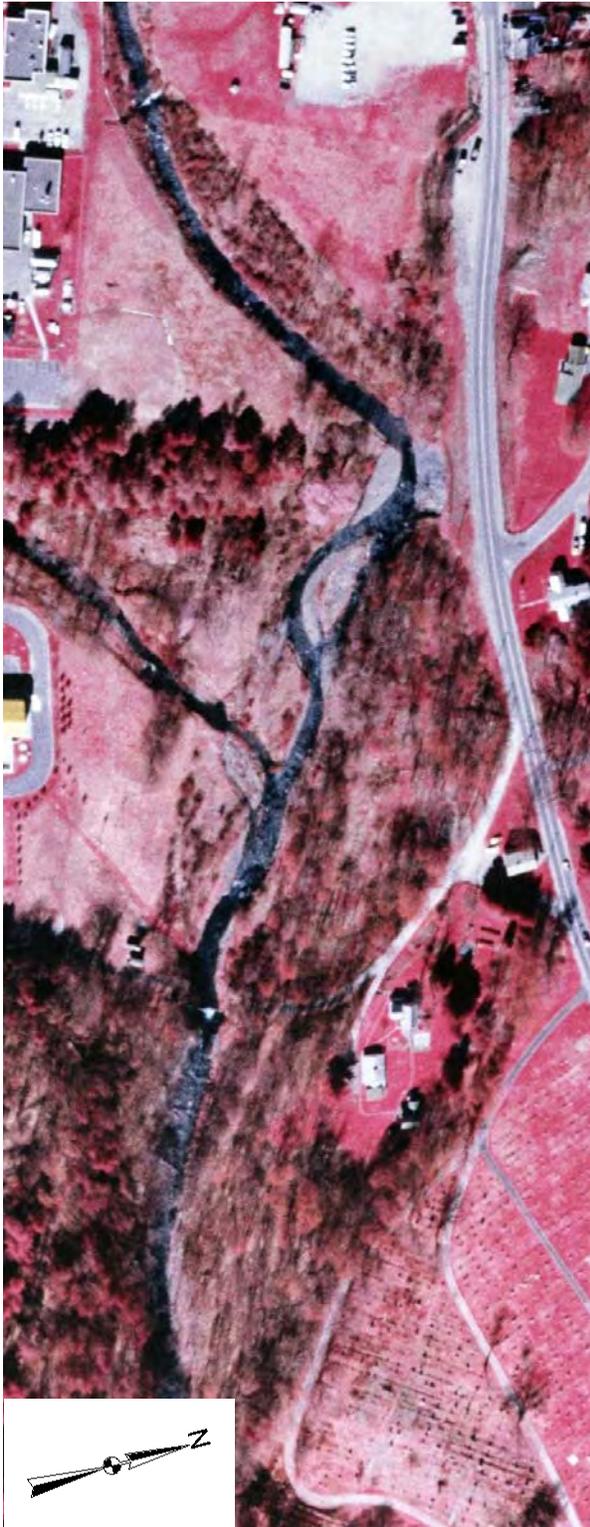
Photo 7. 2001 Aerial Photograph of Management Unit 7.

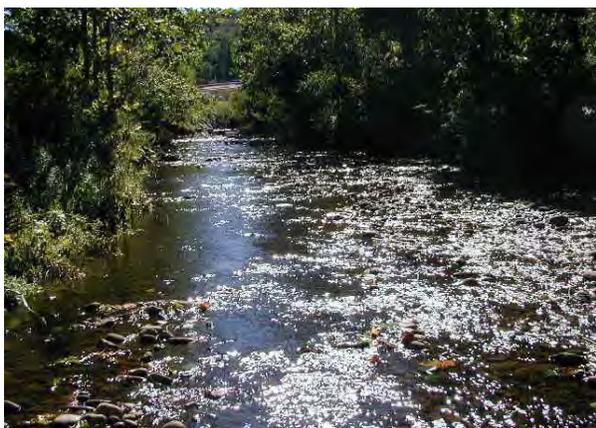
Photo 14. Reach-view looking upstream from XS-170 on DEP property.

densities (Photo 14). A large area containing maintained fields exists along the upper portion of the unit on the right floodplain. The lower section of the unit consists of more dense mature stands of deciduous trees along both floodplains. Although floodplain vegetation was deemed adequate to provide general stability, areas with a relatively low rooting depth to bank height provided minimal vegetative stability. Historical aerial photograph analysis shows an increasing density of riparian vegetation from 1997 to present.

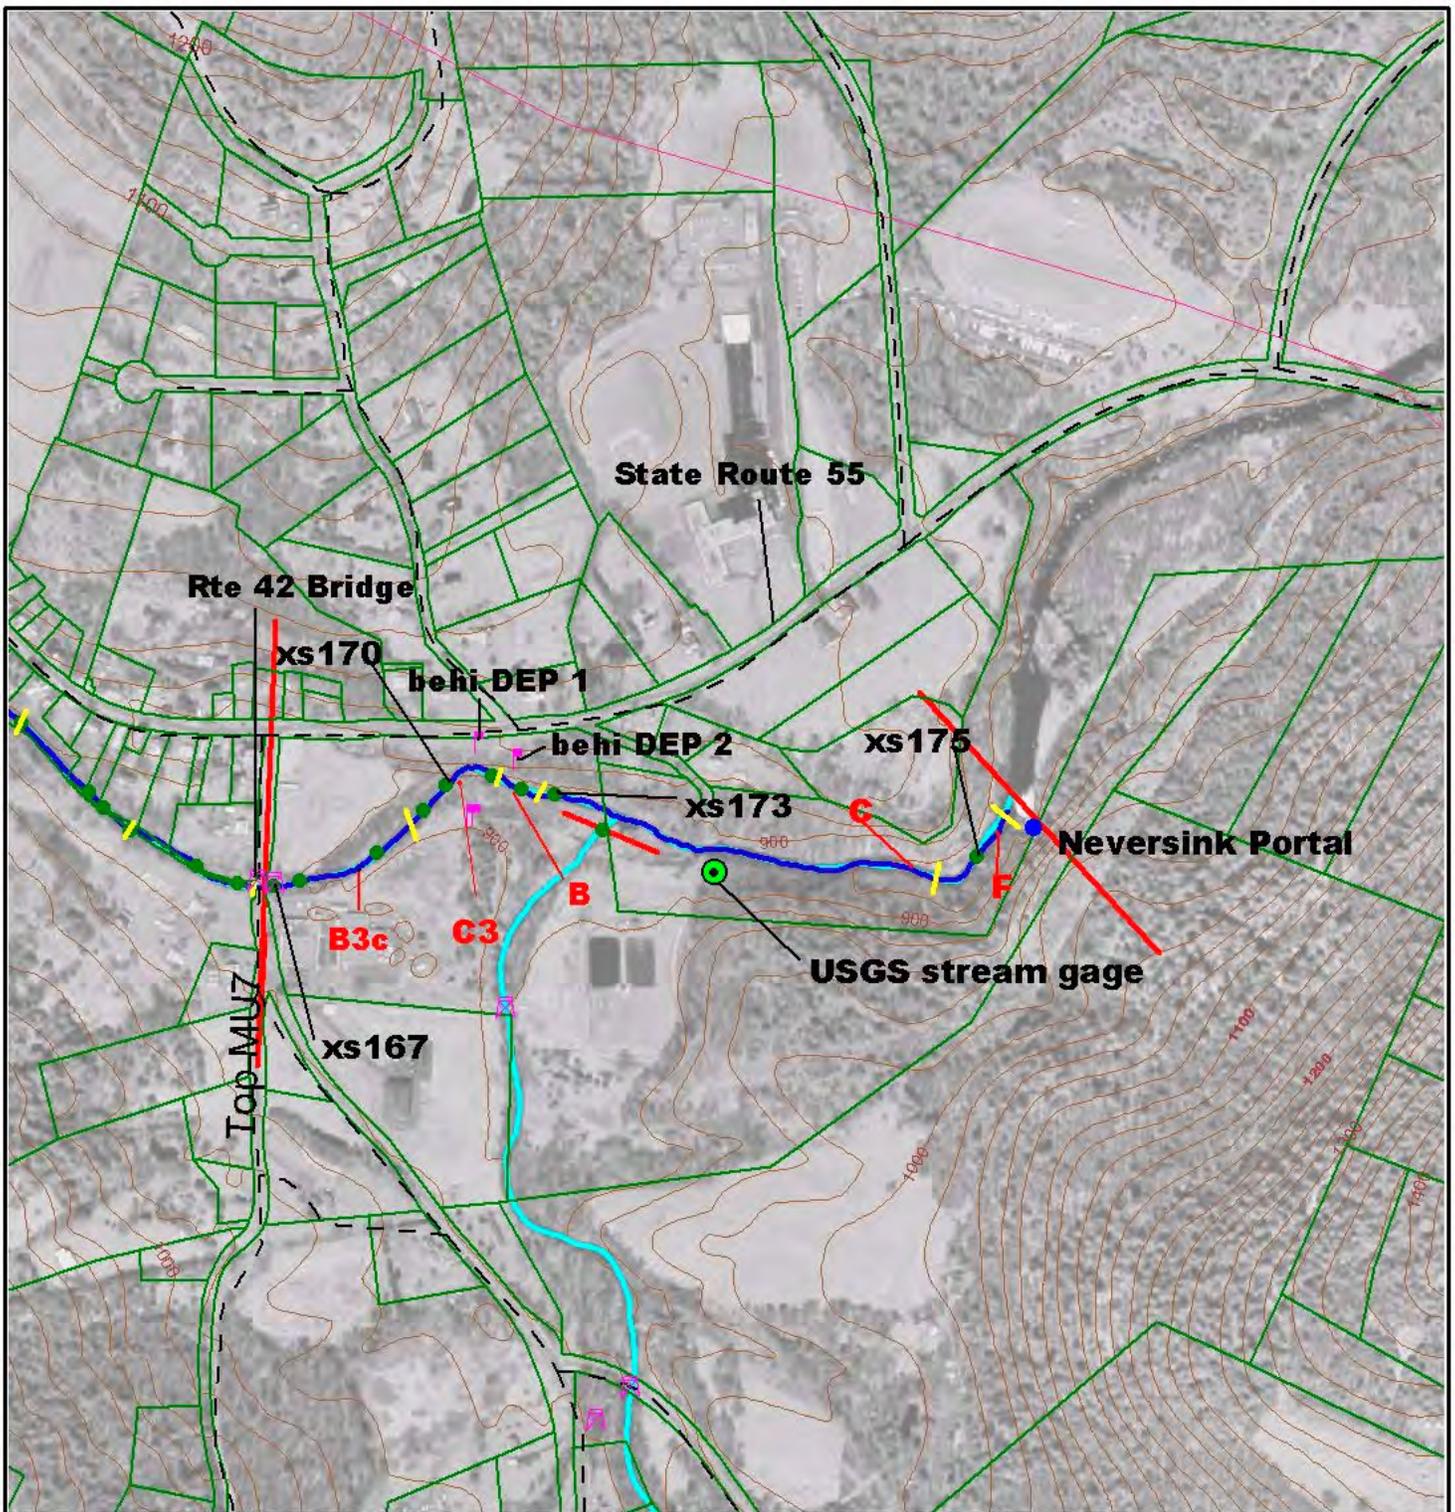
Figure 2. Chestnut Creek MU7 Stream Types & Cross Sections
Stream Assessment Survey 2001

Sediment supply varies within the unit. Storage of sediment in the form of both sidebars and central bars is evident throughout the entire unit. A number of these bars are vegetated, however some areas indicate recent or ongoing deposition. Cobble and gravel comprise the predominant substrate within the bankfull channel and bar formations. Also a small amount of exposed bedrock has been identified below the bridge at Route 42 and below the gage. The morphological data collected along MU7 is summarized in Table 1 in order progressing downstream from the Route 42 Bridge. Also see Stream Type and Cross Section location map, Figure 2.
