East Kill Management Unit 3

Town of Jewett – Vista Ridge Road Bridge (Station 67789) to Station 62465

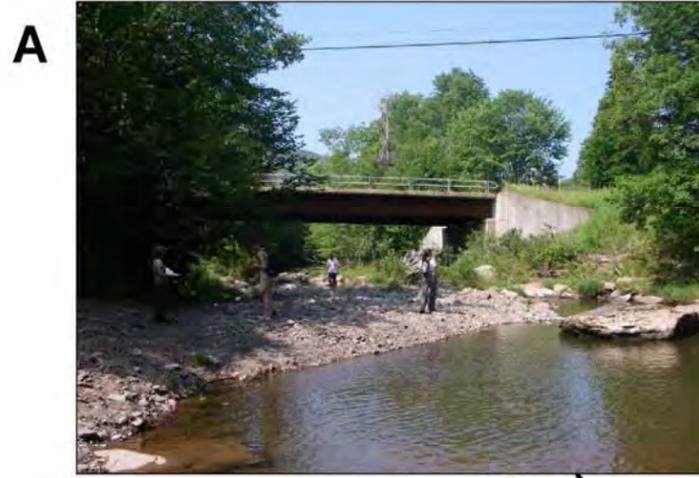
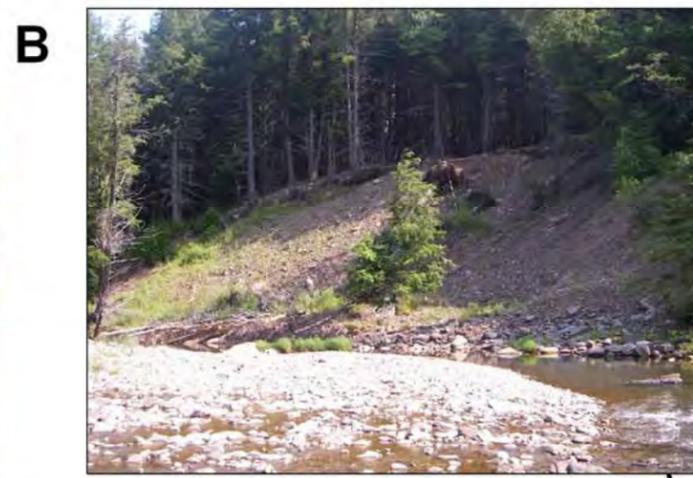
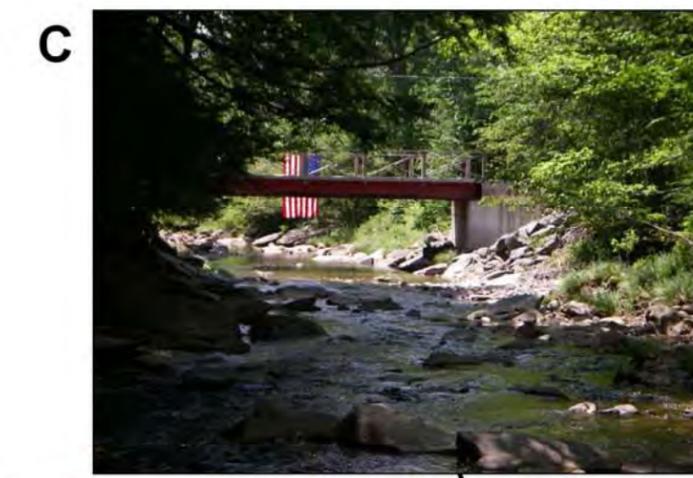
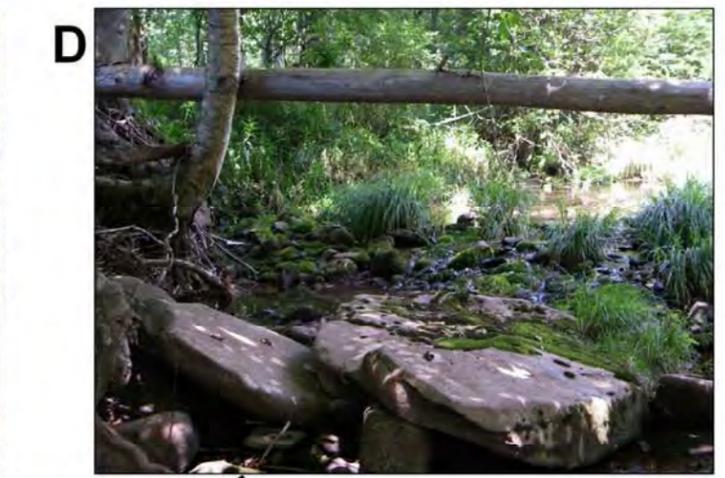
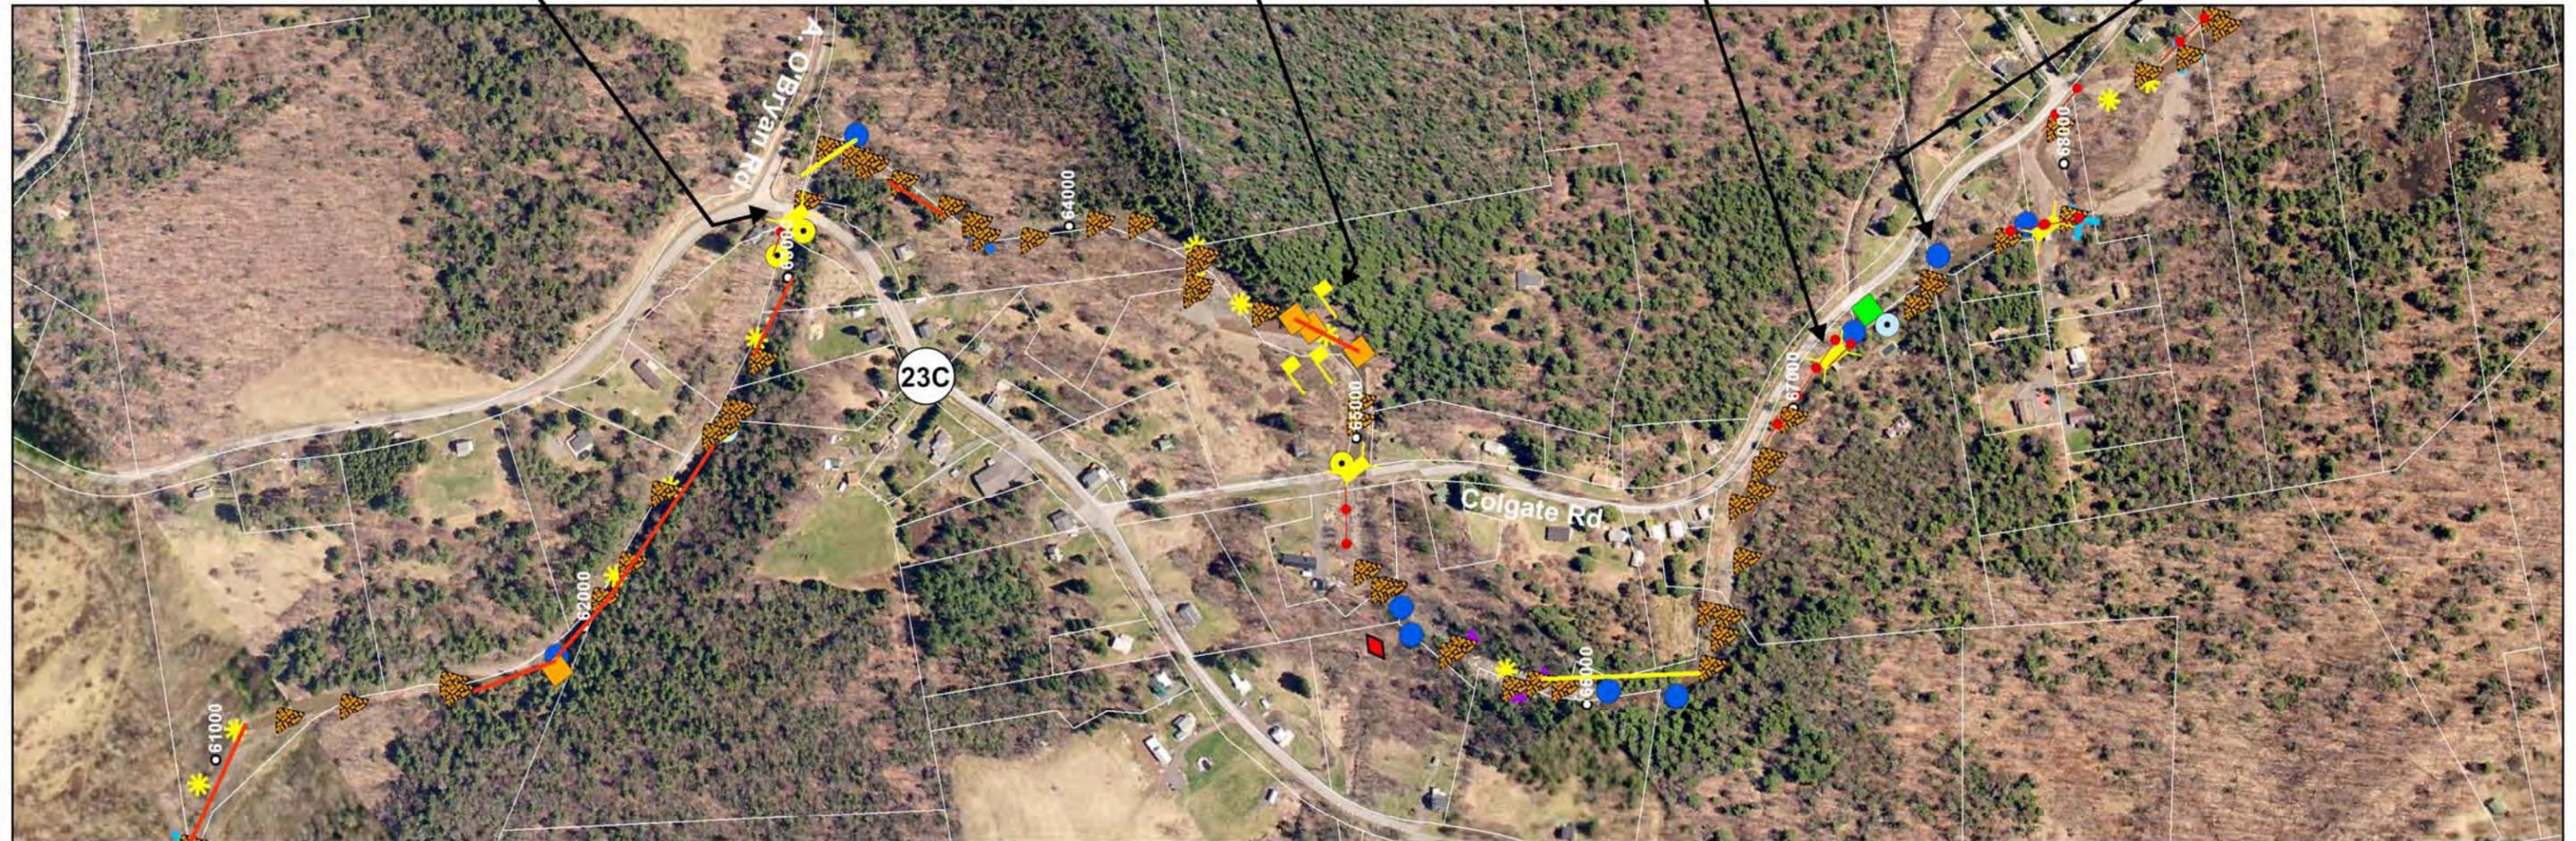
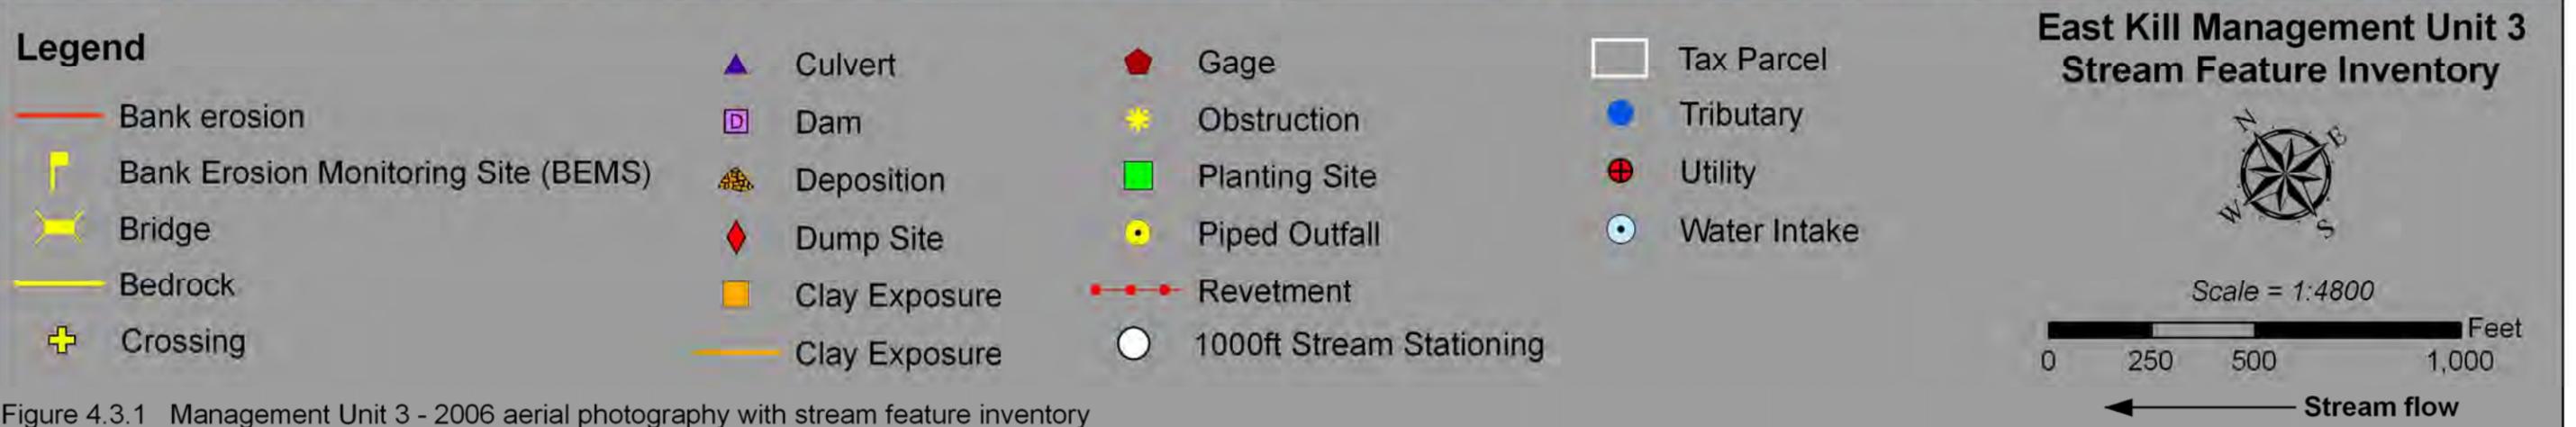
Figure 4.3.1 Management Unit 3 - 2006 aerial photography with stream feature inventory

The 2006 stream feature inventory revealed that 6.0% (637 ft) of the stream banks exhibited signs of active erosion along the 10,647 ft of total channel length in the unit (Figure

4.1.1). *Revetment* had been installed on 5.6% (592 ft.) of the stream banks. No berms were identified in this management unit at the time of the stream feature inventory.

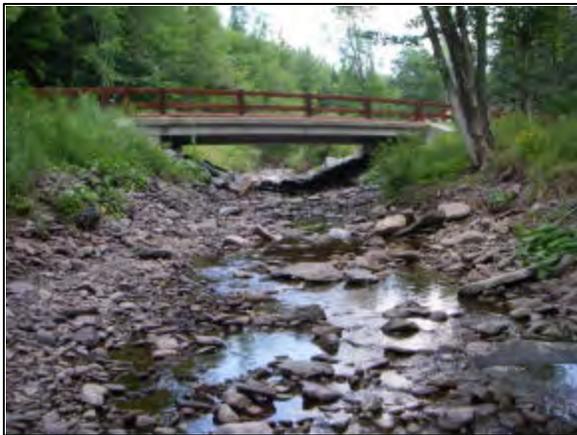
*Halsey Brook at Station 67236
looking upstream*

drains Thomas Cole and Black Dome Mountains before it reaches the flatter topography of the valley floor where it enters the East Kill. The New York State Department of Environmental Conservation classifies streams and rivers based on their “best use” (NYSDEC, 1994). This tributary was classified C(ts) by the NYS DEC, indicating that the best uses for this stream are supporting fisheries, including trout spawning, and other non-contact activities.
