East Kill Management Unit 6

Town of Jewett – Station 40130 to Station 37758

**East Kill Management Unit 6
Stream Feature Inventory**

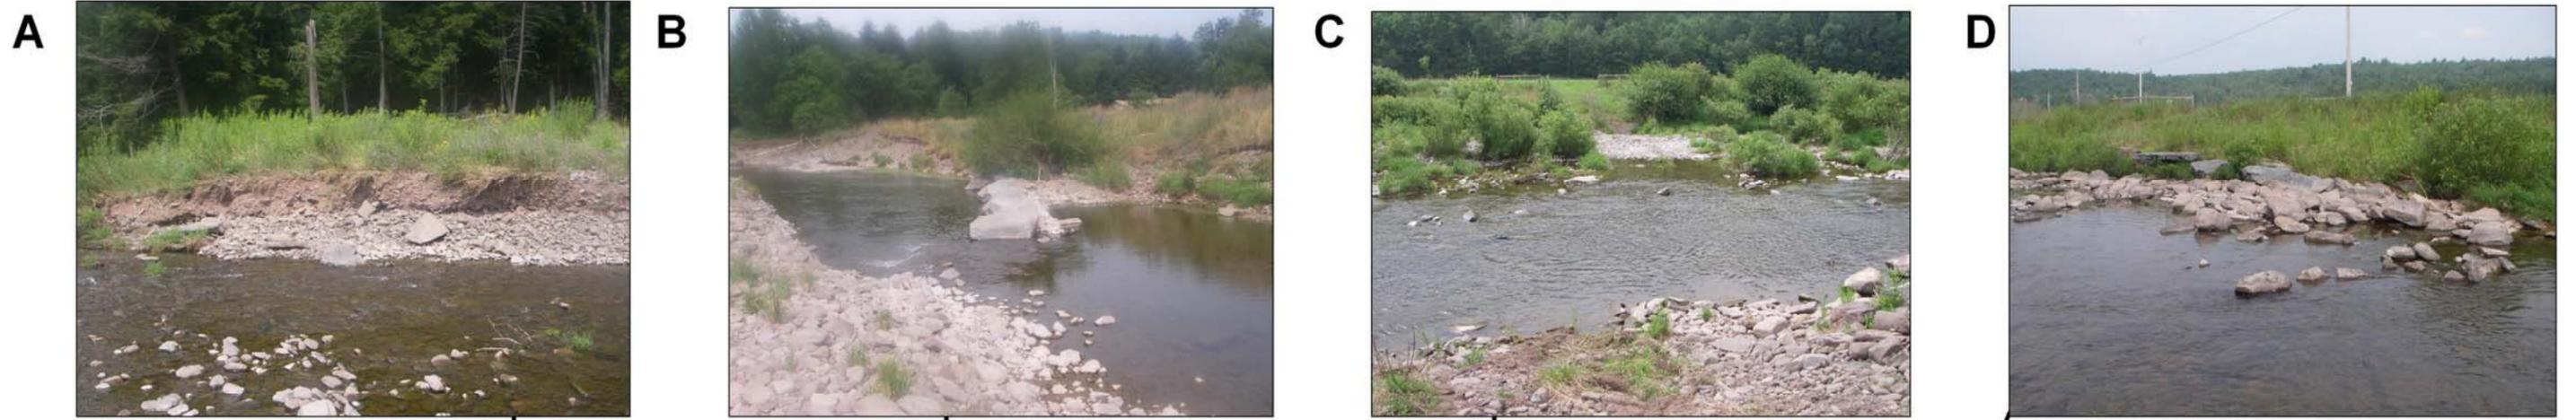
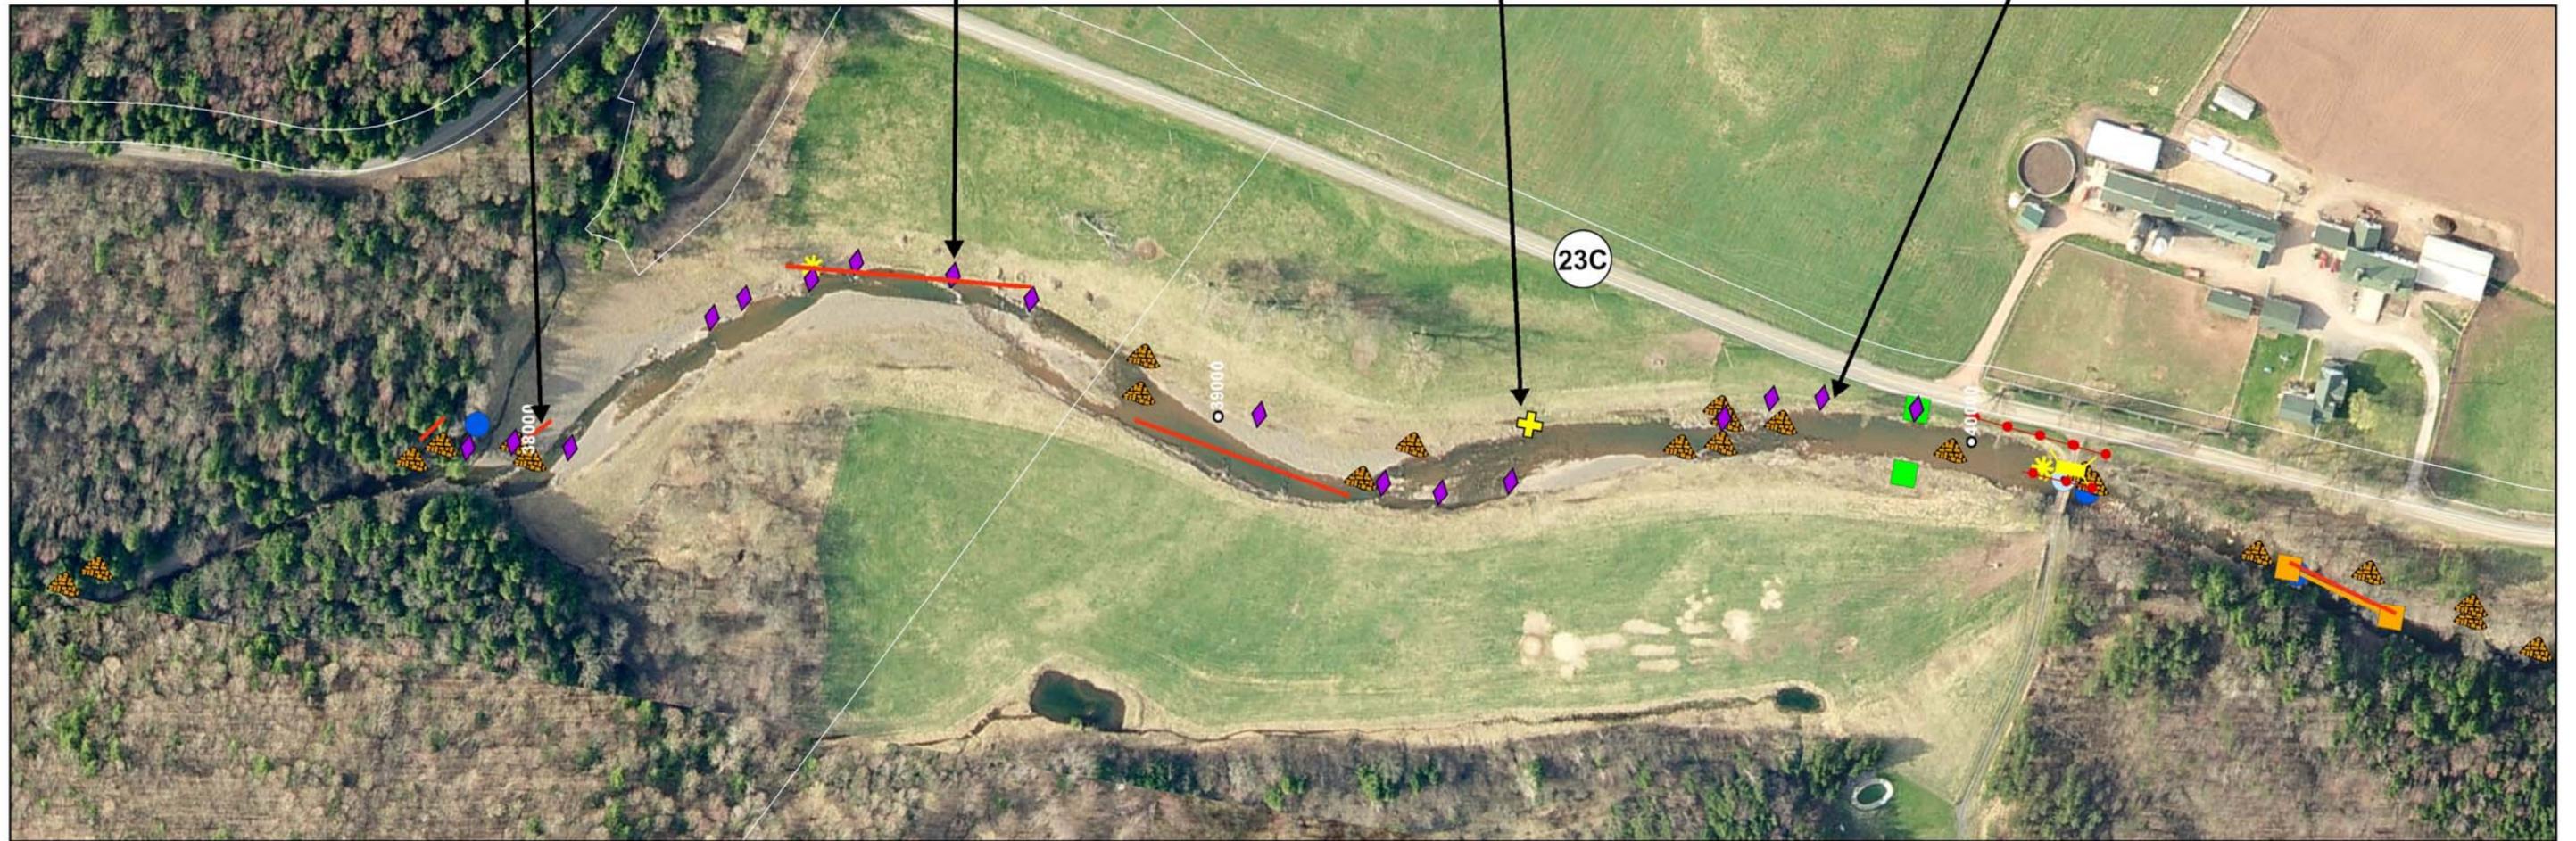
Figure 4.6.1 Management Unit 6 - 2006 aerial photography with stream feature inventory

The 2006 stream feature inventory revealed that 14.7% (696 ft) of the stream banks exhibited signs of active erosion along the 4,744 ft of total channel length in the unit (Figure 4.6.1). *Revetment* had been installed on 4.4% (207 ft) of the stream banks. No berms were identified in this management unit at the time of the stream feature inventory.

The second rock vane (Station 39800), also along the right bank, was in good structural condition but appeared to be in fair functional condition. A significant length of the vane was buried in the bed due to aggradation. The third rock vane (Station 39737, Figure 4.6.1 Inset D), along the right bank, appeared to be in good structural and functional condition. There were some willow and sedges reinforcing this rock vane.

Excessive sediment deposition including, side and point bars, continued downstream. To obtain access to the agricultural fields along the left side of the stream, there was a stream crossing at station 39436 (Figure 4.6.1 Inset C). Continuing downstream, there were three

along this meander bend. The second rock vane (Station 38614, Figure 4.6.1 Inset B) along the meander bend was in good structural and functional condition, with herbaceous vegetation and willows established where the vane keyed into the stream bank. Although the erosion continued downstream of this structure, the bank was relatively stable along this rock vane. The third rock vane (Station 38488) along this meander had been significantly compromised. Half of the structure was buried, and scour and erosion had undermined the structure, which was no longer keyed into the bank. The fourth rock vane (Station 38434) along the eroding meander bend appeared to be in poor structural and functional condition. The erosion ended just downstream of this rock structure, and the right stream bank was stable through the fifth rock vane (Station 38344) along this meander, which was in good structural and functional condition. At the time of the assessment, the cross vane (Station 38306) appeared to be in relatively good structural and functional condition, although some of the rocks forming the key for the right vane arm were becoming exposed. As described here, the condition of the rock structures that were used to construct this meander bend varied; further assessment of these and the other structures within this management unit is recommended. Once an on-site assessment of the constructed channel is conducted and the needed repairs identified, it is recommended that all damaged structures receive repair and reinforcement

assessment. Just downstream of this rock structure, there was erosion (Stations 38053 – 38007, Figure 4.6.1 Inset A) along 46 feet of the right stream bank. There was herbaceous vegetation to the top of the stream bank; stability of this bank may be improved by planting native trees and shrubs to establish a riparian buffer, in combination with sedge plantings to reinforce the toe of the bank. Just downstream of this erosion site, there was the

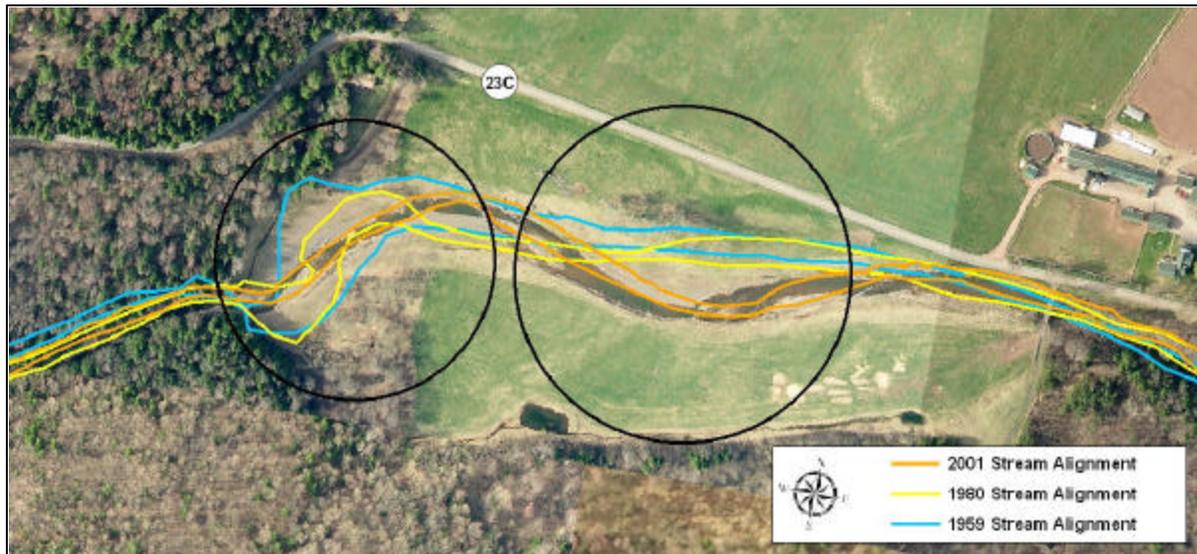
Historic stream channel alignments overlaid with 2006 aerial photograph

As seen from the historical stream channel alignments (above), the *planform* of the channel alignment has changed over the years along this management unit. A review of historic aerial photography showed that there was excessive channel lateral migration in the downstream portion of this management unit, near the confluence of an unnamed tributary. Historically, the stream channel alignment has also been heavily manipulated, resulting in the straightened alignment observed along a significant portion of this reach prior to restoration efforts that were completed in 2000. The Greene County Soil and Water Conservation District designed and coordinated the stream restoration project along this reach, and worked in cooperation with and received support from the NYC Department of Environmental Protection (DEP) for these restoration efforts. The project involved restoring more natural stream morphology with a meandering alignment and higher sinuosity along 2,400 feet of stream channel. The orange (2001) planform seen above represents the constructed channel. For detailed information regarding the restoration project within this management unit see the *Farber Farm Stream Restoration Project – East Kill – Implementation & Monitoring Report* in Appendix E.

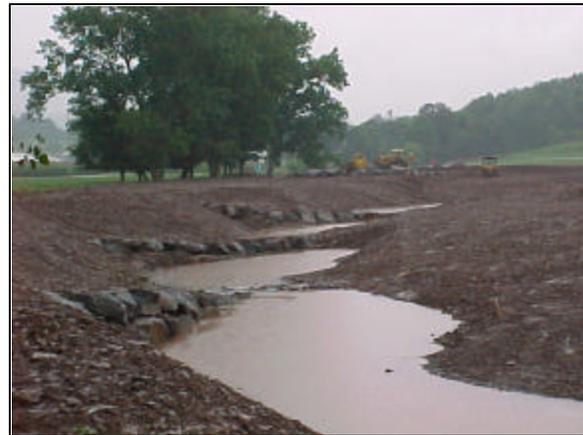
Rock vane construction - Summer 2000

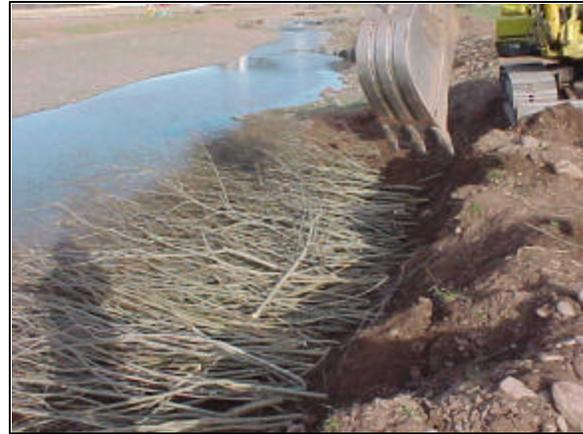
Bioengineering - Spring 2001

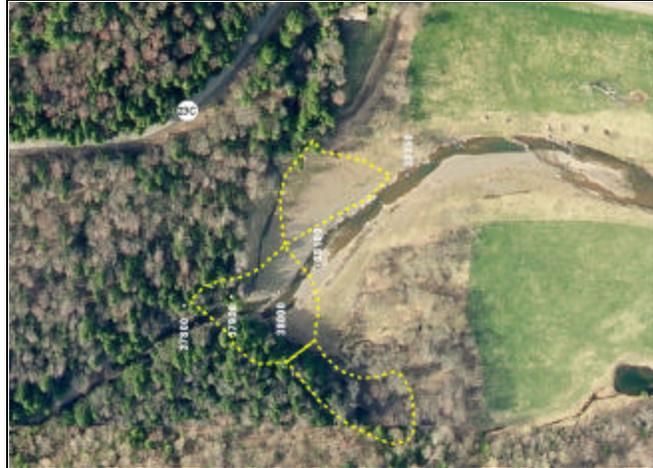
Along the downstream portion of this meander bend there was a 0.6 acre palustrine wetland (Stations 38338 - 38100) with scrub-shrub vegetation along the right stream bank, followed by a 0.9 acre riverine wetland (Stations 38100 - 37816) along both stream banks. These wetlands were classified

*Wetland boundary approximately delineated by NWI
(Stations 38338 - 37816)*

as PSS1A and R3USA respectively (see Section 2.6 for detailed wetland type descriptions). Directly adjacent to the riverine wetland and set back along the left stream bank, there was a 0.6 acre forested palustrine wetland that was classified as PFO1A. Wetlands are important features in the landscape that provide numerous beneficial functions including protecting and improving water quality, providing fish and wildlife habitats, storing floodwaters, and maintaining surface water flow during dry periods.

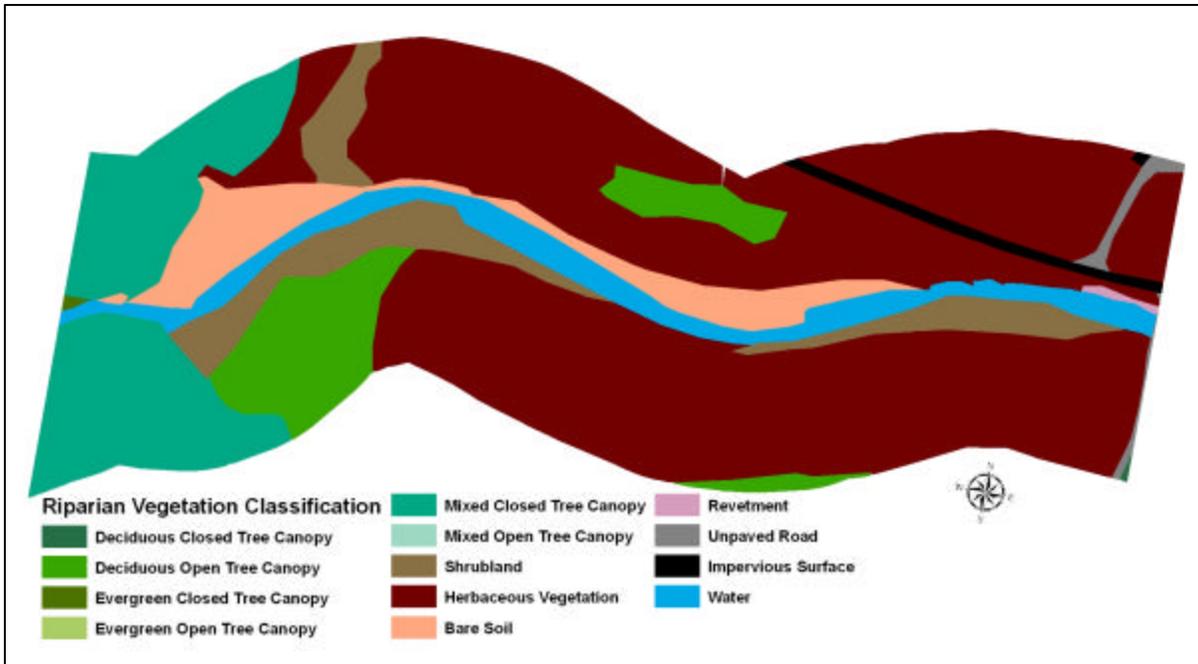
An analysis of vegetation was conducted using aerial photography from 2001 and field inventories (see map below and Riparian Vegetation Mapping, Appendix B). In this management unit, the predominant vegetation type within the 300 ft. riparian buffer was herbaceous (60 %) followed by forested (23%). *Impervious* area (1.2 %) within this unit's buffer was primarily the local and private roadways, and residential structures. Areas of herbaceous (non-woody) cover may present opportunities to improve the riparian buffer with

Riparian vegetation classification map based on aerial photography from 2001

tree plantings in order to promote a more mature vegetative community along the stream bank and in the floodplain.
