# East Kill Management Unit 11

Town of Jewett – Mill Hollow Road Bridge (Station 6699) to confluence with Schoharie Creek (Station 0)

This management unit began at Mill Hollow Road Bridge at County Route 17 (#3201130), and continued approximately 6,698 ft. to the East Kill’s confluence with Schoharie Creek.

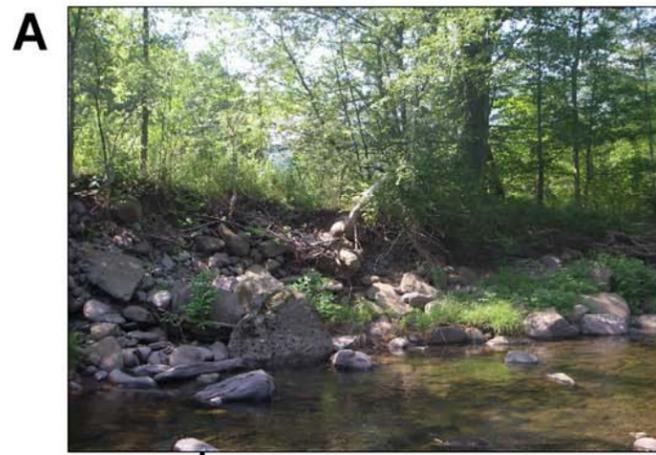
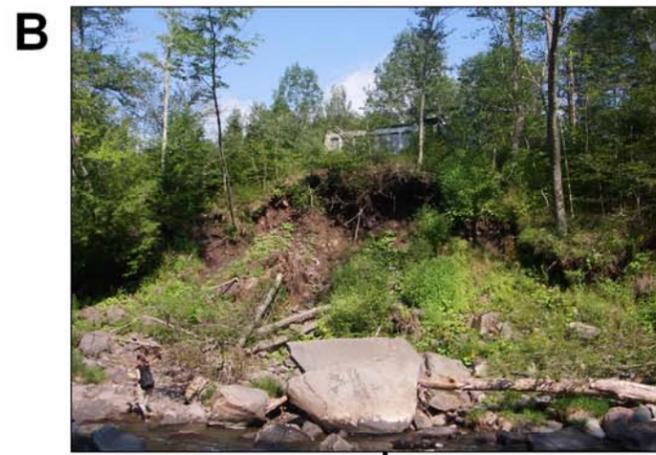
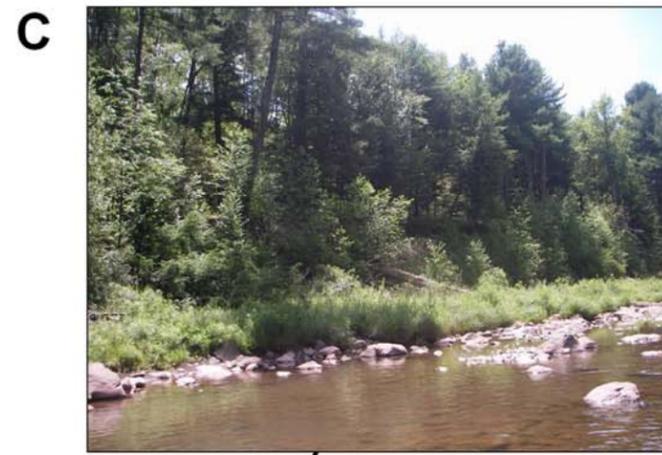
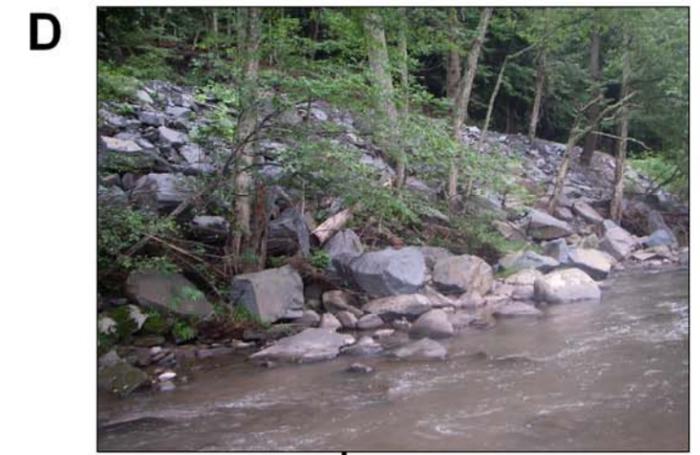
Figure 4.11.1 Management Unit 11 - 2006 aerial photography with stream feature inventory

The 2006 stream feature inventory revealed that 20.4% (2,728 ft) of the stream banks exhibited signs of active erosion along the 13,397 ft of total channel length in the unit (Figure 4.11.1). *Revetment* has been installed on 12.7% (1,707 ft) of the stream banks. No berms were identified in this management unit at the time of the stream feature inventory.

Downstream of the bridge, Whaley Road encroached upon the stream channel along the left stream bank. The embankment has been reinforced with rock rip-rap (Stations 6332 – 5931, Figure 4.11.1 Inset D) along approximately 401 feet of the stream channel. The rip-rap was comprised of a combination of large rock, small rock and gravel of differing ages; the rip-rap was in poor structural and functional condition. Along a portion of the rip-rap, there was a rock wall (Station 6088) reinforcing the stream bank, with rip-rap at the toe and top of the bank and a piped outfall entering through the wall. There were some trees throughout the rip-rap, however, the edge of the road was very close to the top of the revetted stream bank, therefore, deeply rooted woody vegetation is critical along the embankment to provide stability and water quality protection. Interplanting the rip-rap with native tree and shrub species and reinforcing the toe of this stream bank with native sedge species is

extremely susceptible to future erosion. A small tributary and seepage along this bank may exacerbate erosion. Stream bank erosion often occurs on the outside of meander bends where the stream velocity is greatest during high flows. This erosion continued for another 489 ft downstream, but was less severe (Station 4013 – 3524, Figure 4.11.1 Inset C). Slumping and fallen trees on the bank face still provide some protection from erosion.

Downstream, 618 ft of the County Route 17 road embankment was threatened by a large mass failure of the streambank that resulted in the loss of mature vegetation from the face of the streambank (Station 2450-1832, Figure 4.11.1 Inset B). Stormwater from the outlet at the top of this bank appeared to be exacerbating erosion at this site (Inset Station 32130). Outlet protection, such as a rock lined channel, should be

Downstream from the bridge 127 ft along the left bank had scoured (Station 140-13, Figure 4.11.1 Inset A). Planting this bank with native tree and shrub species and reinforcing the toe of this stream bank with native sedge species is recommended. This management unit ended as the East Kill flowed into the Schoharie Creek.

recommended. This planting will help to strengthen the revetment, while enhancing aquatic habitat.

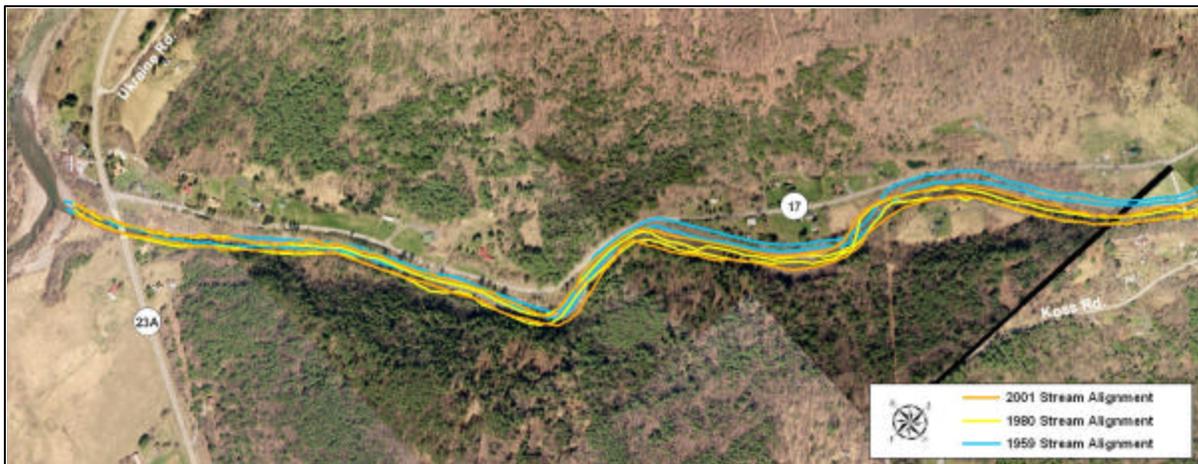
*Historic stream channel alignments overlaid with 2006 aerial photograph*

As seen from the historical stream channel alignments (above), the *planform* of the channel alignment has not changed significantly over the years along this management unit; the channel has remained fairly stable.

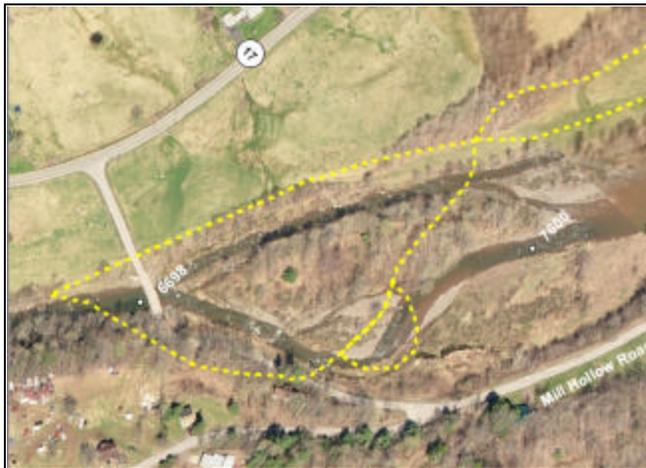
*Wetland boundaries approximately delineated by NWI  
(Stations 7543 - 6528)*

There was a 4.6 acre palustrine wetland (Stations 7543 – 6528) that began in management unit #10, a small portion of this wetland continued through to management unit #11. This wetland was classified as PFO1A (see Section 2.6 for detailed wetland type descriptions). Wetlands are important features in the landscape that provide numerous beneficial functions including protecting and improving water quality, providing fish and wildlife habitats,
