# Manor Kill Management Unit 1

Town of Conesville – Station 53,637 to Manor Creek Road (Station 45,598)

This management unit begins at a large NWI wetland complex, continuing approximately 8,039 ft to Manor Creek Road in the Town of Conesville.

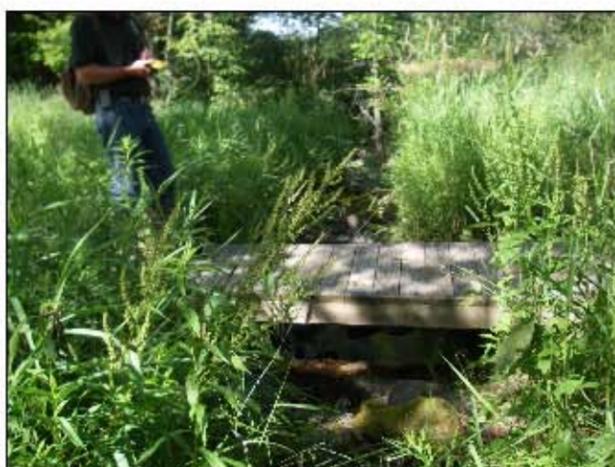
**B**

Downstream of the berm, there was a private wooden foot bridge (Figure 4.1.1, Inset B, Station 46755). This bridge was adequate width and height for low flows, but may pose an obstruction during higher flows. At the time of the assessment flow became subsurface downstream of the bridge.

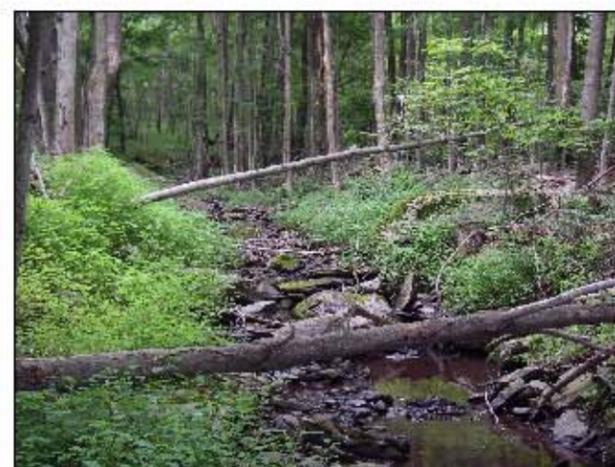
**C**

Further downstream there were multiple observations of woody debris, including some fallen trees across the stream (Station 50032, Figure 4.1.1, Inset C). Woody debris is beneficial to a stream system. It provides critical habitat for fish and insects and adds essential organic matter that will benefit organisms downstream. Although the trees did not pose an obstruction at low flow, they may pose a more significant obstruction during higher flows. Unless the woody debris is causing an imminent threat to infrastructure or long-term bank stability (meaning it may cause a mass bank failure) it should be left in the stream.

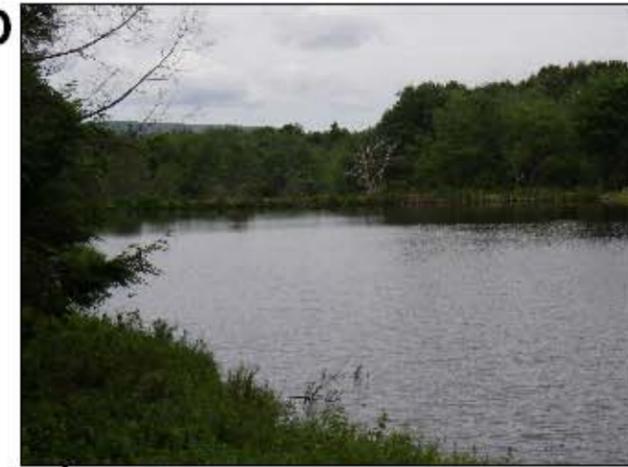
**D**

Continuing downstream, there was a private earth dam (NY00832, Station 52058) that was completed in 1977 to form a recreational pond (Figure 4.1.1, Inset D, looking downstream, Station 52800-52071). It measures 15 feet high and approximately 230 feet in

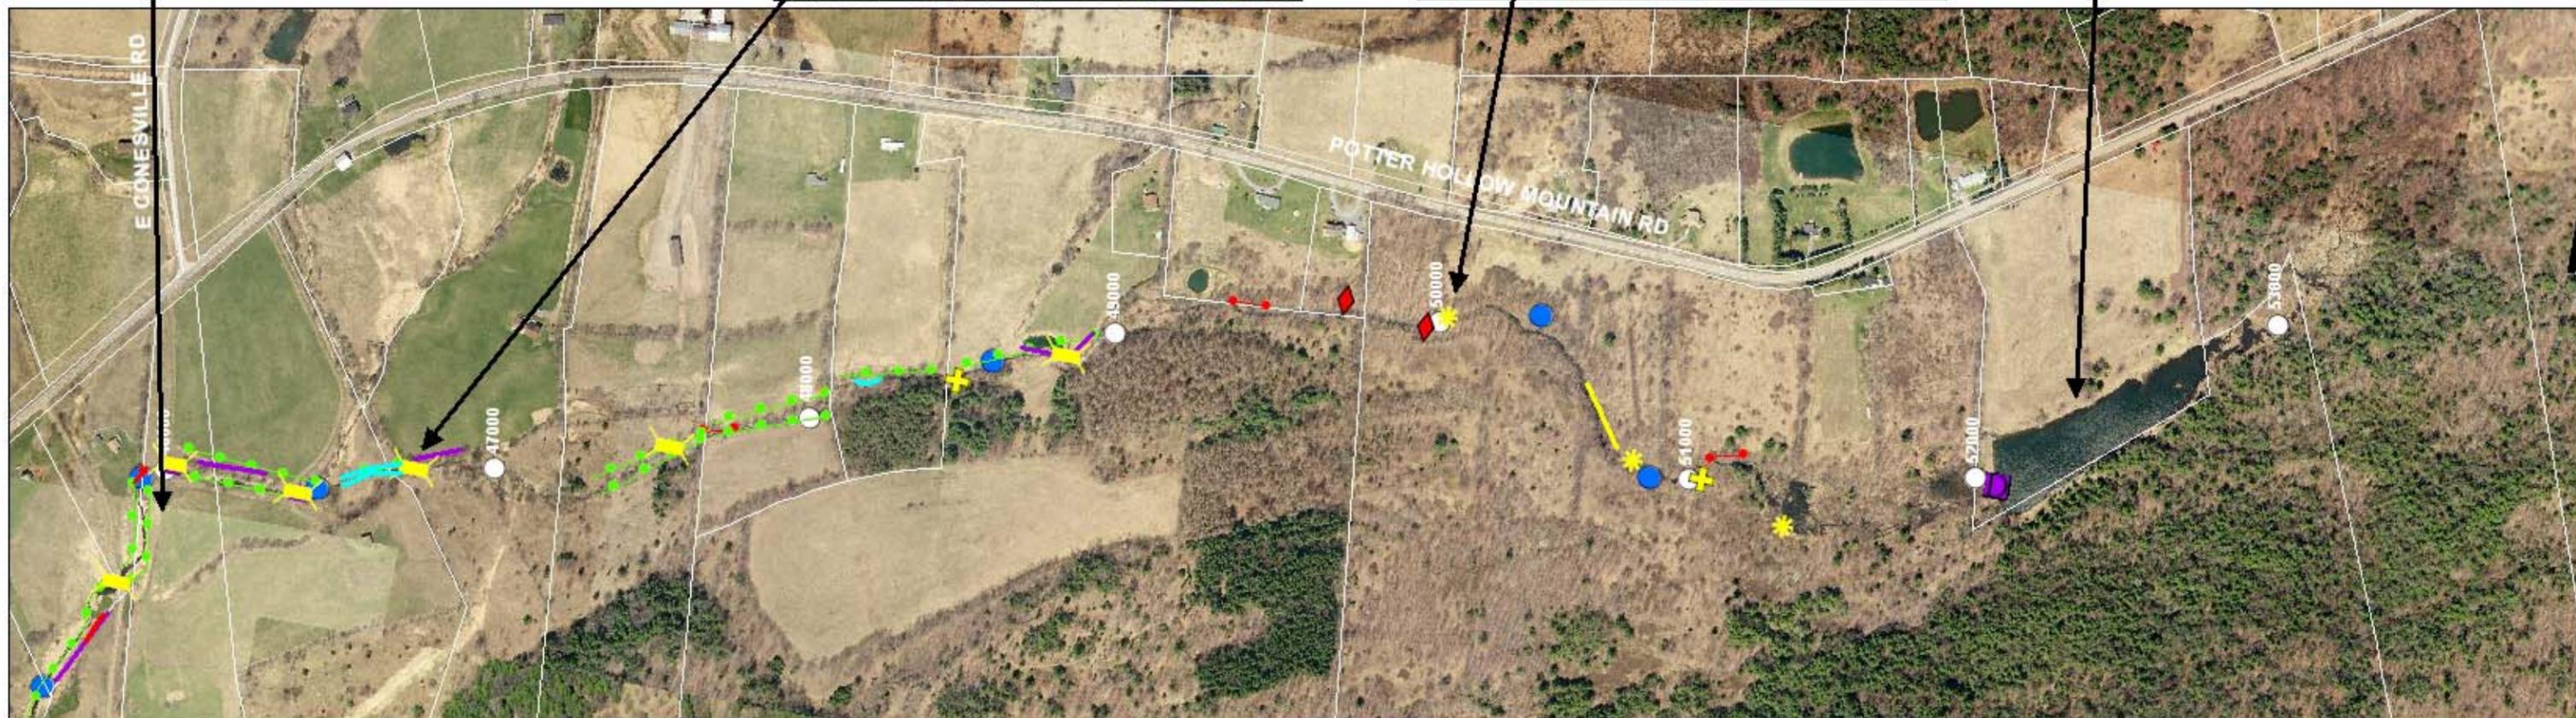
Figure 4.1.1 Management Unit 1 - 2006 aerial photography with 2008 stream feature inventory.

The 2008 stream feature inventory revealed that 3.0% (472 ft.) of the streambanks exhibited signs of active erosion along the 16,075 ft. of total streambank length in the unit (Fig. 4.1.1). *Revetment* has been installed on 2.3% (376 ft.) of the streambanks. Approximately 3.6% (579.5 ft.) of the streambanks have been bermed.

Summary of Recommendations Management Unit 1	
Intervention Level	Assisted Self-Recovery
Stream Morphology	No recommendations at this time.
Riparian Vegetation	Monitor for introduction of Japanese knotweed and eradicate new introductions. Plant a buffer of trees and shrubs along proposed planting sites and increase width of riparian buffer in appropriate locations.
Infrastructure	When bridges are replaced, construct with the appropriate height and width to allow conveyance of flood flows.
Aquatic Habitat	Watershed Aquatic Habitat Study
Flood Related Threats	No recommendations at this time.
Water Quality	Removal of dump sites.
Further Assessment	Consider hydraulic analysis of bridge openings.
