Manor Kill Management Unit 8

Town of Conesville – Station 9805 to Station 4523

This management unit began at Station 9805 and continued approximately 5,282 ft to Station 4523 in the Town of Conesville.

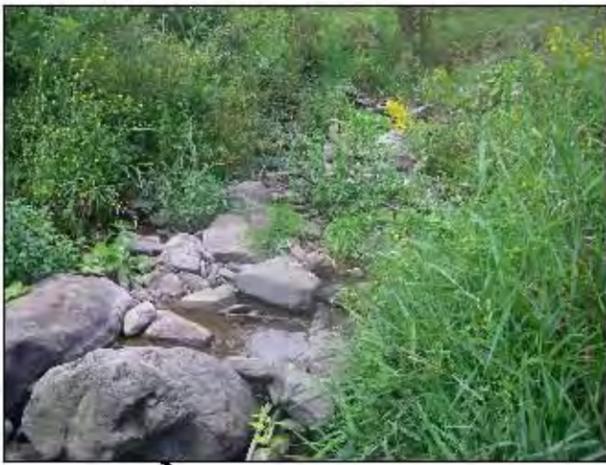
Continuing downstream, an unnamed tributary (Figure 4.8.1, Inset A, Station 4552) entered from the right streambank. This tributary was classified A by the NYS DEC, indicating that the best uses for this stream are drinking, supporting fisheries and other recreational activities. At the mouth of the tributary, and along the upper portion of the stream bank, a large stand of knotweed was observed. Management Unit 8 ended just downstream of the tributary at Station 4523.

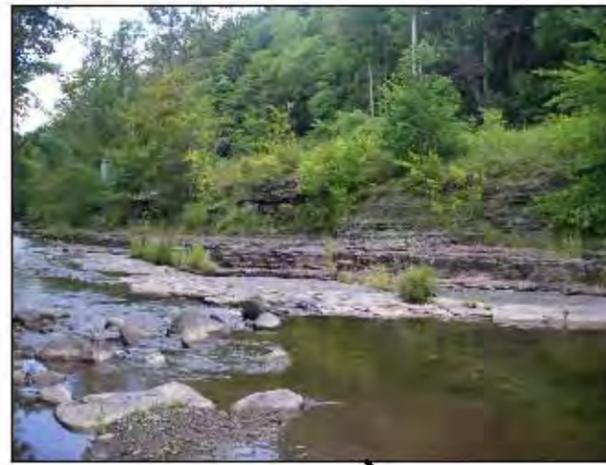
B

interplanted into the rip rap. As the stream turned sharply to the left, bedrock (Figure 4.8.1, Inset B, Stations 7368-6336) extended from the top of the bank along State Route 990V into the channel of the right streambank and bed for approximately 1,032 feet. This bedrock at times covered the full bed of the stream channel. The bedrock provides lateral control along the right bank by limiting stream bank erosion; it provides grade control for the channel by preventing degradation or downcutting of the stream, the process by which streambeds and floodplains are lowered in elevation by eroding downward into the stream bed over time.

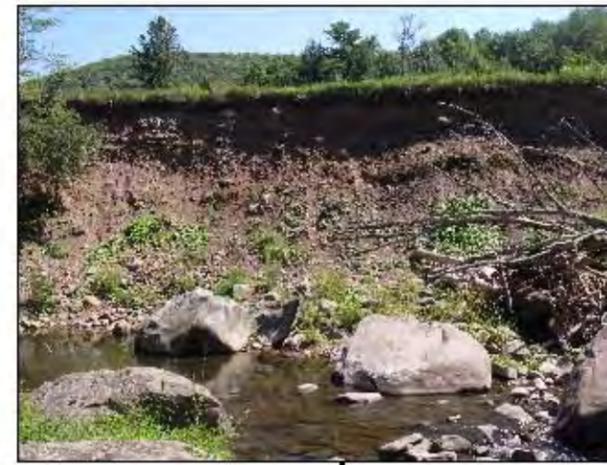
C

As the stream meandered to the right, the *thalweg*, or deepest part of the stream channel, flowed up against the left streambank causing a mass failure (Figure 4.8.1, Inset C, Stations 8388 – 8269). This mass failure resulted in an erosion area of approximately 3,956 ft², exposing roots and compromising

mature trees along the upstream and downstream portions of the bank. The vegetation along this site had been mowed to the edge of the bank. During the field assessment, this bank was identified as a proposed Bank Erosion Monitoring Site (BEMS) to study erosion along this reach. To monitor BEMS, a cross-section and long profile may be conducted to collect baseline data. Once the baseline data has been collected, this cross-section can be resurveyed in the future to calculate the bank's erosion rate.

Summary of Recommendations Management Unit 8	
Intervention Level	Assisted Self-Recovery
Stream Morphology	No recommendations at this time.
Riparian Vegetation	Treat, remove and prevent the spread of Japanese knotweed where feasible. Plant a buffer of trees and shrubs along proposed planting sites and increase width of riparian buffer in appropriate locations.
Infrastructure	When bridges are replaced, construct with the appropriate height and width to allow conveyance of flood flows.
Aquatic Habitat	Watershed Aquatic Habitat Study
Flood Related Threats	No structures in 100-year floodplain – protect floodplain from development.
Water Quality	Encourage homeowners to participate in the CWC septic program, if eligible.
Further Assessment	Consider hydraulic analysis of bridge openings; establish bank erosion monitoring sites at the two mass failures (Stations 8388 – 8269 and Stations 8123-7800).

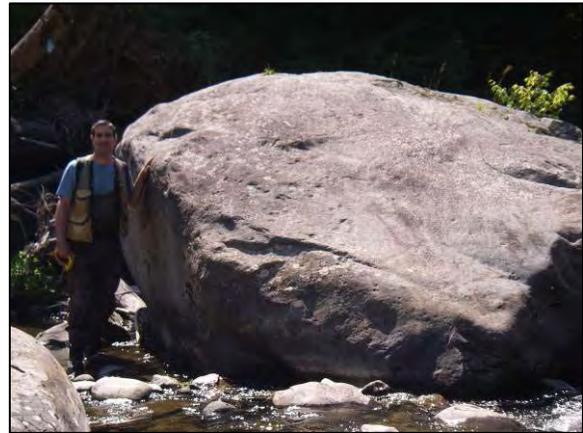
Along this erosion clay was exposed in the bed and bank for approximately 10 feet. Clay inputs into a stream are a serious water quality concern because they increase turbidity, degrade fish habitat, and can act as a transport mechanism for other pollutants and pathogens. Large boulders in the stream contributed to aggradation as well as the scouring of pools along the erosion. Multiple large trees (Stations 8346) had fallen into the stream channel contributing to minor scouring and deposition. Woody debris such as this is beneficial to a stream system; it provides critical habitat for fish and insects, and adds essential organic matter that will benefit organisms downstream.

Boulder at Station 8322

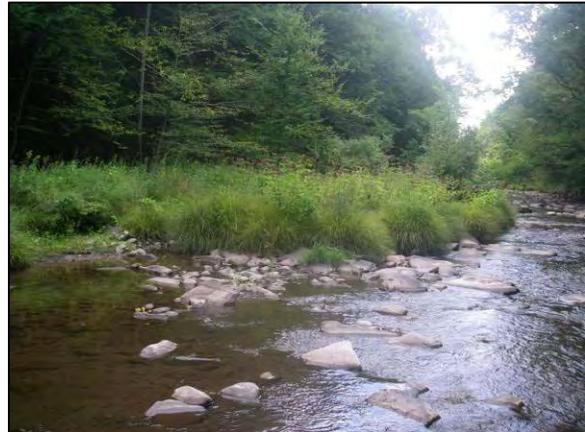
Continuing downstream, the stream was experiencing full channel aggradation (Station 5916) composed of boulders, cobble and gravel for approximately 30 feet. Aggradation continued downstream with an additional center and a side bar. Opposite the deposition, the right bank was reinforced with rip rap for approximately 200 feet (Stations 5995-5800). This revetment appeared to be old, was in fair structural and functional condition and did not appear to provide any scour protection. At station 5420, a small tributary entered from the left streambank. There was no flow at the time of assessment.

Side Bar at Station 5204
