# Rondout Creek Management Unit 4

Management Unit 4  
Between Station 7900 and Station 7100

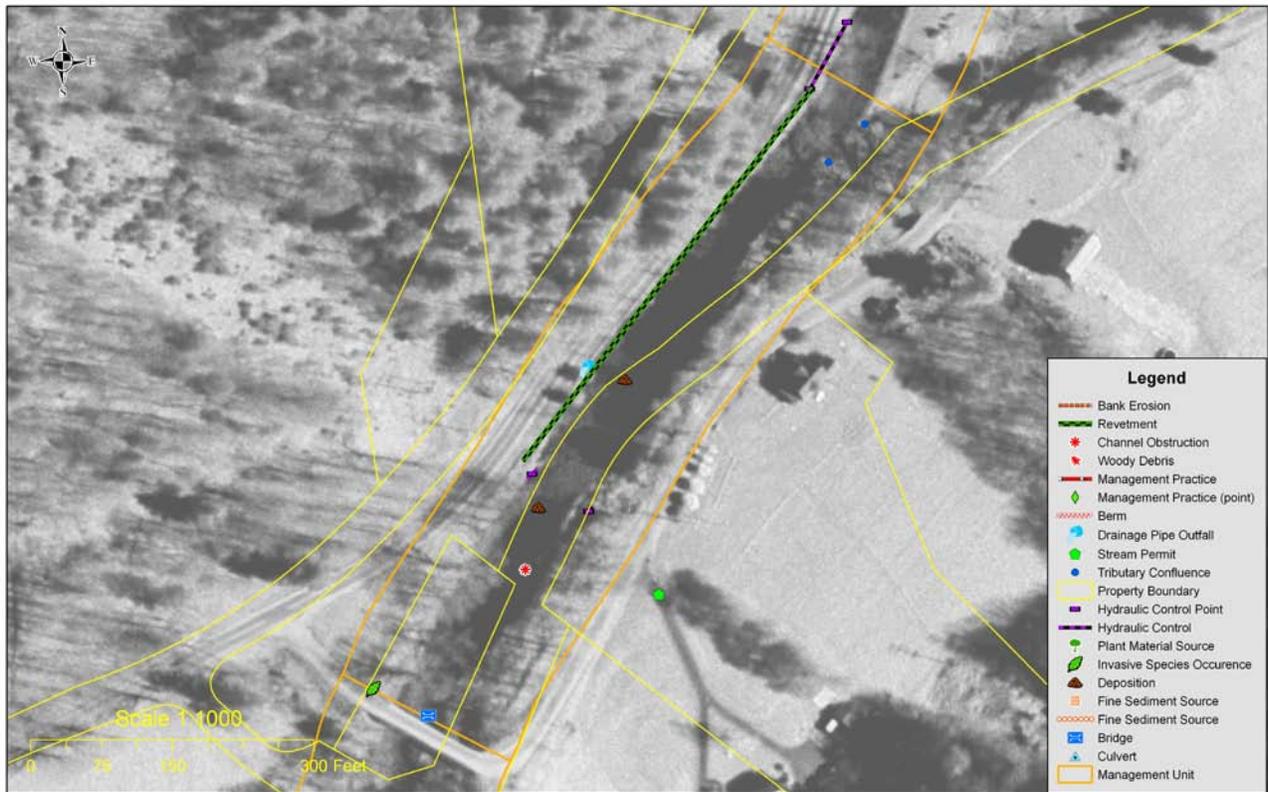
Figure 1 Stream feature inventory, MU4

The 2009 stream feature inventory revealed that 0% (0 ft.) of the stream length exhibited signs of active erosion along 808 ft. of total channel length (Fig. 1). Revetment has been installed on 34.71% (562 ft.) of the stream length. No berms were identified in this management unit at the time of the stream feature inventory.

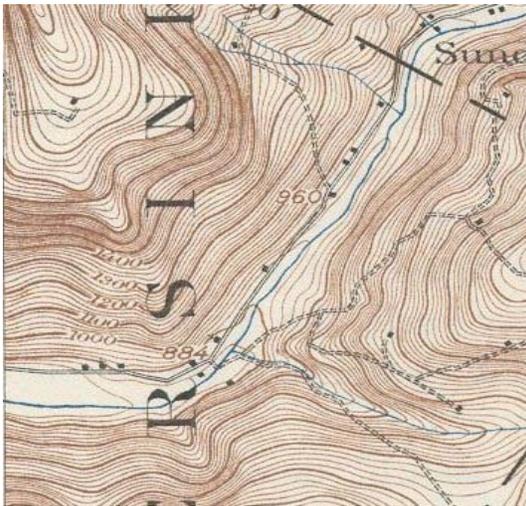
Figure 2 Excerpt of 1905 USGS topographic map MU4

The somewhat narrow valley floor here is an *alluvial fan* created by the material eroded out of East Mountain Brook and that deposited by the stream when, during large flood events, the quantity of *bedload* from upstream tributaries –particularly Stone Cabin Brook, High Falls Brook and Sundown Creek-- overwhelmed the Rondout’s ability to transport it. Alluvial fans at confluences such as this tend to reduce channel slopes in the mainstem and backwater upstream, building the floodplain. Additionally, East Mountain Road has had a bridge crossing of Rondout Creek in this management unit for over a hundred years (see Fig 2); because they often restrict channel or floodplain flows, bridge crossings can also cause upstream backwater and sediment deposition (and downstream scour). The historic bridge abutments for a covered bridge, which remain in place upstream of the current crossing, encroached approximately ten feet into the bankfull channel, so even channel forming flows are restricted. The channel in MU4 has been extensively managed through the 20<sup>th</sup> century to maintain the crossing and protect the roadways, which encroach on the right and left floodplains.

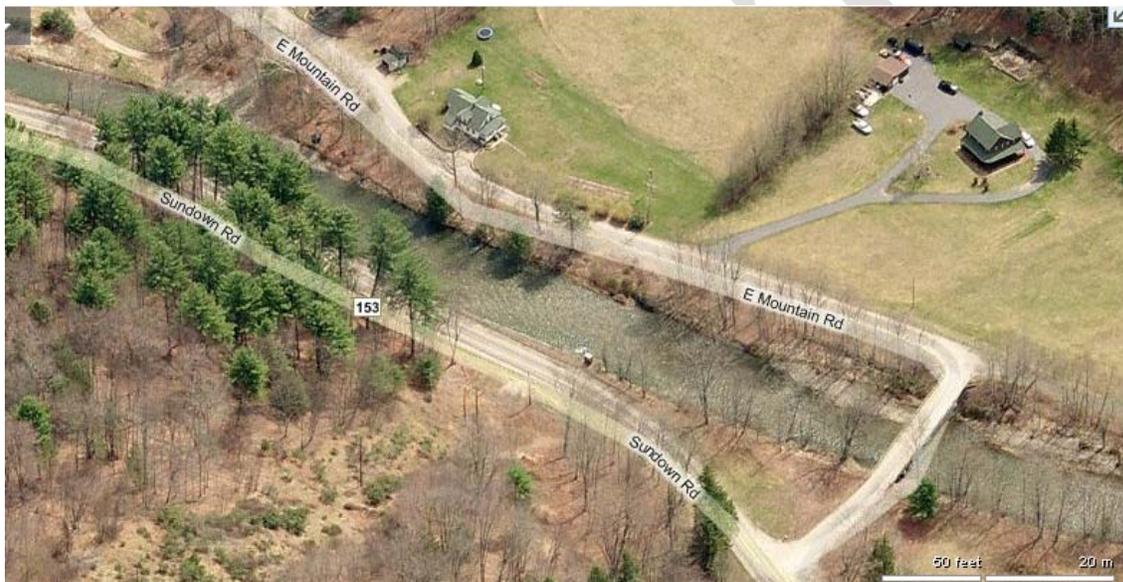
*Figure 3 Management Unit 4*

Management Unit 4 consists of a short, straight run of channel, laterally controlled on either side by encroaching roadway, and at its downstream end by the abutments of the bridge carrying East Mountain Road across the creek. MU4 begins just upstream of the confluence East Mountain Brook with Rondout Creek on the left at Station 7800 (Fig. 4).

Just opposite the confluence, on the right, the concrete crib-wall revetment protecting Sullivan County Rte 153/Sundown Road has been battered by the flows coming out of the tributary, and large rock has been dumped to protect the embankment for a length of approximately 100 ft. where the cribbing is failing. Cribbing begins to be functional, although still in poor condition, around Station 7700, and continues to Station 7400.

<b>Summary of Recommendations Management Unit 4</b>	
Intervention Level	Assisted restoration in restoration of bank stabilization along Sundown Road
Stream Morphology	None
Riparian Vegetation	Develop and implement plan to eradicate Japanese knotweed
Infrastructure	Restore failing concrete cribbing
Aquatic Habitat	Conduct fish study of Rondout Creek
Flood Related Threats	Support development and adoption of new FIRMs
Water Quality	Evaluate possible sources of fine sediment through a stream feature inventory of East Mountain Brook; improve riparian buffer
Further Assessment	Monitor bed aggradation processes upstream of channel constrictions
