Rondout Creek Management Unit 5

Management Unit 5
Between Station 9600 and Station 7900

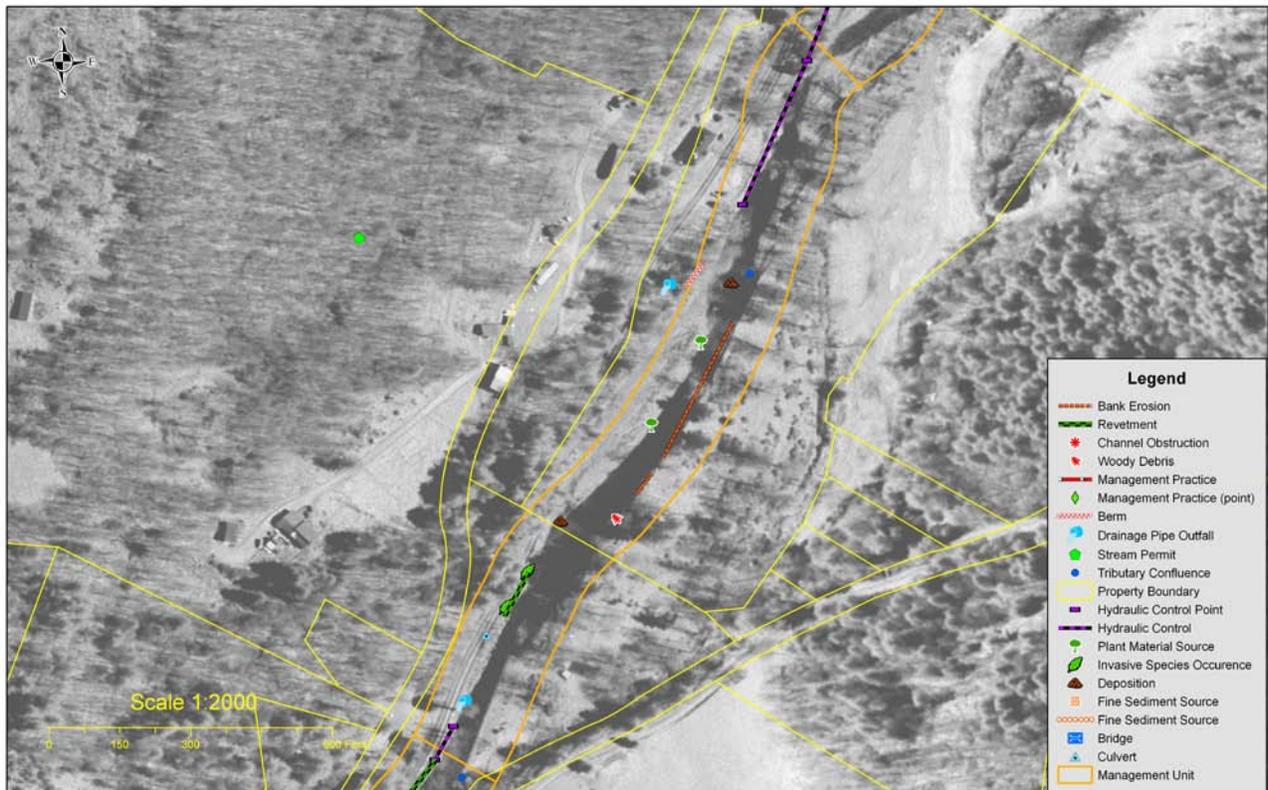
Figure 1 Stream feature inventory MU5

Stream Feature Statistics

11 % of stream length is experiencing erosion

3.14 % of stream length has been stabilized

1.16 acres of inadequate vegetation within the 100 ft. buffer

763 ft. of stream is within 50 ft. of the road

1 house located within the 100-year floodplain boundary

The 2009 stream feature inventory revealed that 11 % (381 ft.) of the stream length exhibited signs of active erosion along 1,717 ft. of total channel length (Fig. 1). Revetment has been installed on 3.14 % (108 ft.) of the stream length. 57.1 ft. of berms were identified in this management unit (1.66 % of stream banks) at the time of the stream feature inventory.

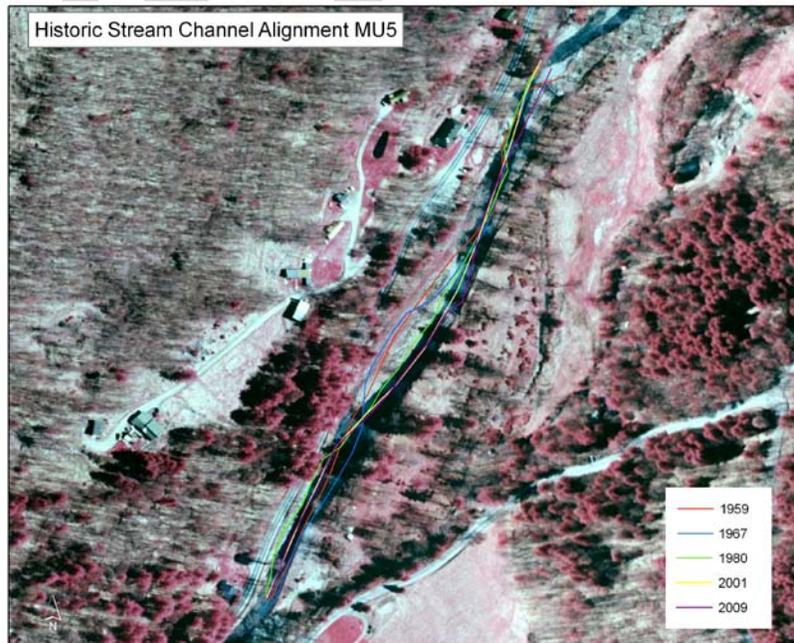
Figure 3 Historic channel alignments, MU5

the roughly one hundred and twenty centuries since the retreat of the glaciers, the position of Rondout Creek has moved back and forth across this floodplain numerous times. While MU5 is a straight reach, the alignment of the channel has shifted somewhat since 1959 (Fig. 3), and there is indication that it is trying to reestablish some sinuosity.
