PROJECT REPORT

Bank Stabilization East Branch Rondout Creek Demonstration Project Ulster County Highway Garage

Report produced by John G. Perrella, Construction Supervisor

Fall/Winter 2011

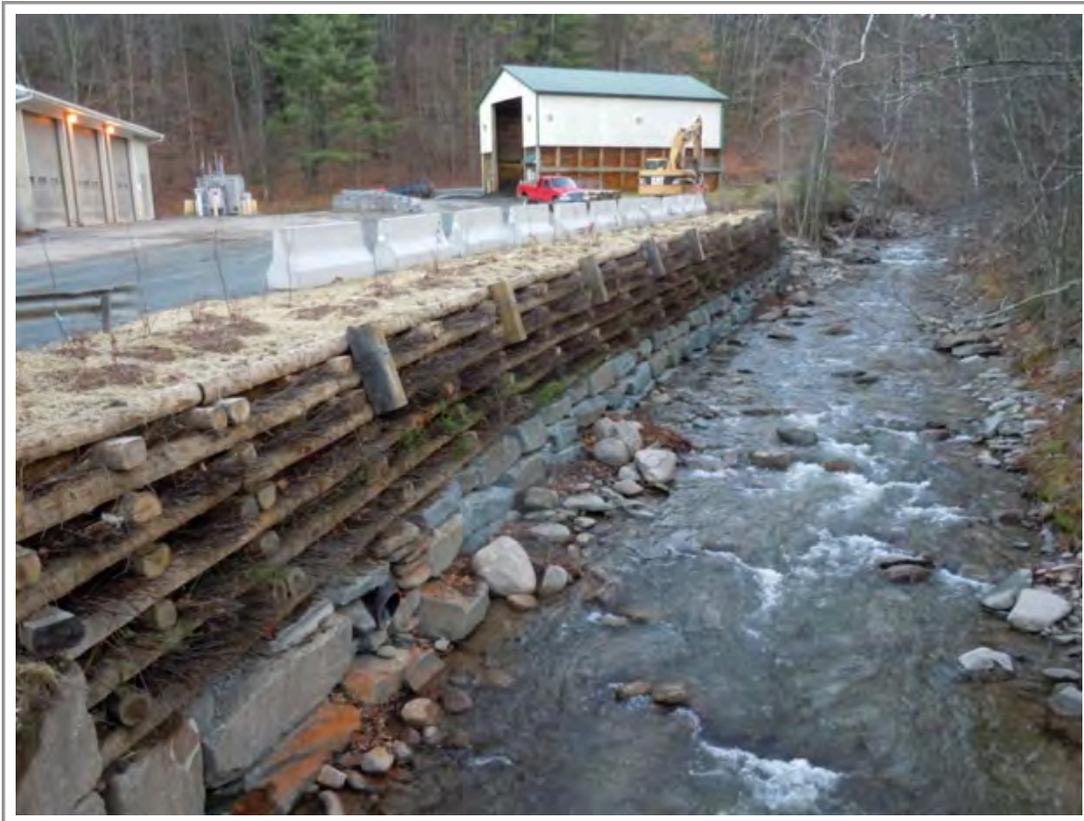
The finished project exhibits the live willow planted oak crib wall atop the stone base with native plants and traffic barriers at the top.

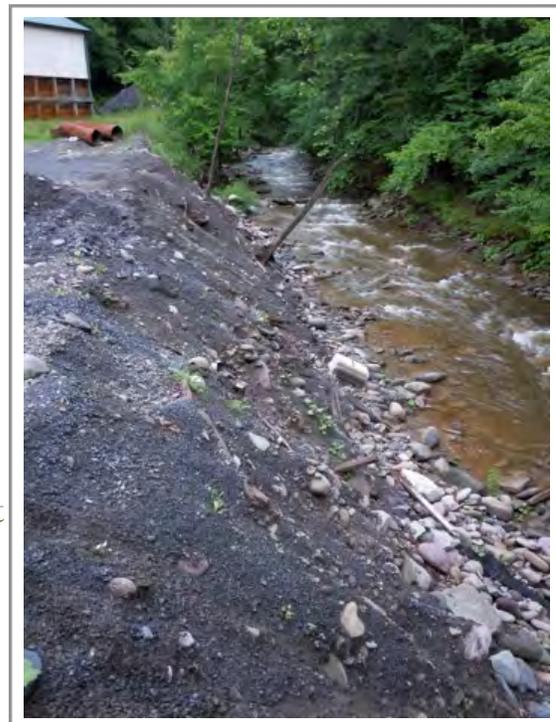
Pre-Construction Conditions

The project area covers approximately 700 linear feet of the stream corridor and includes the road abrasive storage yard for the Ulster County Highway Garage located on the right bank. At the time of the site inspection, there were several coarse gravel piles in two grading material storage locations that were not contained by silt fencing or other stormwater best management practices. The gravel piles closest to Sheely Road appeared to be eroding during rain events with gravel conveyed by runoff onto the right bank and into the channel, leading to bank failure at this location.

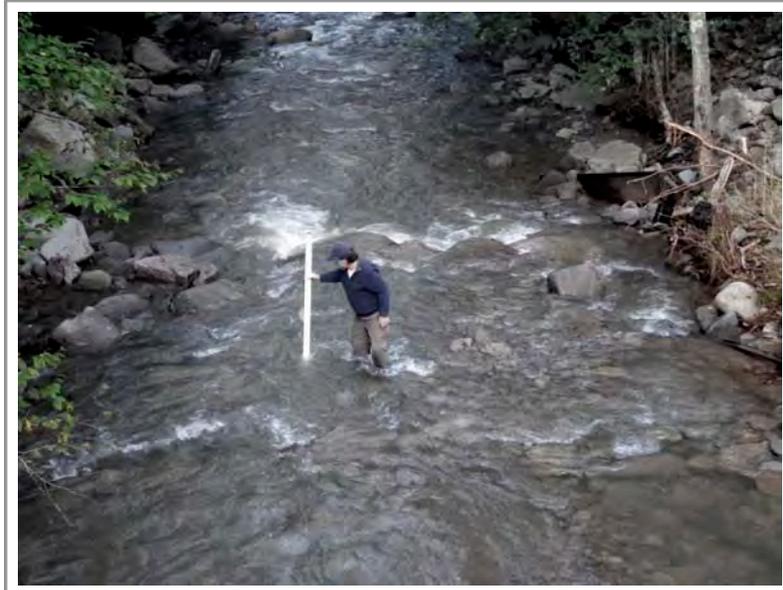
On July 28, 2011 Tropical Storm Irene swept through the Catskills and inflicted major damage to much of the area. This storm affected the demonstration site by scouring a substantial amount of material from the stream bank of the demonstration site. The photo above left shows existing conditions just upstream of the demonstration site before storm event. On the right hand photo above it can clearly be seen that a large amount of material was removed from the bank resulting in a change order to the contract (Appendix I).

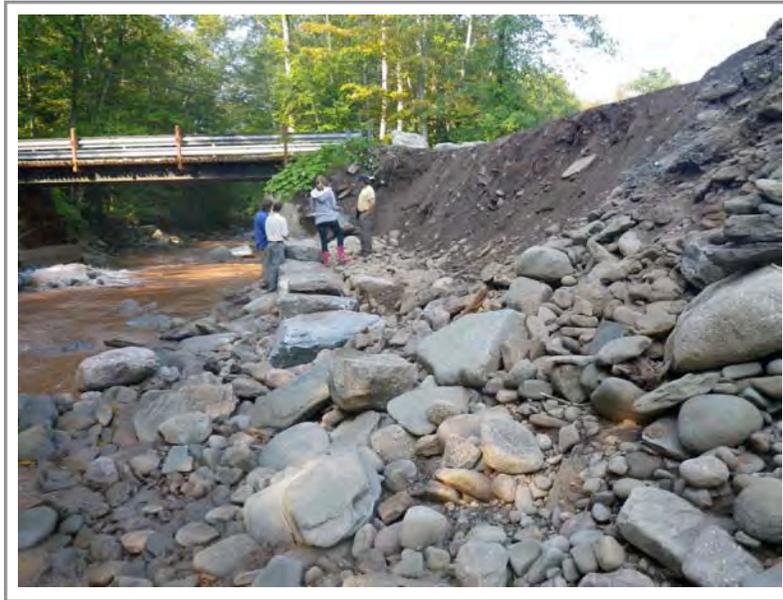
Ultimately, Thompson 12JSCJ-DJDST-45H-MC ENVIROPRIME® Solids Handling Jet Pumps designed for flows up to 7,800 gallons per minute (17.4 cfs) were used at the site. A temporary coffer dam was built just upstream of the work area. Water was pumped via two 12' pipes past the work site. The turbidity in the stream is the result of the very heavy rains and subsequent damage caused by Tropical Storm Irene.

The contract specified for dewatering pumps with a minimum discharge of 20 cubic feet per second (cfs) be maintained to by-pass water around the construction site. Additionally, in an emergency flooding event, the contractor was to supply pumps capable of discharging larger flows of 50 cfs within 24 hours notice.

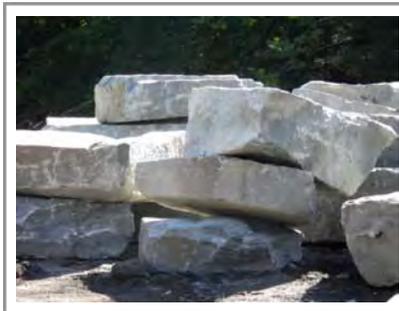
An early meeting with Mark Vian and Osterhoudt Excavating to discuss the manner and placement of the base stones for the large stone portion of the project. The stones were keyed 18” below grade at the line of the stone wall. This photo further illustrates conditions of the stream bank at the start of the project.

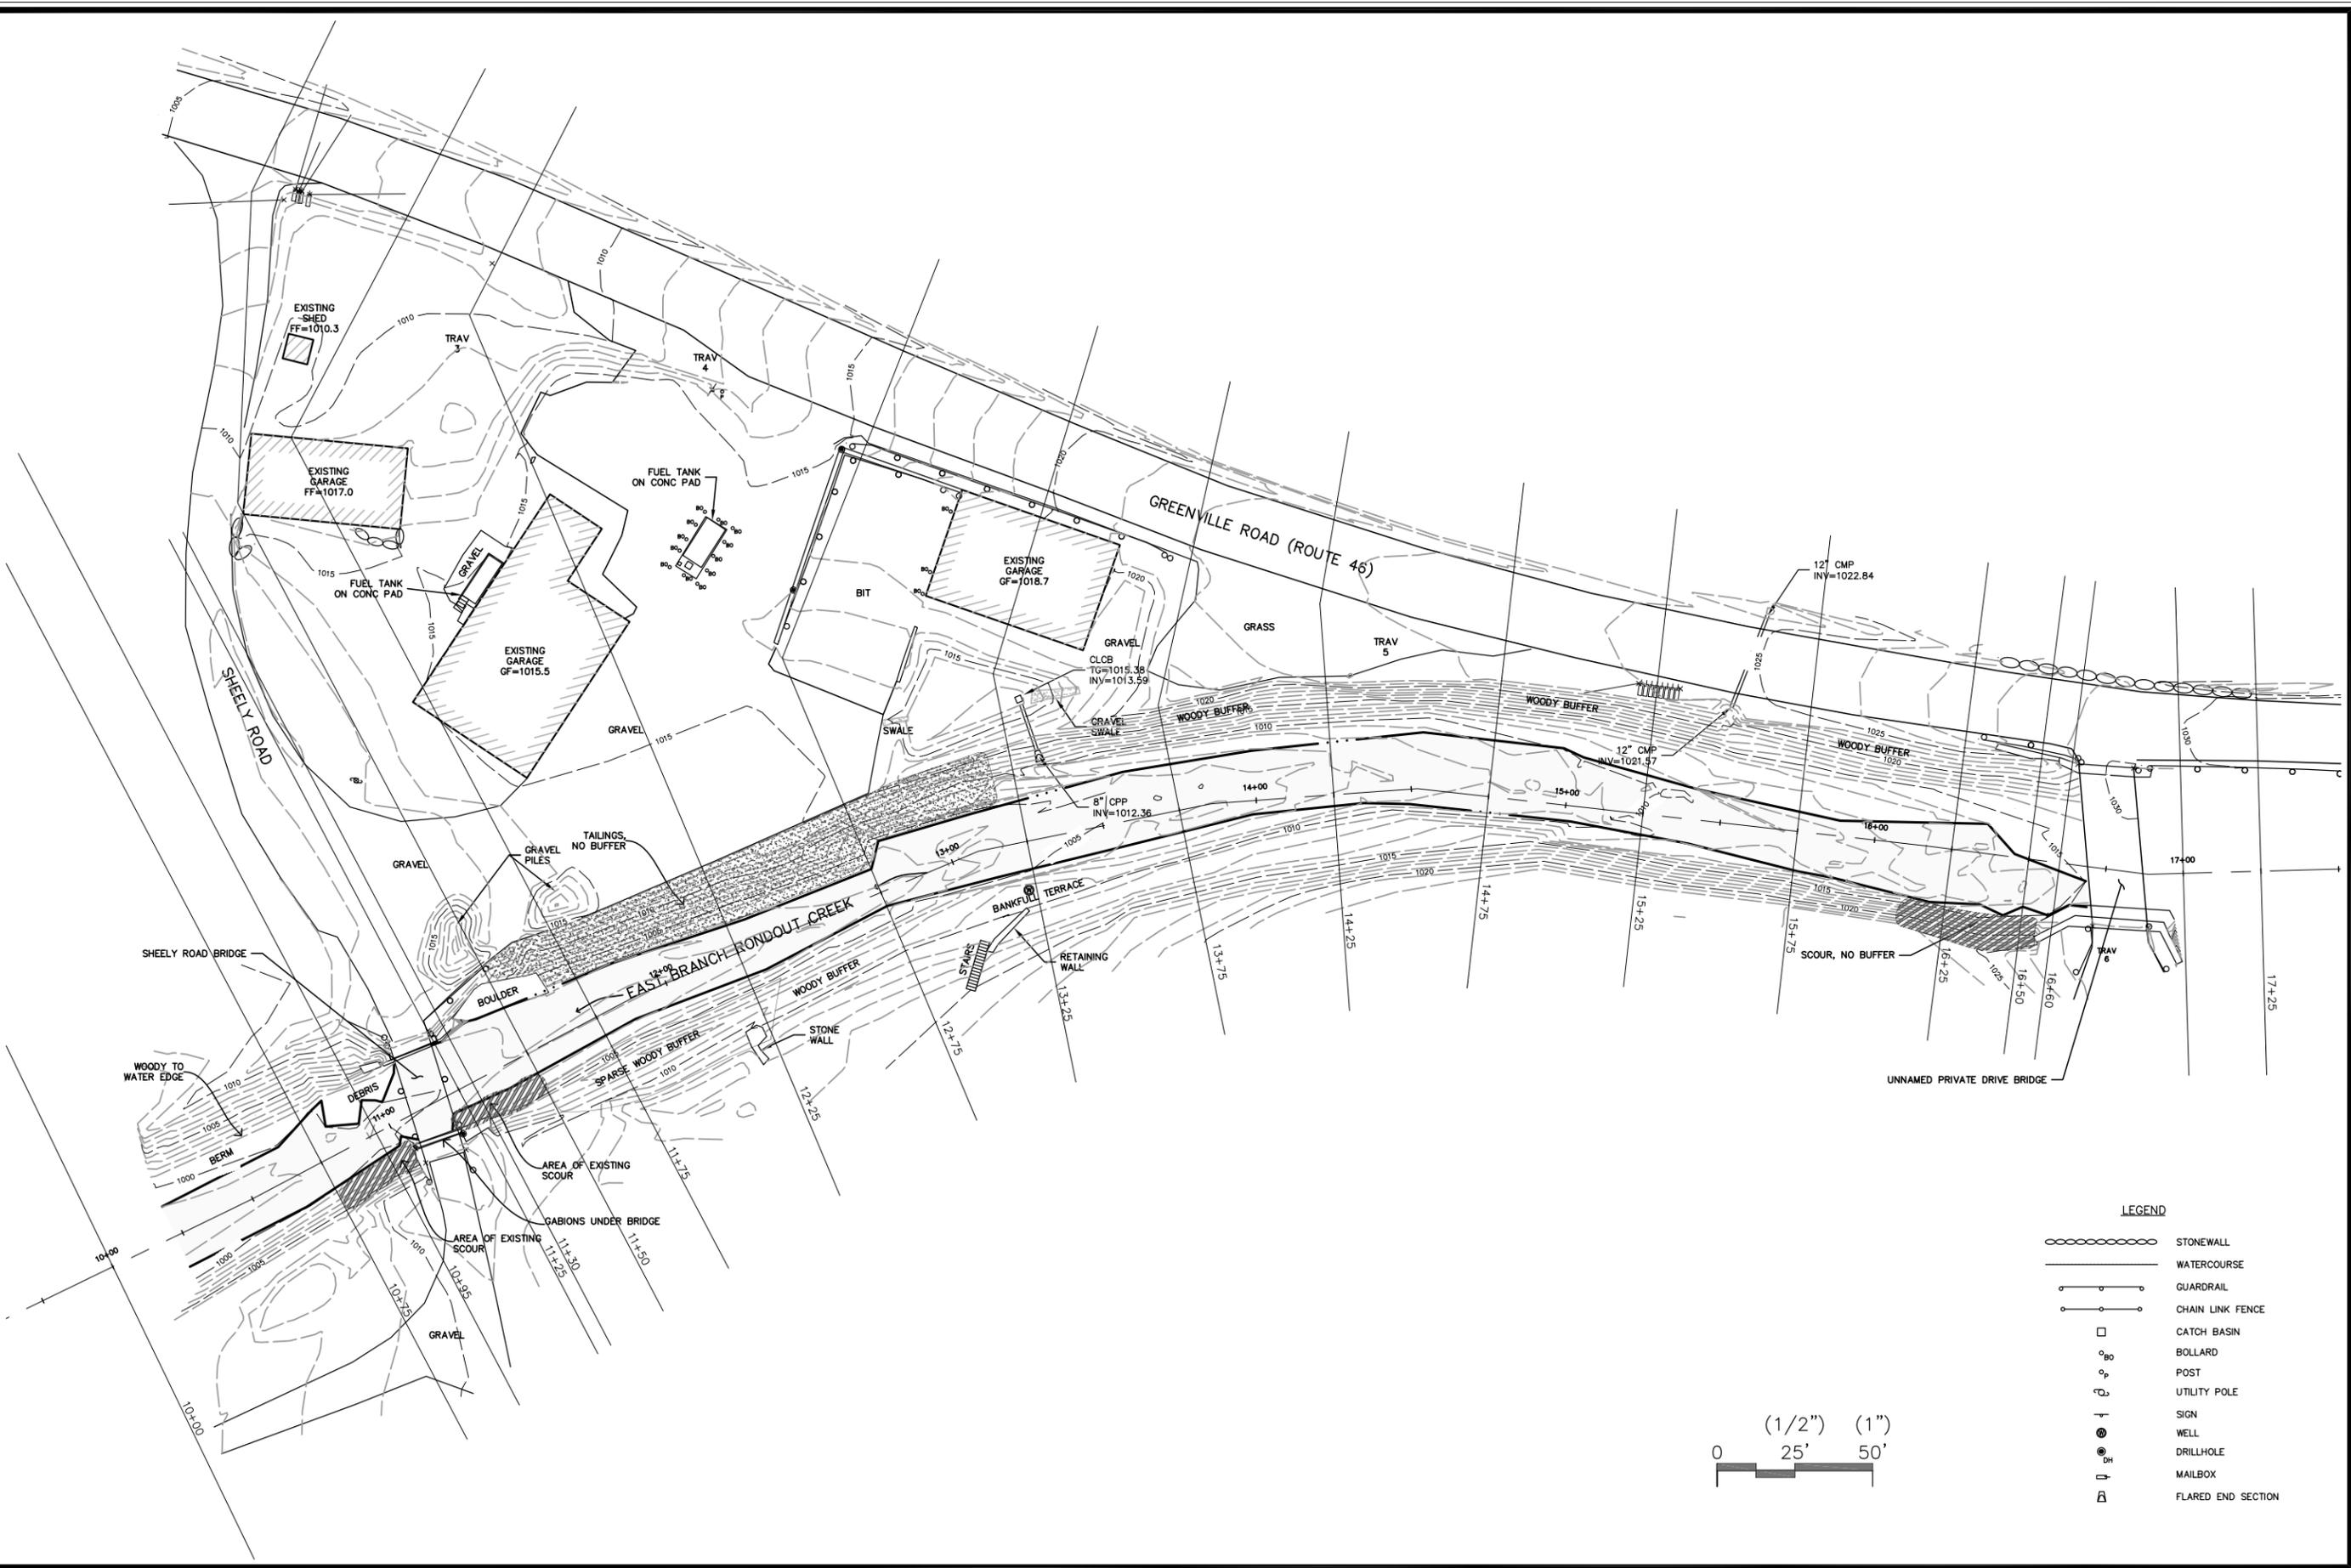
The study reach is characterized as being confined by high ground, straight alignment, and having a rocky rapids bed. The mean bed slope is 2.6%. The right bank downstream of the private drive bridge has a 2:1 slope with a sparse woody buffer extending from the bankfull height to the top of the bank. Near station 14+00, the woody buffer is replaced with fine gravel and sand deposited by surficial runoff from the eastern edge of the DPW garage staging area. From the Sheely Road Bridge to station 13+25, the right bank has a combination of stone retaining wall and placed riprap on the lower slope and gravel cover on the upper slope at the DPW garage. About 175 linear feet of the right bank has had a slope failure between station 11+50 and station 13+25 (Photo 1).

Photo 1: Bank Failure site on right bank upstream of Sheely Road Bridge.
