Schoharie Creek Management Unit 2

Town of Hunter – Dale Lane (Station 151439) to Bunny Lane (Station 148641)

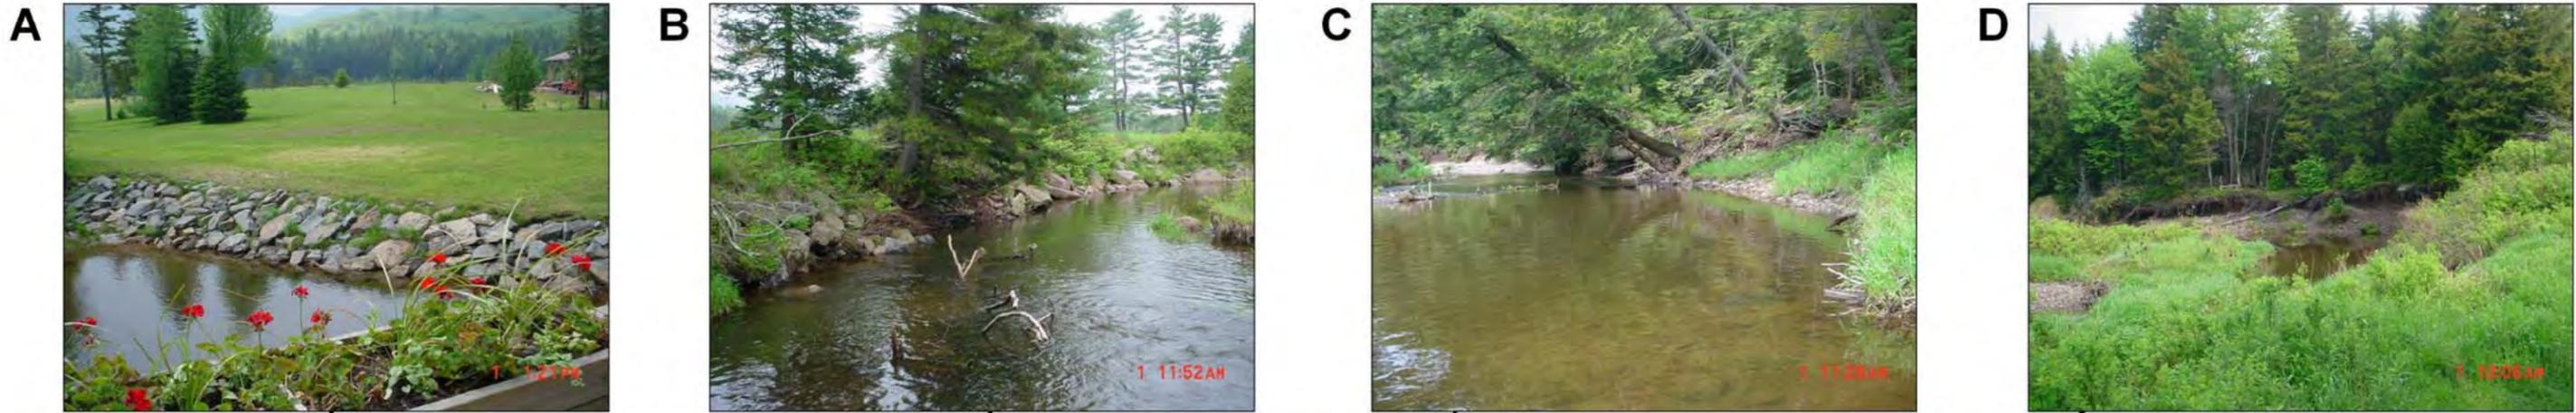
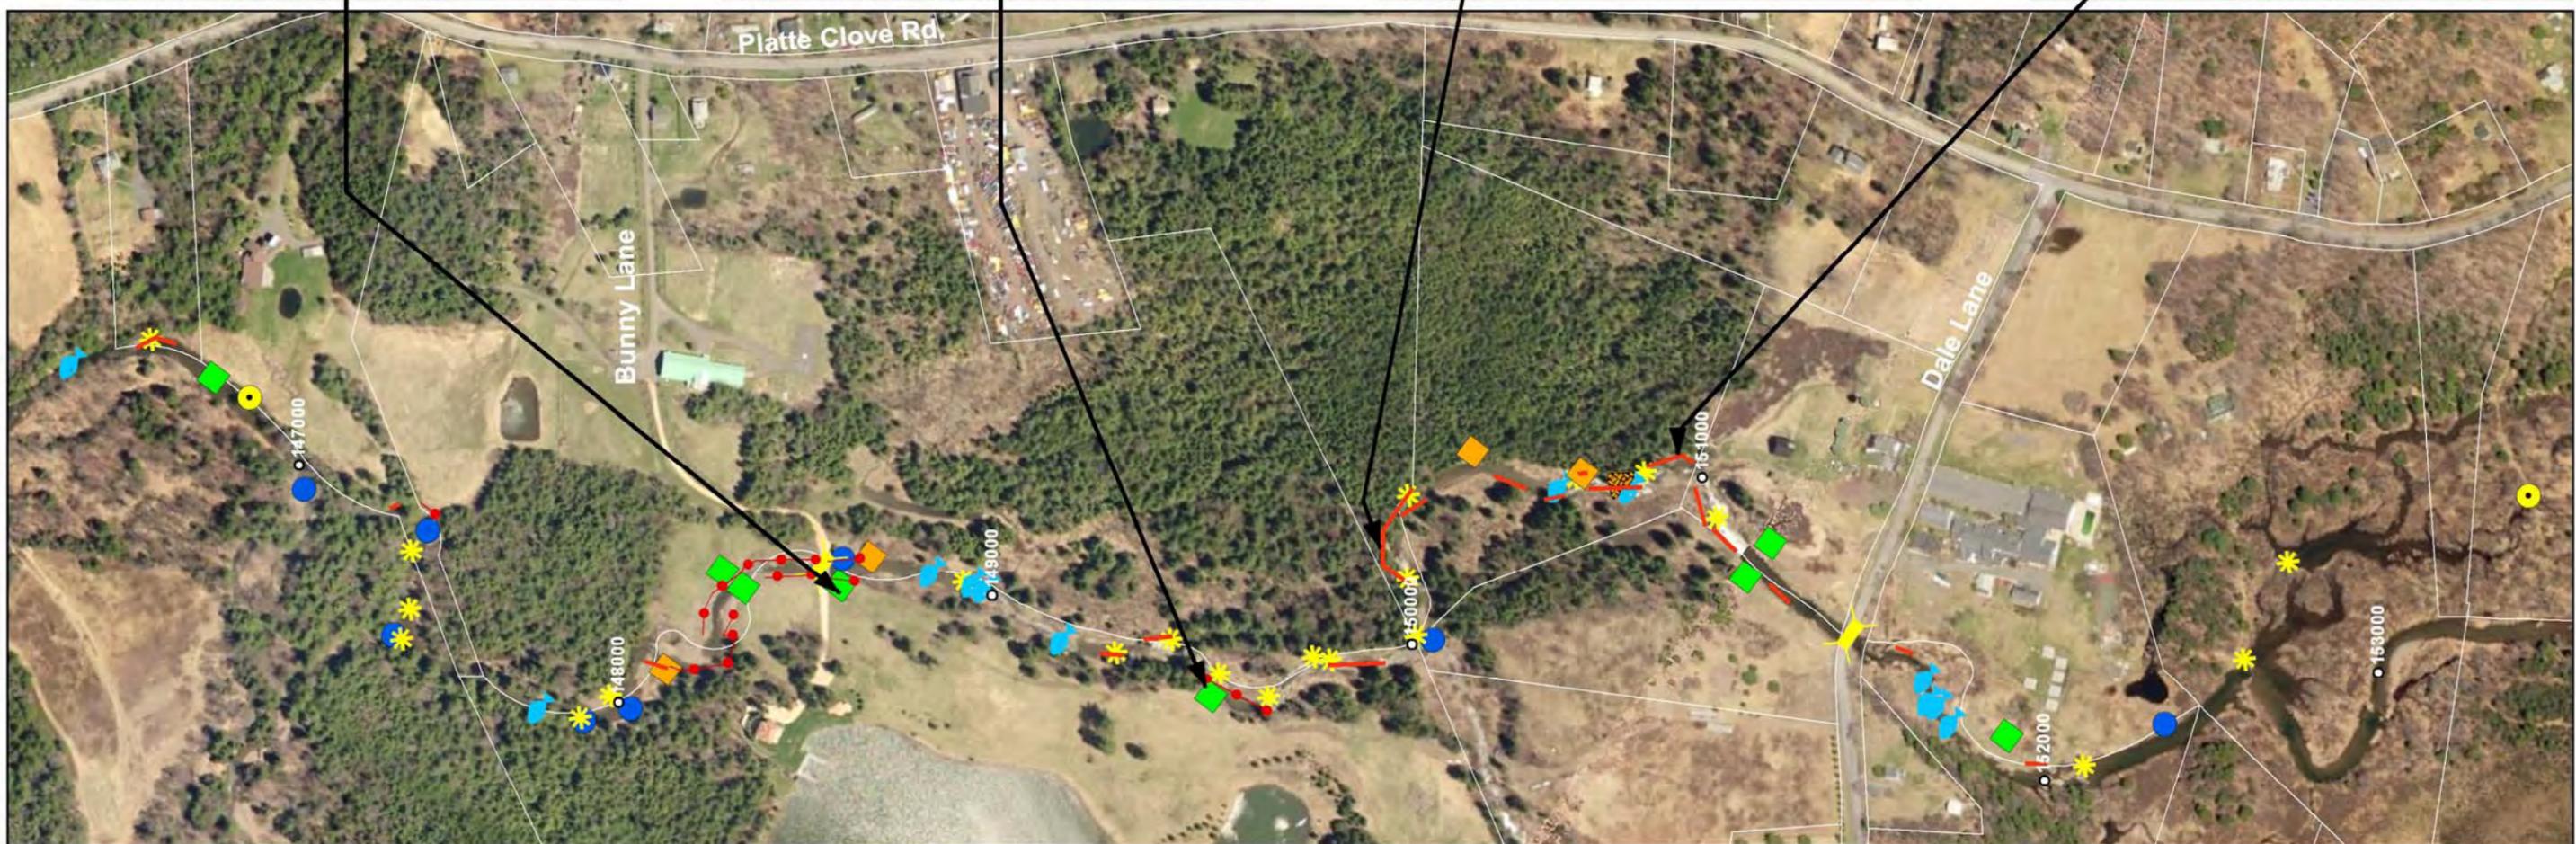
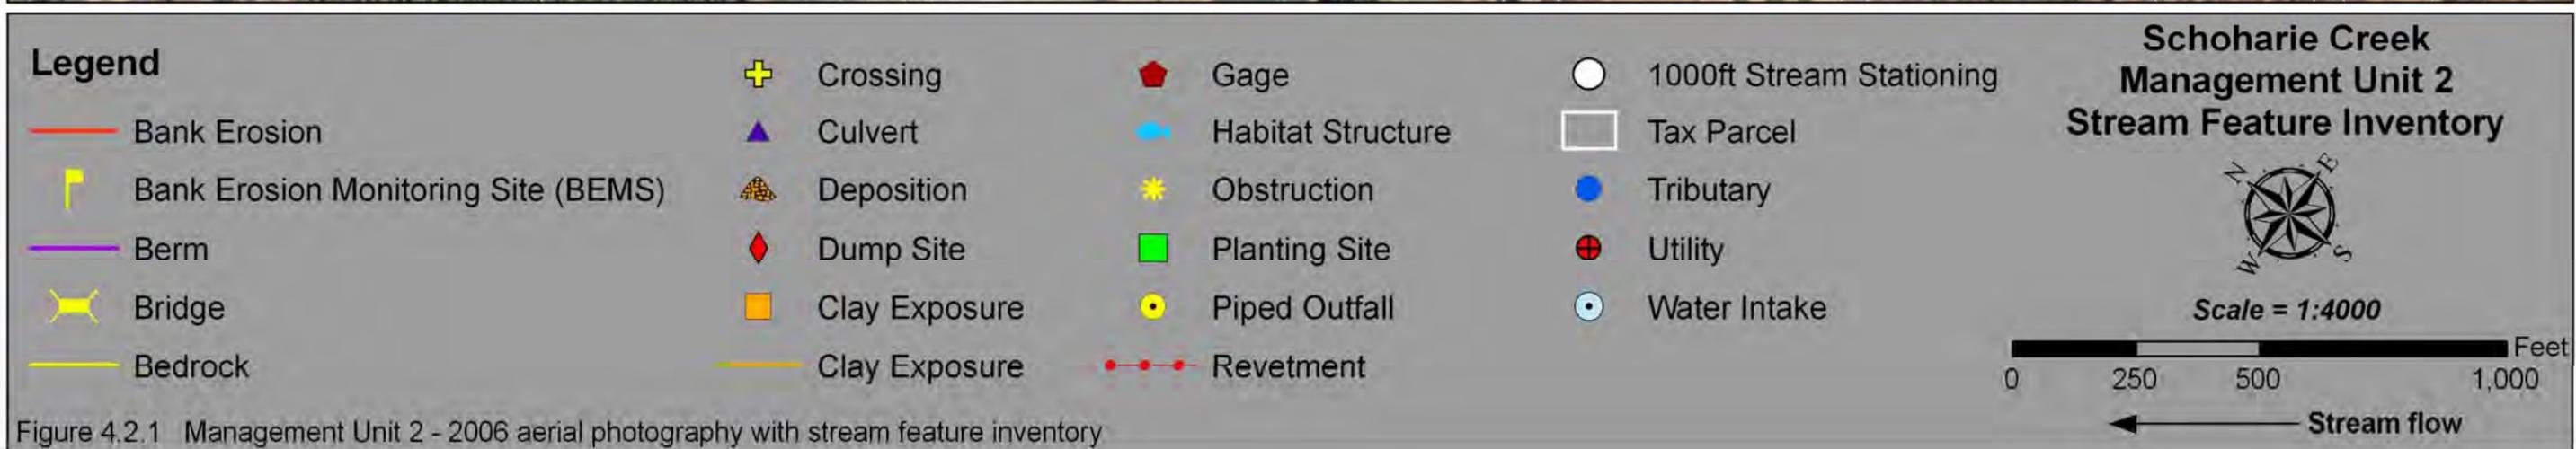
Figure 4.2.1 Management Unit 2 - 2006 aerial photography with stream feature inventory

The 2006 stream feature inventory revealed that 19.5% (1093 ft.) of the streambanks exhibited signs of active erosion along the 5,597 ft. of total channel length in the unit (Fig. 4.2.1). The total surface area of active erosion totaled approximately 6,456 ft². *Revetment*

Valley *morphology* in this management unit is unconfined with a broad glacial and *alluvial* valley flat. Generally, stream conditions in this management unit were stable. There were two significant erosional areas but the majority of the documented eroding streambanks were small and less severe. Management

As the land use on the left streambank changed from forested to residential, the buffer thinned and rip-rap was installed to protect the bank (Station 149530, Inset B). This old rip-rap was approximately 184ft in length, and while only in fair condition still provided some protection of the streambank toe. Japanese knotweed (*Fallopia japonica*) has colonized the disturbed area above the rip-rap. This was the first occurrence of Japanese knotweed on the Schoharie Creek mainstem. Knotweed is an invasive non-native species.

Downstream from this exposure, rip-rap covered both streambanks to the bridge (Inset A). This rip-rap, installed in 2004, was in good structural and functional condition. Interplanting of the rip-rap, by inserting native shrub plantings into the soil between the rocks, would strengthen and increase its longevity. These plantings would also improve the aquatic habitat by providing shade, resulting in cooler water temperatures. To provide protection against toe erosion, sedges or willows could be planted along the toe of the stream bank. The riparian areas at the top of both banks were mowed. Native trees and shrubs should be planted in this upland area. Increasing the stream buffer width will improve streambank stability and buffer functionality.

Removal of Japanese knotweed is recommended at this site because it does not provide adequate erosion protection due to its very shallow rooting system, and it grows rapidly to crowd out more beneficial streamside vegetation (See Section 2.7 Riparian Vegetation). It is also recommended to interplant native shrub and sedge species through the rip-rap and along the toe of this streambank. This planting will help to strengthen the revetment, while enhancing aquatic habitat.
