Schoharie Creek Management Unit 3

Town of Hunter – Bunny Lane (Station 148641) to Station 138610

Schoharie Creek Management Unit 3 Stream Feature Inventory

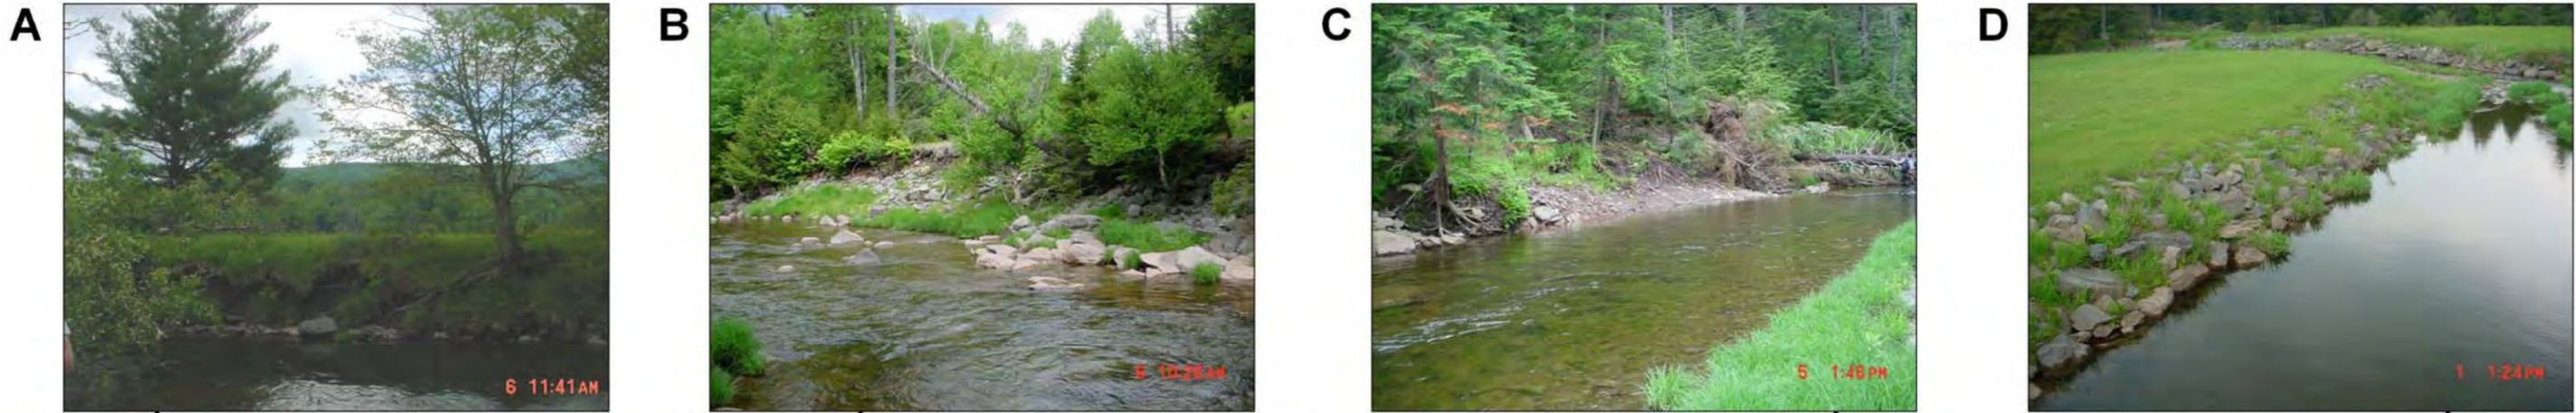
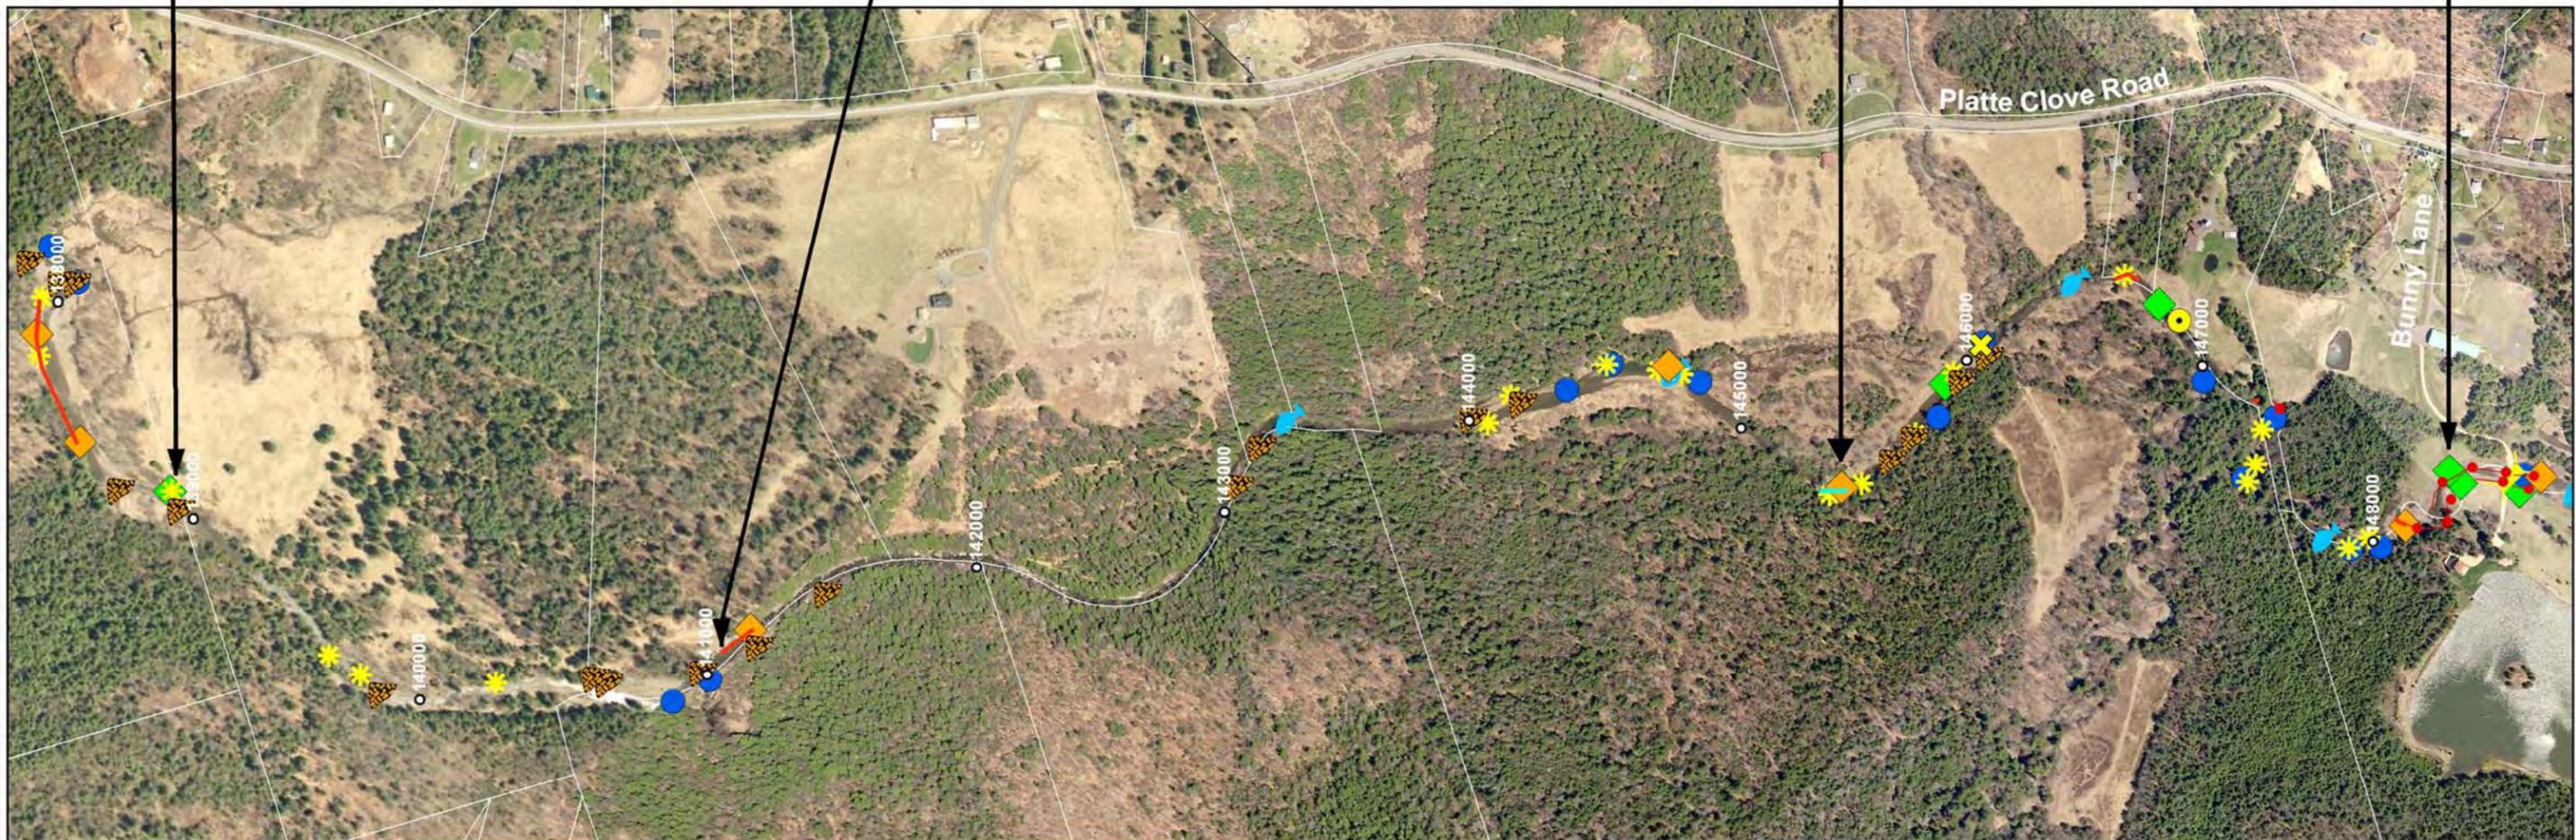
Figure 4.3.1 Management Unit 3 - 2006 aerial photography with stream feature inventory

The 2006 stream feature inventory revealed that 1.9% (378 ft.) of the streambanks exhibited signs of active erosion along 20,063 ft. of total channel length in the unit (Fig. 4.3.1). The total surface area of active erosion totaled approximately 1,757 ft². Revetment has been installed on 3.6% (728 ft.) of the streambanks. No berms were identified in this management unit at the time of the stream feature inventory.

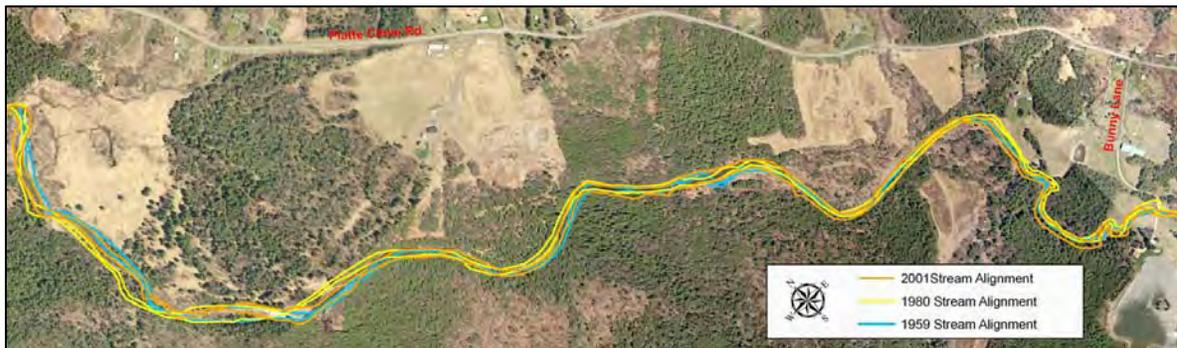
As seen from the historical stream alignments, the *planform* of the channel has remained fairly stable since 1959 (below). There were remnants of many fish habitat structures throughout this unit in various states of functionality. Due to its rural nature and headwater location in the watershed, the unit had a lot of beaver activity. While beaver impoundments can sometimes be a nuisance, beavers have historically played a beneficial and ecologically important role in the stream system. Beaver activity adds organic debris (trees, leaves, etc. which provide the base of the food chain), reduces water velocities and flood-related hazards downstream, and creates wetland areas that filter sediment and release water to the stream and groundwater slowly throughout the year.

Historic stream channel alignments overlaid with 2006 aerial photograph
