Schoharie Creek Management Unit 9

Town of Jewett – Carr Road Bridge (Station 83957) to County Route 17 (Station 70652)

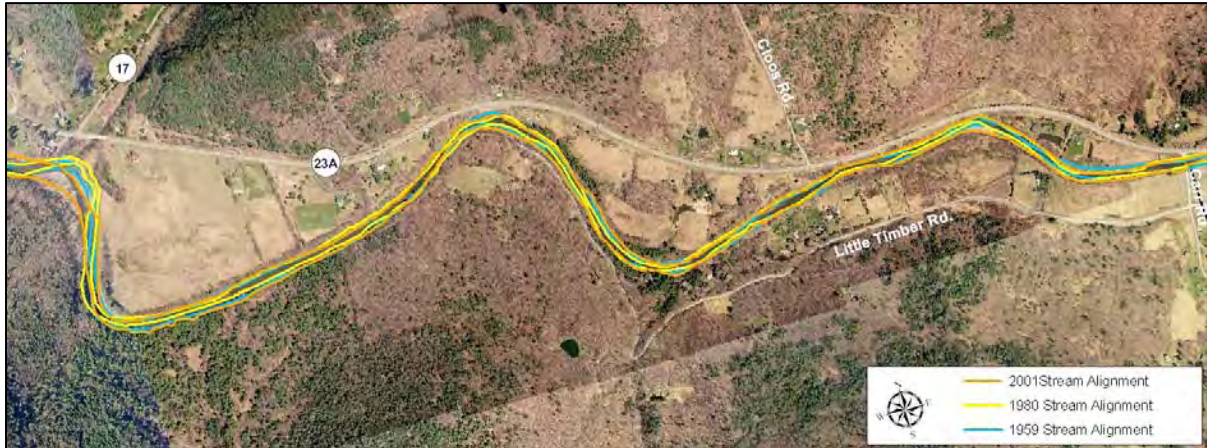
As seen from the historical stream alignments (below), the *planform* of the channel has remained fairly stable since 1959.

Historic stream channel alignments overlaid with 2006 aerial photograph

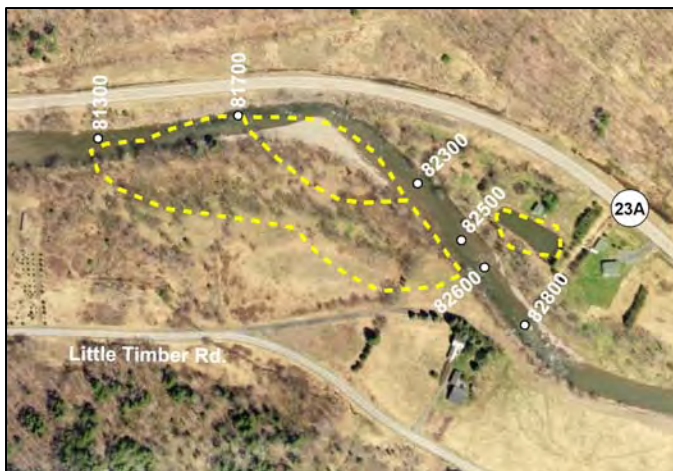
Wetlands (Station 82800-82500 & 82600-81300 & 82300-81700) Approximate wetland boundary delineated by NWI

There were three wetlands in this vicinity. On the right streambank was a 0.4 acre impounded palustrine wetland (PUBFh, Station 82800-82500). On the left streambank was a large 4.7 acres palustrine forested wetland (PFO1A, Station 82600-81300) along with a 1.4 acre riverine lower perennial wetland (R2USA, Station 82300-81700) (see Section 2.6 for detailed wetland type descriptions).

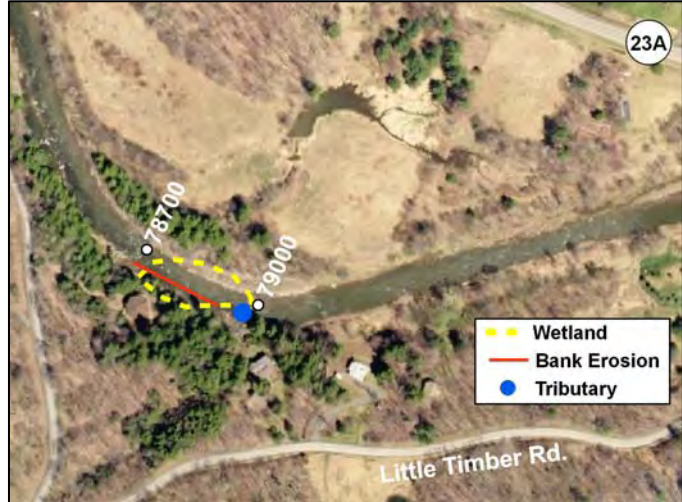
As the stream *meandered* downstream a 0.5 acre riverine, upper perennial, seasonally flooded wetland was located within the stream channel (R2USC, Station 79000-78700). Near the upstream end of this wetland an unnamed tributary entered the Schoharie Creek from the left streambank (Station 78965). This tributary drained the steep slopes of Evergreen Mountain, before it reached the flatter topography of the valley floor where it entered the Schoharie Creek. As a result of this stream slope change, the tributary lost its ability to transport sediment gathered from the mountain slopes, and began to deposit sediment at its mouth and into the more gently sloped Schoharie Creek. This is a common feature of confluence areas, which often contain extensive sediment bars, function as important sediment storage areas, and are typically among the most dynamic and changeable areas in the stream system. This tributary was classified C by the NYSDEC (NYSDEC, 1994).

*Wetland (Station 79000-78700)
Approximate wetland boundary delineated by NWI*

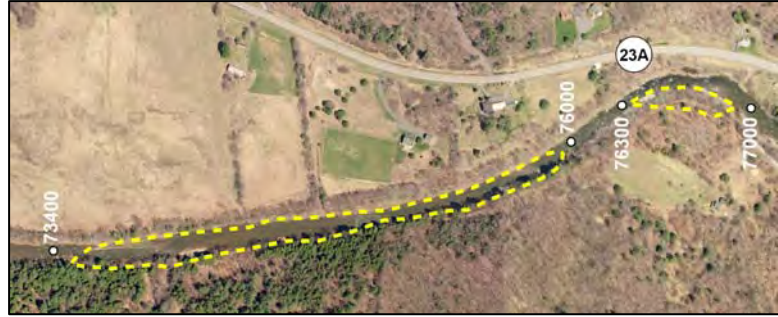
There was a 0.9 acre riverine, upper perennial, seasonally flooded wetland located along the left streambank (R2USC, Station 77000-76300). A larger 5.4 acre riverine, upper perennial, permanently flood wetland was located within the stream channel downstream (R2UBH, Station 76000-73400).

Wetland (Station 7700-76300 & 76000-73400)
Approximate wetland boundary delineated by NWI

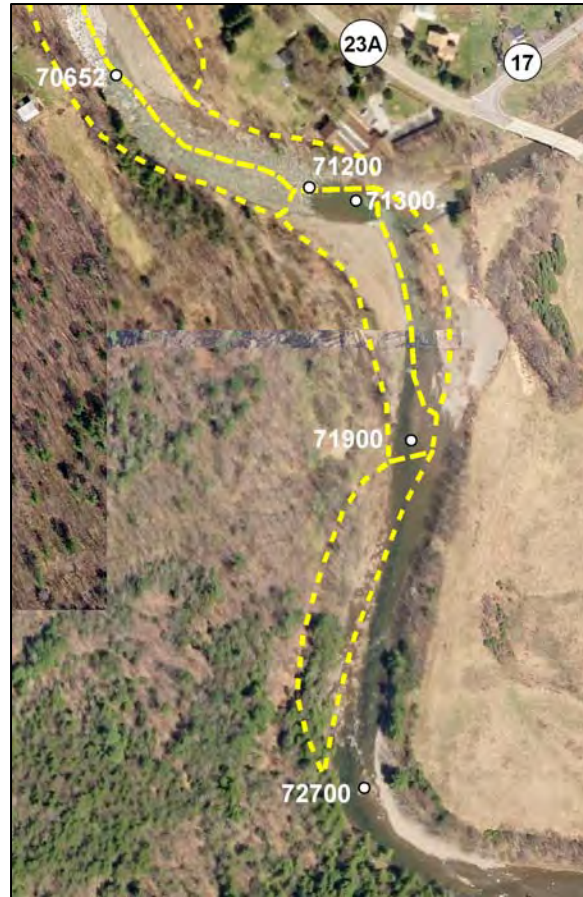
The downstream end of this management unit was dominated by wetlands including four riverine, upper perennial wetlands, totaling 5 acres (R2USC, Station 72700-71900) (R2USC, Station 71900-71300) (R2USC, R2UBH, Station 71200-70652). A 1.7 acre palustrine, forested wetland was located along the left streambank (PFO1A, Station 71900-71200).

*Wetlands at downstream end of management unit
Approximate wetland boundary delineated by NWI*

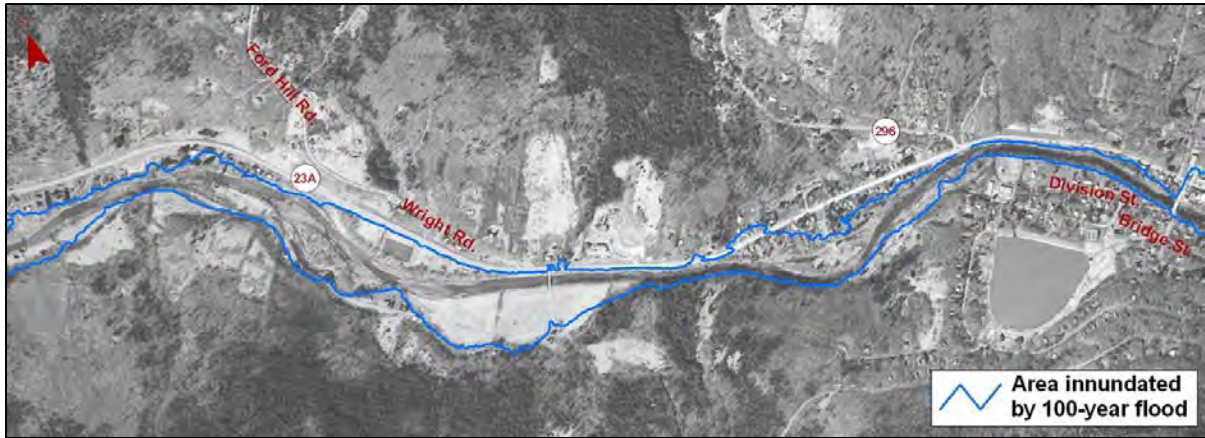
100-year floodplain boundary map

According to the current floodplain maps (below), fourteen existing structures in this unit appeared to be situated within the estimated 100-year floodplain. The 100-year floodplain is that area predicted to be inundated by floods of a magnitude that is expected to occur once in any 100-year period, on the basis of a statistical analysis of local flood record. Most communities regulate the type of development that can occur in areas subject to these flood risks.
