# Schoharie Creek Management Unit 11

Town of Lexington – Bush Road Bridge (Station 63446) to County Route 42 Bridge (Station 55350)

Figure 4.11.1 Management Unit 11 - 2006 aerial photography with stream feature inventory

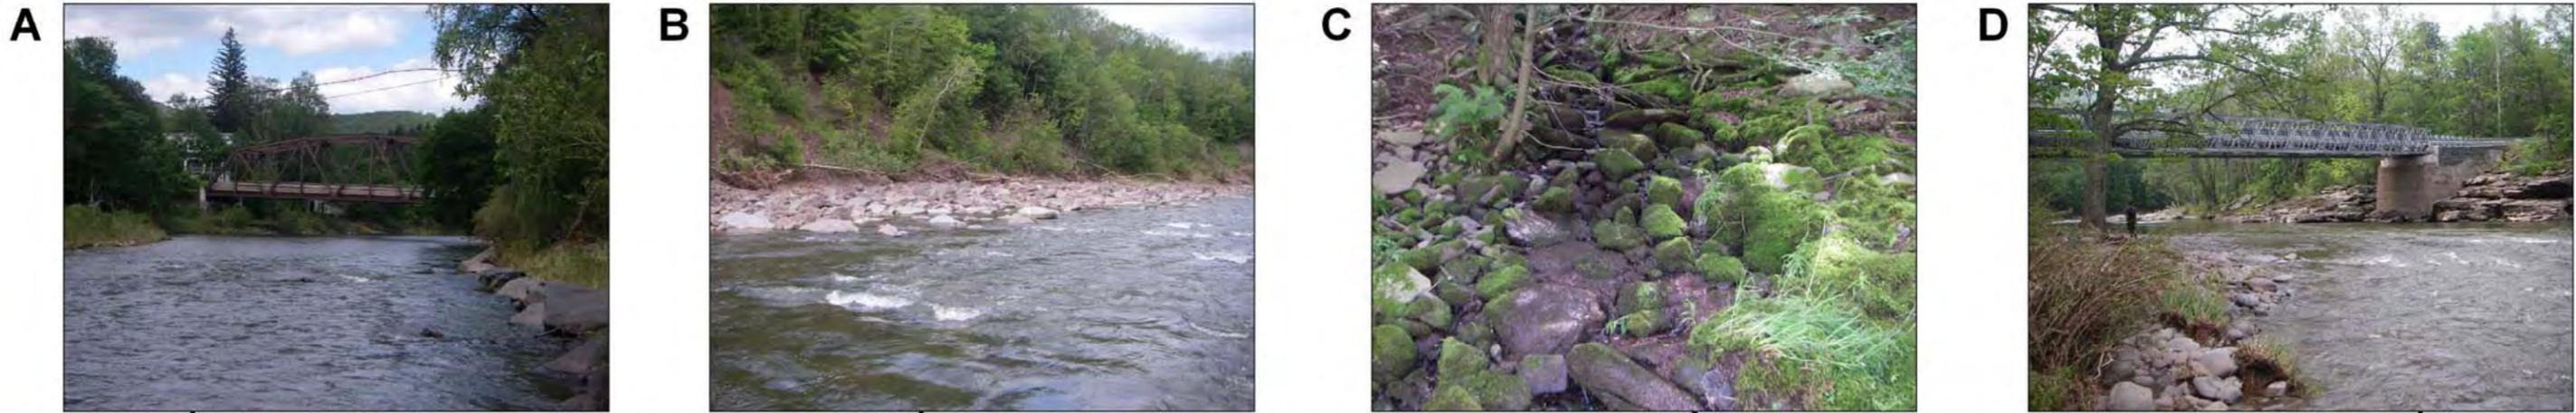
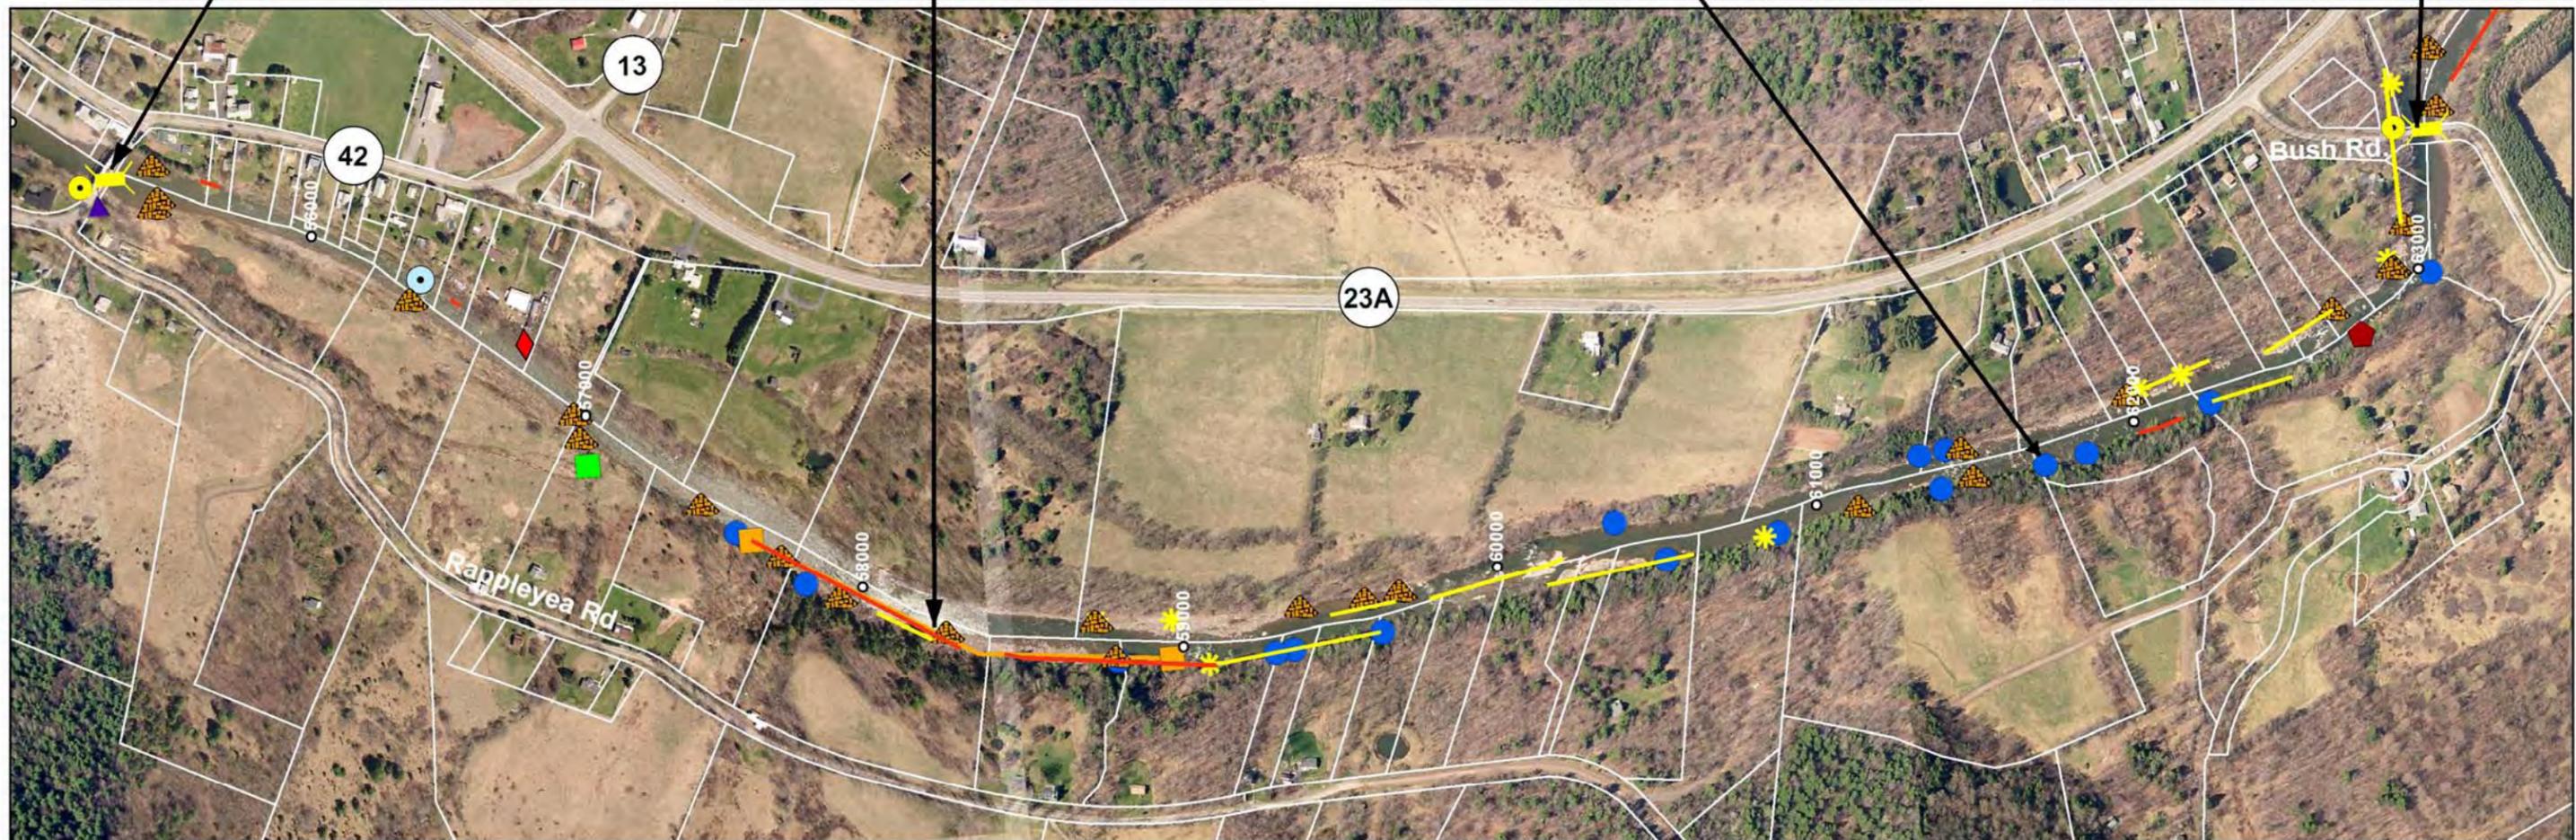
The 2006 stream feature inventory revealed that 9.9% (1,602 ft) of the streambanks exhibited signs of active erosion along the 16,192 ft of total channel length in the unit (Figure 4.11.1). The total surface area of active erosion totaled approximately 77,340 ft<sup>2</sup>. *Revetment* had been installed on 9.9% (1,609 ft) of the streambanks. No *berms* were identified in this management unit at the time of the stream feature inventory.

The *thalweg*, or deepest part of the stream channel, flowed up against the left streambank causing the first significant bank erosion in the management unit (Inset D, Station 62100). This *mass failure* had resulted in an erosion area of approximately 11,248 ft<sup>2</sup>, exposing areas of mixed till as well as compromising mature trees at the top of the bank. Streambank erosion often occurs on the outside of meander bends where the stream velocity is greatest during high flows.

At the next downstream meander bend there was another erosion site (Inset B, Station 59100). The hillslope was undermined by toe erosion, resulting in the mass wasting of a 65,306 ft<sup>2</sup> area along 1,363 ft of the bank. This erosion had left the face of the streambank unvegetated. Throughout the bank *lacustrine clay* deposits were exposed. Clay inputs into a stream are a serious water quality concern because they increase *turbidity*, degrade fish habitat, and can act as a carrier for other pollutants and pathogens. This bank may introduce significant amounts of suspended sediment and woody debris during rainfall events. While woody debris is valued as a feature of good fish habitat, in some instances it can present a threat to infrastructure. This site may stabilize on its own over time. It appeared a low bench may have started to develop at the toe of the eroding bank which may act to reduce flood water velocities near the bank. A bank erosion monitoring site (BEMS) could be installed along this bank to study this bank's erosion rate and document its potential recovery. In-depth survey and design would be necessary to effectively restore this erosion site.

Downstream, aggradation or a raising of the streambed due to the deposition of sediment that cannot be moved by the shallower flows at these greater stream widths was noted (Station 57000). This aggradation also steepened the stream channel gradient downstream of the deposition site by raising the elevation of the channel.

Further downstream, an old dumpsite containing an old truck and metal debris was observed on the right streambank (Station 56700). Removal of the trash is recommended to avoid its introduction into the stream.

Summary of Recommendations Management Unit 11	
Intervention Level	Preservation, Passive, Assisted Self-Recovery
Stream Morphology	No recommendations at this time
Riparian Vegetation	Enhancement of riparian buffer at Station 57100.
Infrastructure	No recommendations at this time
Aquatic Habitat	Watershed Aquatic Habitat Study
Flood Related Threats	No recommendations at this time
Water Quality	Removal of dump site at Station 56700.
Further Assessment	Installation of bank erosion monitoring site at Station 59100.

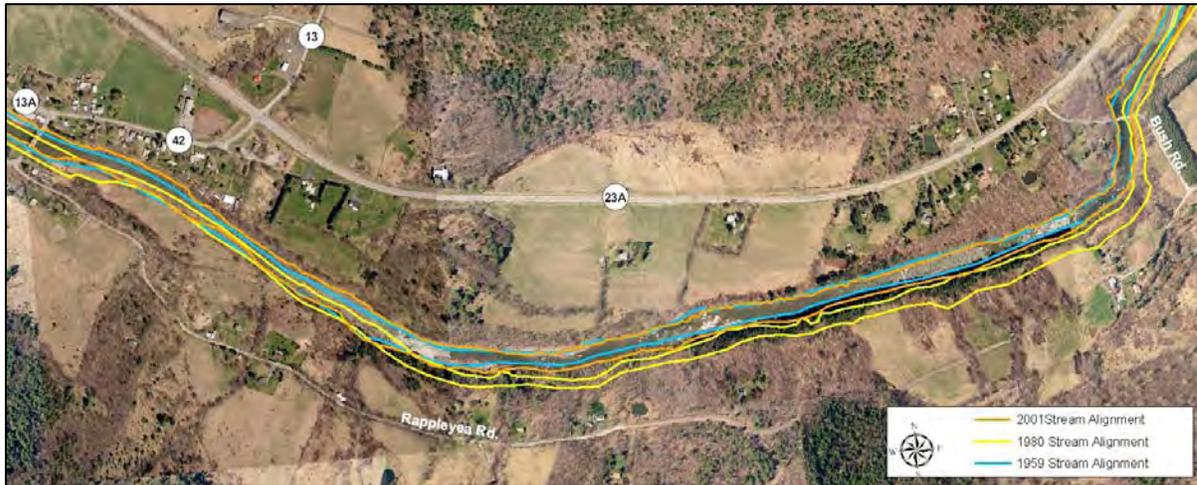
As seen from the historical stream alignments (below), the *planform* of the channel has remained fairly stable since 1959. As of 2006, according to available NYS DEC records dating back to 1996, there had been no stream disturbance permits issued in this management unit.

*Historic stream channel alignments overlaid with 2006 aerial photograph*
