Schoharie Creek Management Unit 13

Town of Lexington – Station 48154 to Mosquito Point Bridge (Station 41722)

Figure 4.13.1 Management Unit 13 - 2006 aerial photography with stream feature inventory

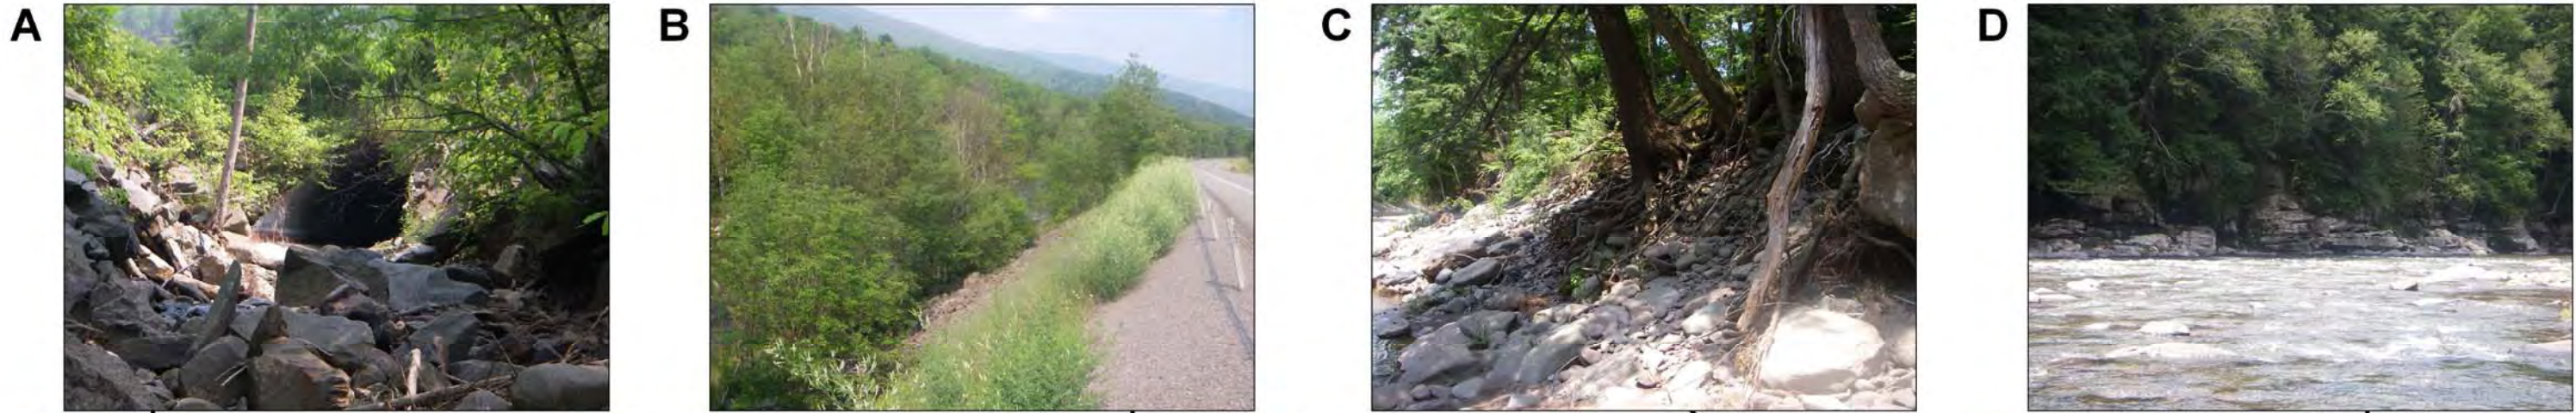
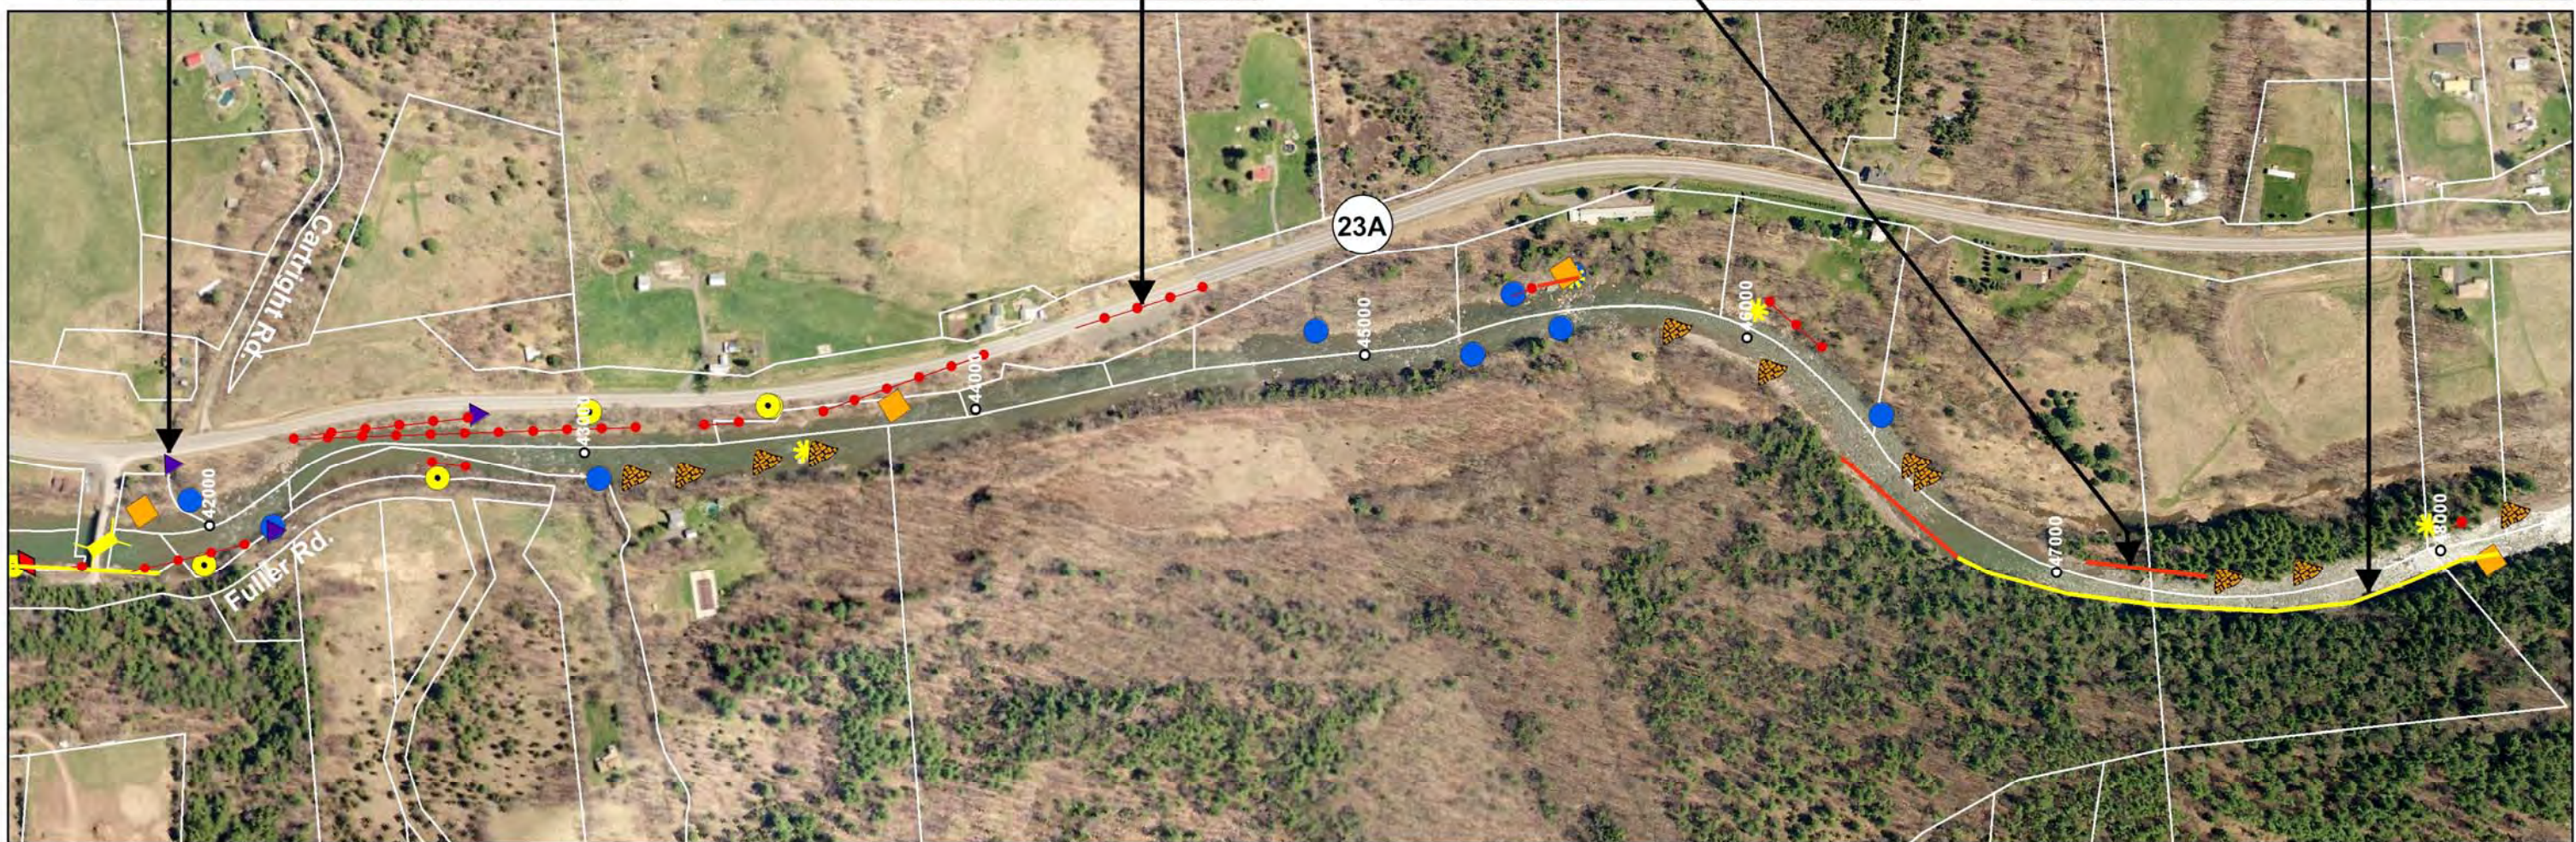
The 2006 stream feature inventory revealed that 6.3% (806 ft) of the streambanks exhibited signs of active erosion along the 12,864 ft of total channel length in the unit (Figure 4.13.1). The total surface area of active erosion totaled approximately 33,005 ft². *Revetment* had been installed on 22.1% (2,844 ft) of the streambanks. No *berms* were identified in this management unit at the time of the stream feature inventory.

Valley *morphology* of this management unit was generally confined by valley form and the County Route 23A embankment in the downstream half of the management unit. Generally, stream conditions in this management unit were stable, with the exception of three erosional areas. Management efforts in this unit should focus on addressing improving bank stability and aquatic habitat through riparian zone plantings.

Summary of Recommendations Management Unit 13	
Intervention Level	Passive, Assisted Self-Recovery
Stream Morphology	No recommendations at this time
Riparian Vegetation	Interplanting of rip-rap at Station 43800 & 42050
Infrastructure	No recommendations at this time
Aquatic Habitat	Watershed Aquatic Habitat Study
Flood Related Threats	No recommendations at this time
Water Quality	No recommendations at this time
Further Assessment	No recommendations at this time

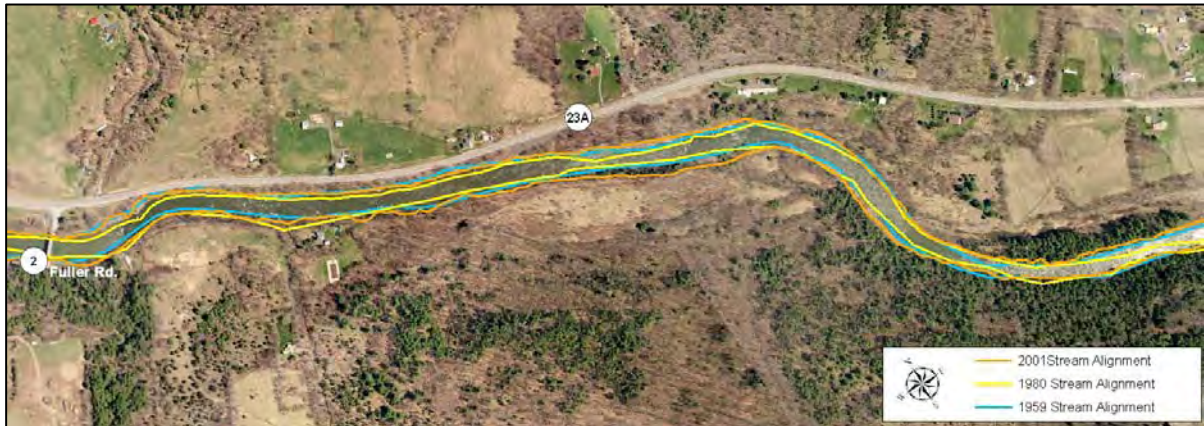
Historic stream channel alignments overlaid with 2006 aerial photograph

As seen from the historical stream alignments (below), the *planform* of the channel has remained fairly stable since 1959. As of 2006, according to available NYSDEC records dating back to 1996, there had been no stream disturbance permits issued in this management unit.

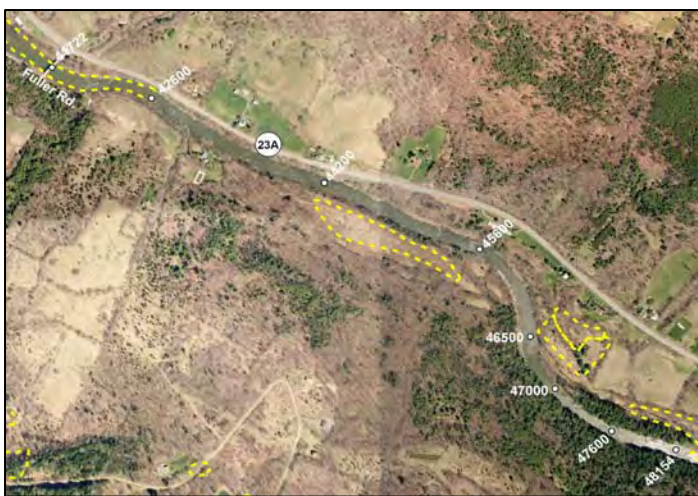
Wetlands (Stations 48154-41722)
approximate wetland boundary delineated by NWI

Five wetlands were located within this management unit. Continued from the previous unit, there was a palustrine wetland with shrub-scrub vegetation along the right streambank at the beginning of the unit (PSS1E, 1.1 ac, Station 48154-47600). Just downstream, two palustrine wetlands were located along the right streambank, one was dominated by shrub-scrub vegetation

while the other emergent vegetation (PSS1E, 2.6ac, PEM1E, 1.5ac, Station 47000-46500). A fourth palustrine shrub-scrub wetland was located along the left streambank (PSS1E, 4.5ac, Station 45600-44200). The wetland at the downstream end of the unit was classified as riverine lower perennial, signifying it was contained in the natural channel and characterized by a low gradient and slow water velocity (R2UBH, 2.2ac Station 42600-41722). Wetlands are important features in the landscape that provide numerous beneficial functions including protecting and improving water quality, providing fish and wildlife habitats, storing floodwaters, and maintaining surface water flow during dry periods (see Section 2.6 for detailed wetland type descriptions).

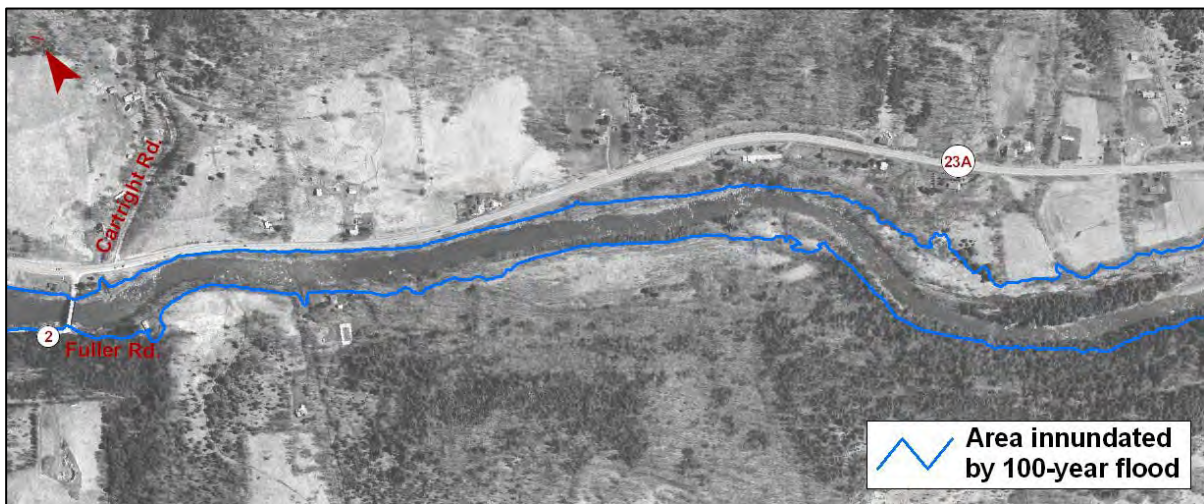
100-year floodplain boundary map

According to the current floodplain maps (above), no existing structures in this unit appeared to be situated within the estimated 100-year floodplain. The 100-year floodplain is that area predicted to be inundated by floods of a magnitude that is expected to occur once in any 100-year period, on the basis of a statistical analysis of local flood records. Most
