Schoharie Creek Management Unit 14

Town of Lexington – Mosquito Point Bridge (Station 41722) to Station 34336

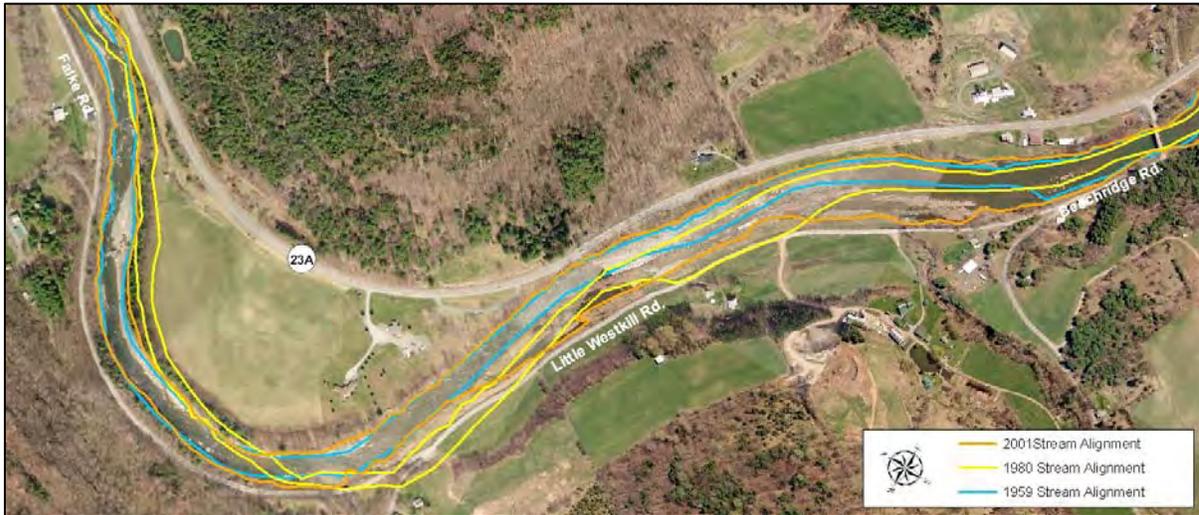
As seen from the historical stream alignments (below), the *planform* of the channel has remained fairly stable since 1959. As of 2006, according to available NYSDEC records dating back to 1996, there have been no stream disturbance permit issued in this management unit.

Historic stream channel alignments overlaid with 2006 aerial photograph

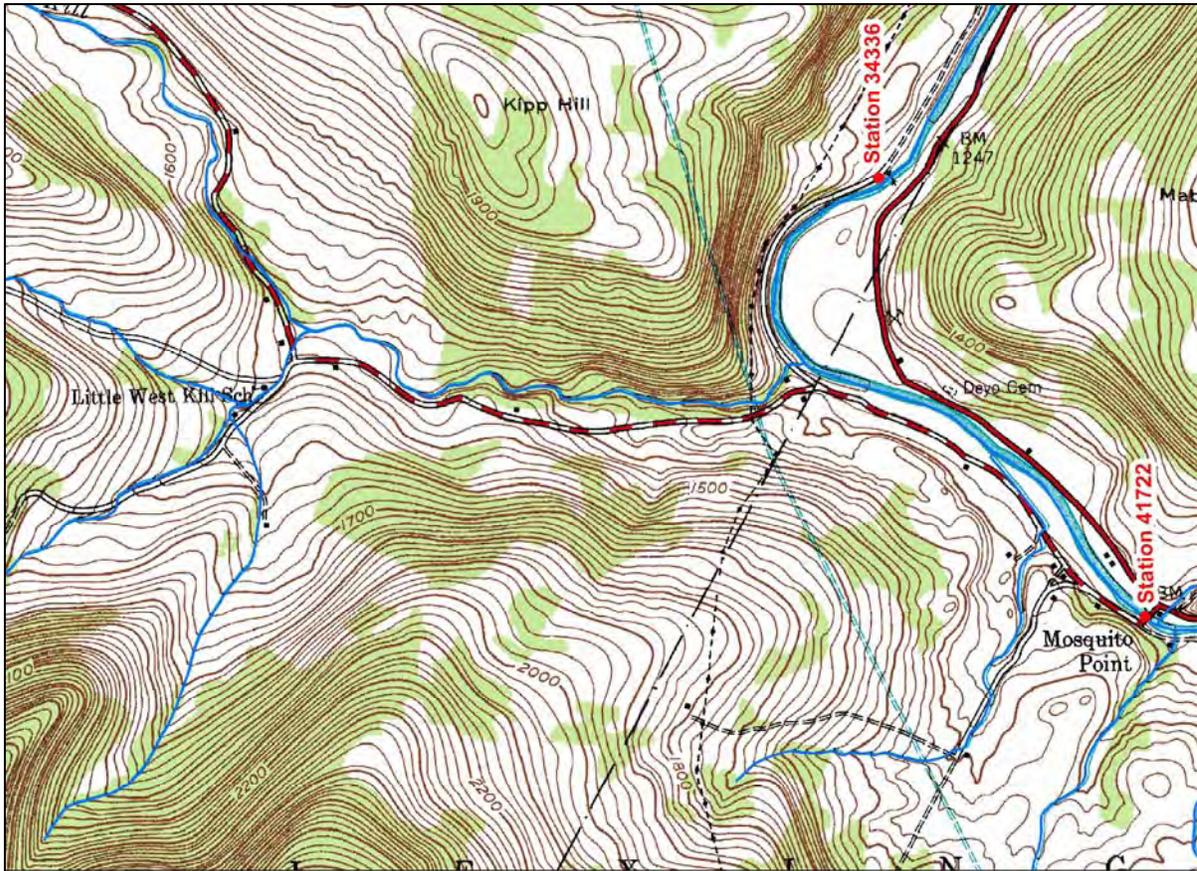
1980 USGS topographic map - Prattsville Quadrangle contour interval 20ft

Valley *morphology* of this management unit was generally confined by valley form, infrastructure and encroachment. Little West Kill Road, which runs along the left streambank, has suffered repetitive flood damage due to its location within the 100-year floodplain (Station 41722-36900). Generally, stream conditions in this management unit were stable, with the exception of four erosional areas which could be addressed with vegetative treatments and bioengineered bank stabilization. Management efforts in this unit

should focus on addressing Little West Kill Road flooding issues and enhancement of riparian vegetation at recommended sites.

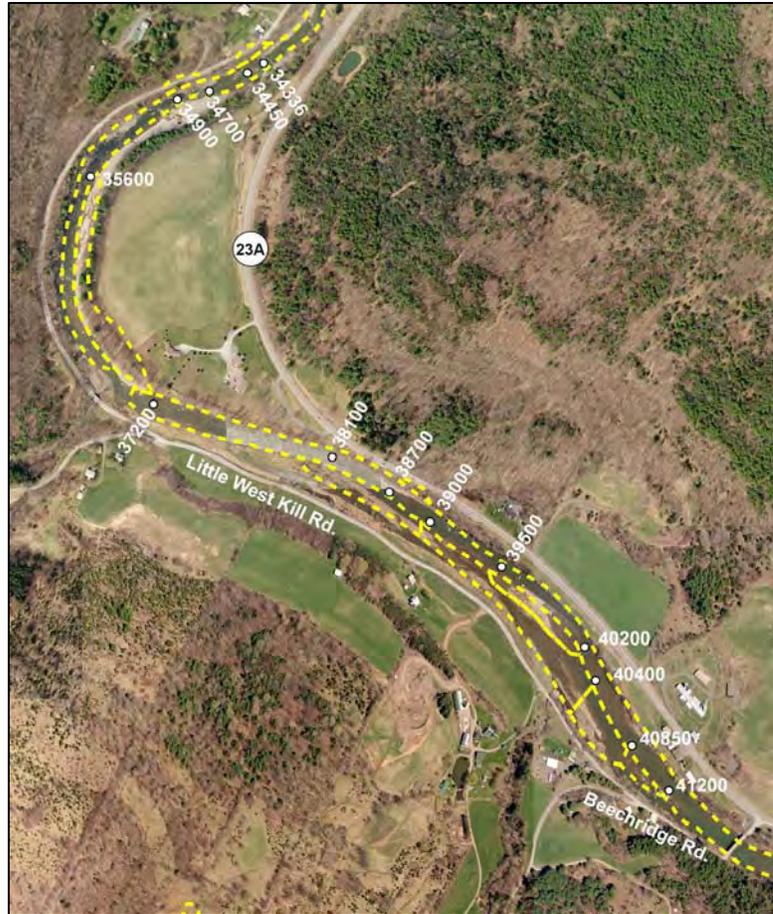
Ten wetlands were located within this management unit. Three wetlands, along the stream channel were classified as riverine lower perennial, signifying they were contained in the natural channel and characterized by a low gradient and slow water velocity (R2UBH, 18.5ac Station 41722-34336) (R2USC, 1.1ac Station 40200-39500) (R2USA, 0.2ac Station 39000-38700). The remaining wetlands were classified as palustrine; five had emergent vegetation (PEM1E, 0.5ac, Station 41200-40850) (PEM1C, 3.9ac, Station 40400-

*Wetlands (Station 41722-34336)
approximate wetland boundary delineated by NWI*

39000) (PEM1E, 3.3ac, Station 37200-35600) (PEM1E, 0.3ac, Station 34900-34700) (PEM1E, 0.3ac, Station 34450-34336), one along the left streambank at the upstream end of the unit was dominated by shrub-scrub vegetation (PSS1C, 1.7ac, Station 40850-40400), and one along the left streambank in the middle of the unit was forested (PFO1A, 1.7ac, Station 39000-38100). Wetlands are important features in the landscape that provide numerous beneficial functions including protecting and improving water quality, providing fish and wildlife habitats, storing floodwaters, and maintaining surface water flow during dry periods (see Section 2.6 for detailed wetland type descriptions).

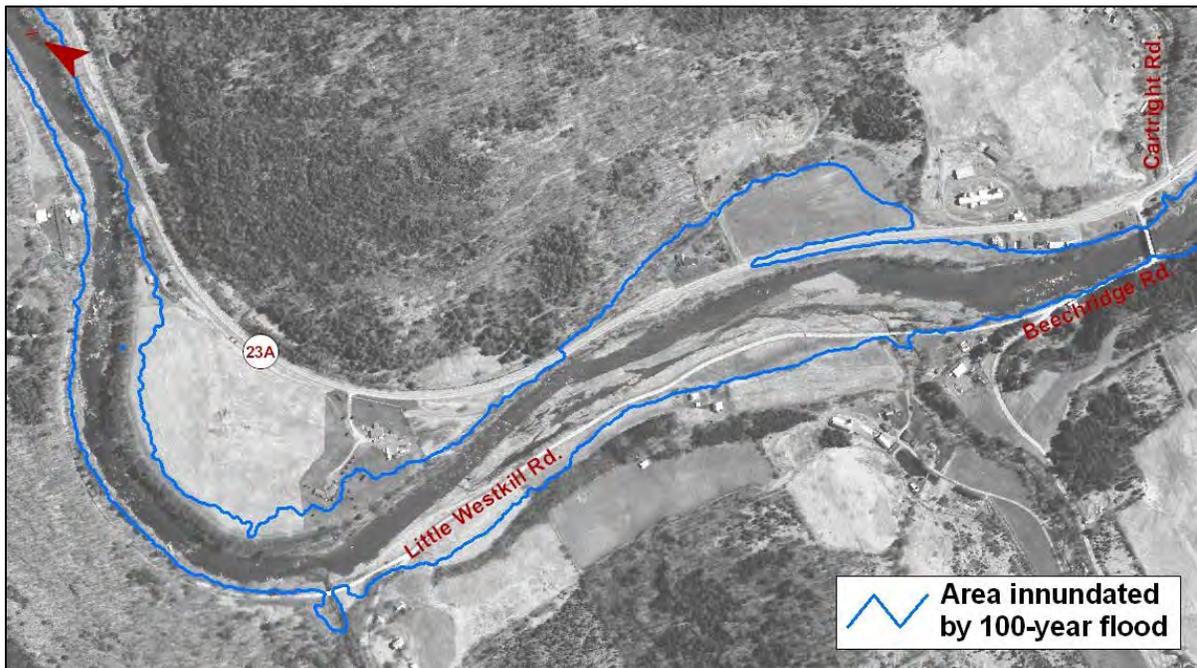
According to the current floodplain maps (below), three existing structures in this unit appeared to be situated within the estimated 100-year floodplain. The 100-year floodplain is

100-year floodplain boundary map
