Schoharie Creek Management Unit 16

Town of Prattsville – Station 31388 to County Route 23 (Station 19376)

Schoharie Creek Management Unit 16 Stream Feature Inventory

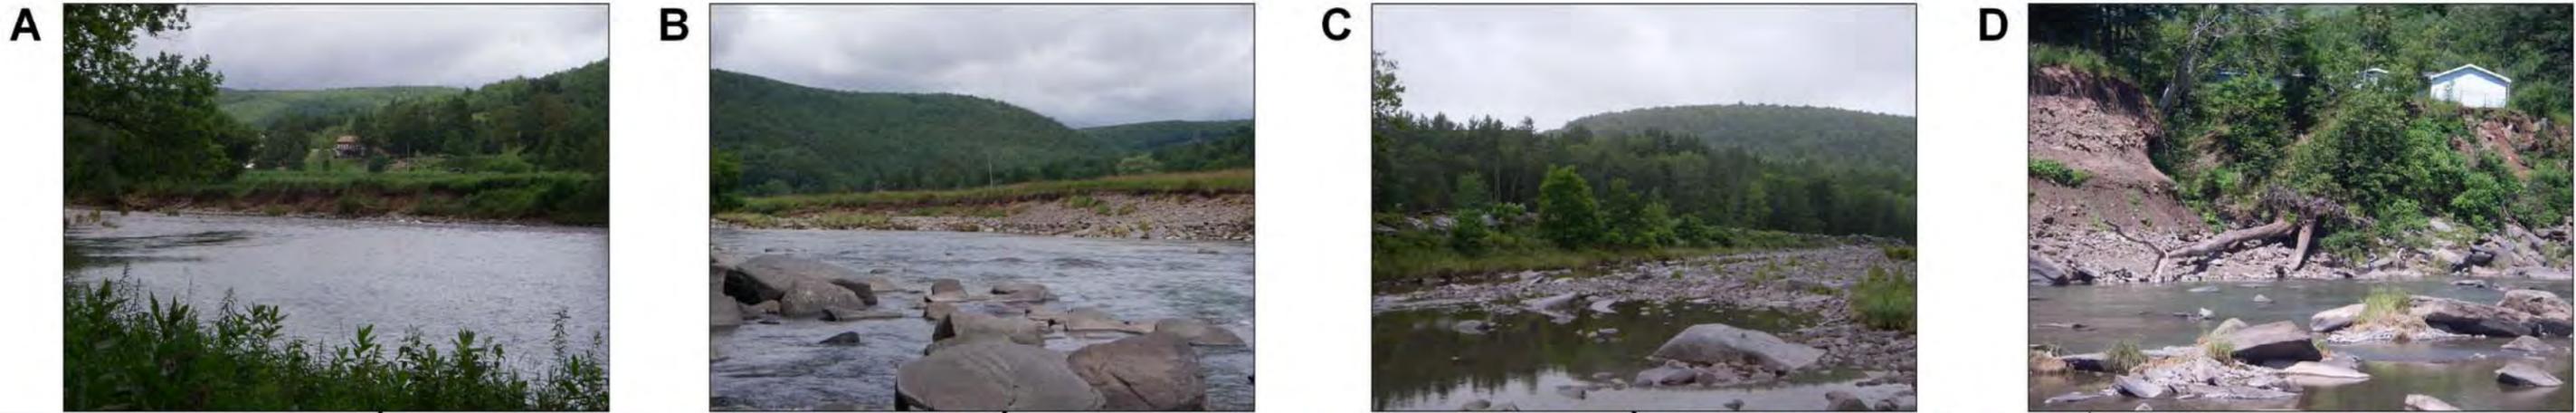
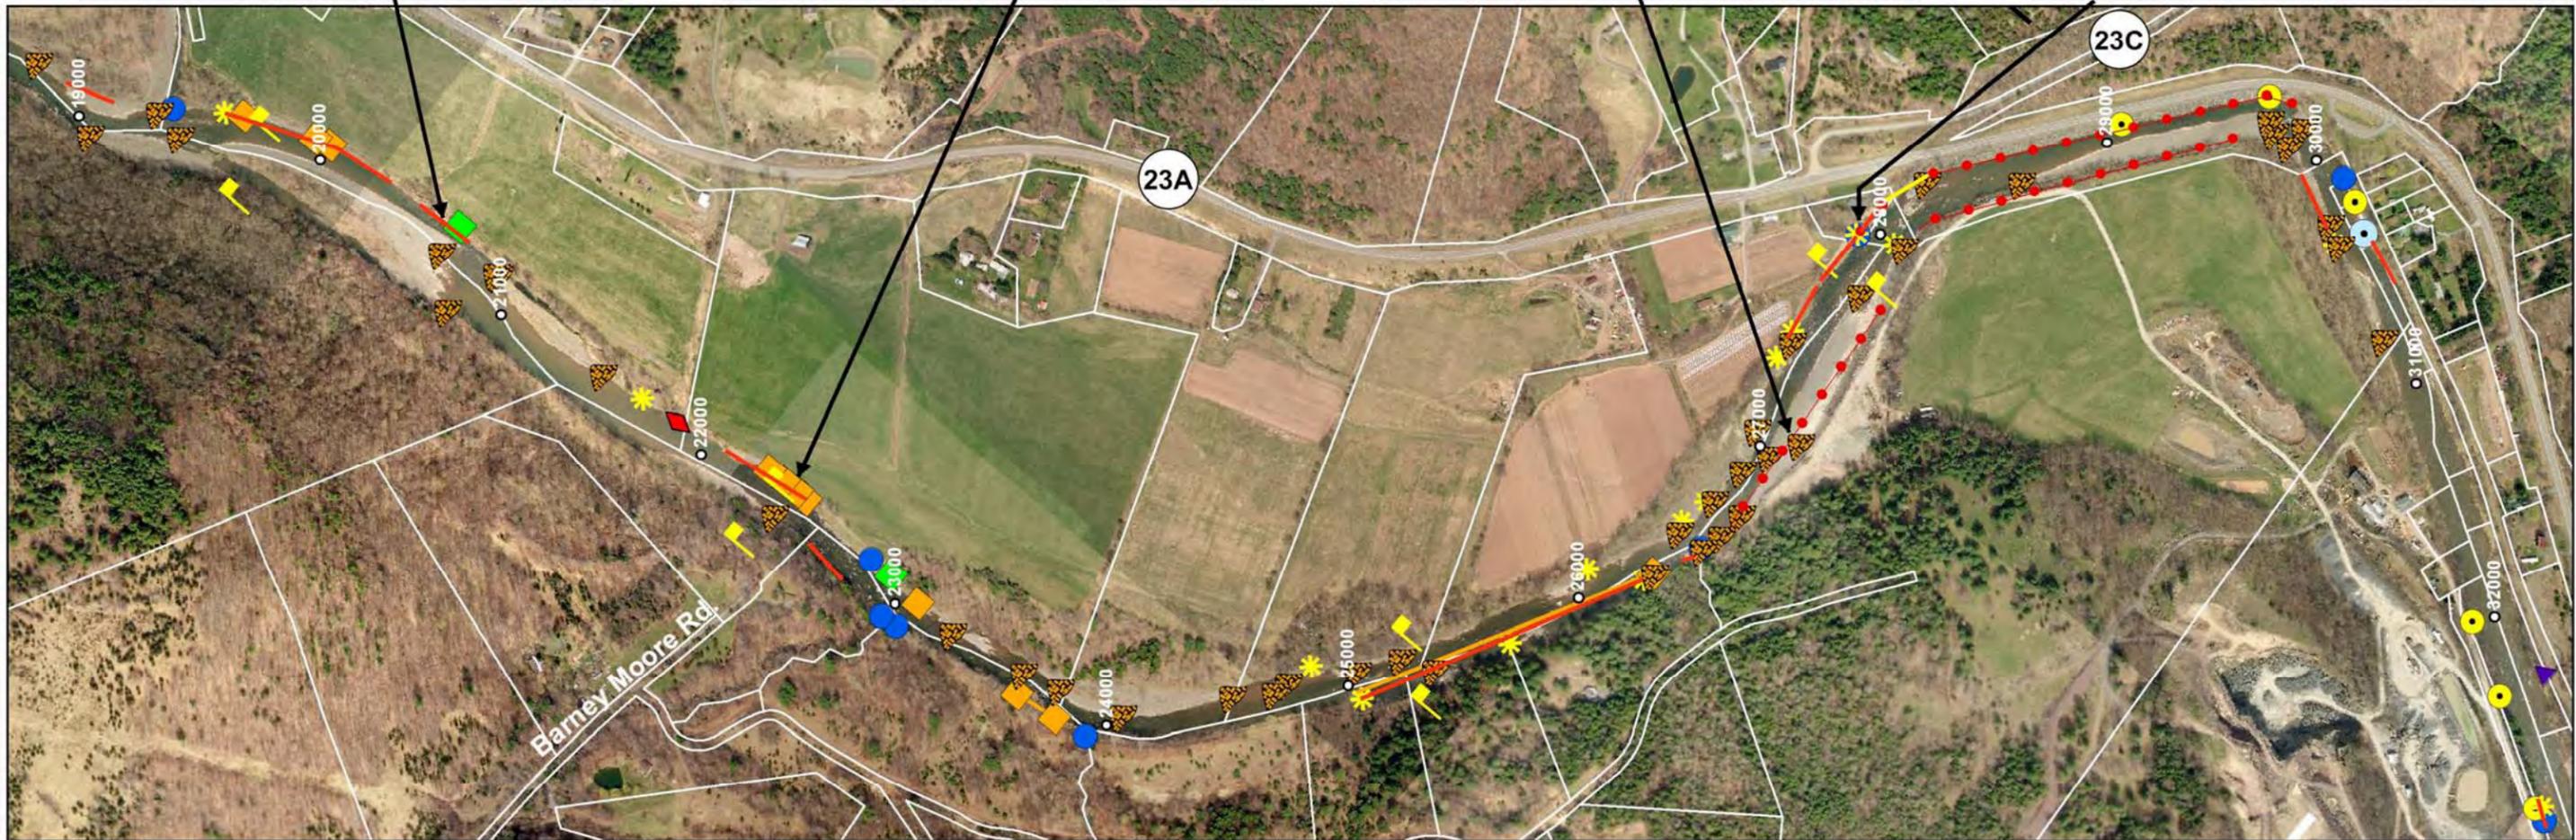
Figure 4.16.1 Management Unit 16 - 2006 aerial photography with stream feature inventory

The 2006 stream feature inventory revealed that 16.5% (3,962 ft) of the streambanks exhibited signs of active erosion along the 24,025 ft of total channel length in the unit (Figure 4.16.1). The total surface area of active erosion totaled approximately 76,453 ft². *Revetment* had been installed on 16.9% (4,064 ft) of the streambanks. No *berms* were identified in this management unit at the time of the stream feature inventory.

Summary of Recommendations Management Unit 16	
Intervention Level	Passive, Assisted Self-Recovery
Stream Morphology	No recommendations at this time
Riparian Vegetation	Plantings for assisted self-recovery of eroding banks at Stations 30600 & 20750, enhancement of riparian buffer at Station 22900, 20750, & 20300, and interplanting of rip-rap at Stations 29750, 29500 & 27700.
Infrastructure	No recommendations at this time
Aquatic Habitat	Watershed Aquatic Habitat Study
Flood Related Threats	No recommendations at this time
Water Quality	Removal of dump site at Station 21850.
Further Assessment	Resurvey of bank erosion monitoring site at Stations 27840, 25340, 22350 & 19770 to assess erosion rate.

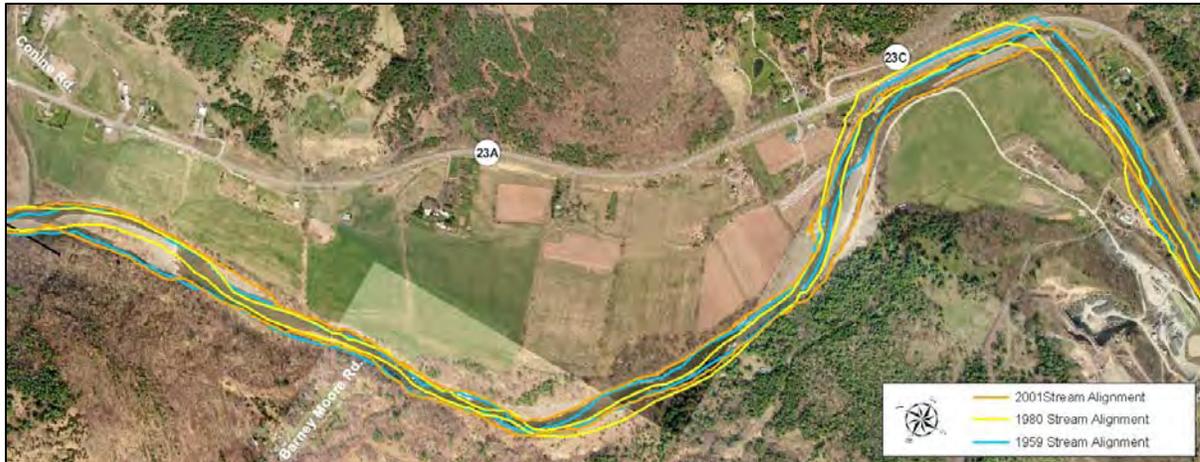
As seen from the historical stream alignments (below), the *planform* of the channel has remained fairly stable since 1959.

Historic stream channel alignments overlaid with 2006 aerial photograph

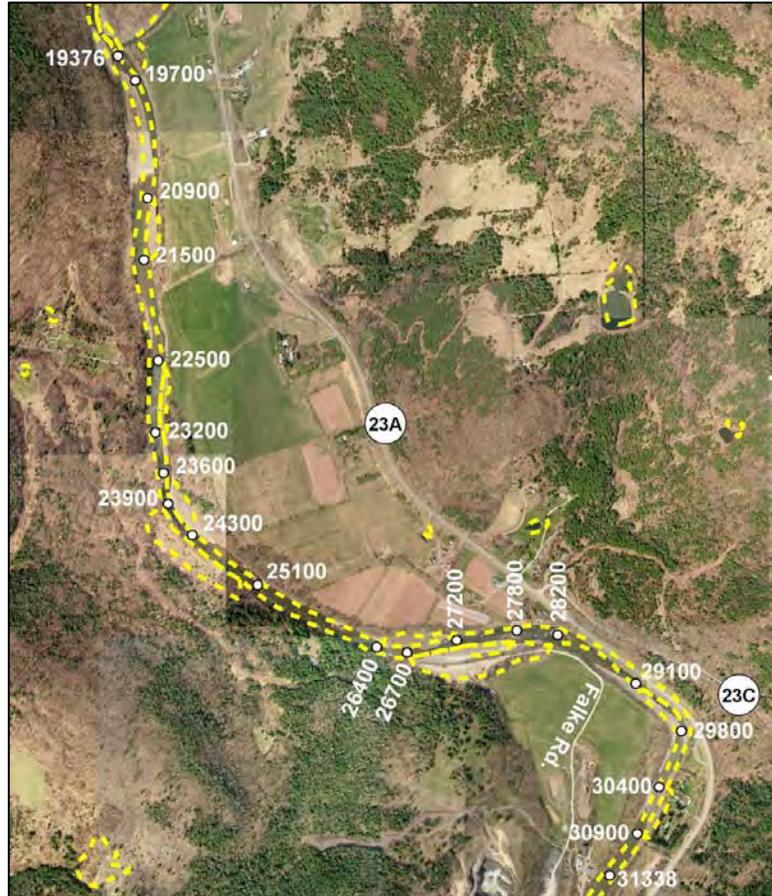
Eleven wetlands were located within this management unit. Three wetlands, including the entire stream channel within this unit, were classified as riverine lower perennial wetlands signifying they were contained in the natural channel and characterized by a low gradient and slow water velocity (R2UBH, 30.1 ac Station 31388-19376) (R2USC, 0.9 ac, Station 30900-30400) (R2USC, 1.1 ac, Station 29800-29100). The remaining wetlands were all classified as palustrine wetlands; two were forested (PFO1C, 5.9 ac,

Station 28200-26700) (PFO1A, 0.9 ac, Station 19700-19400), four had shrub-scrub vegetation (PSS1E, 1.4 ac, Station 27200-26400) (PSS1C, 1.5 ac, Station 24300-23600) (PSS1C, 0.9 ac, Station 23200-22500) (PSS1C, 1.3 ac, Station 21500-20900), and two were dominated by emergent vegetation (PEM1E, 0.9 ac, Station 27800-27200) (PEM1E, 5.0 ac, Station 25100-23900). Wetlands are important features in the landscape that provide numerous beneficial functions

*Wetlands (Station 31388-19376)
approximate wetland boundary delineated by NWI*

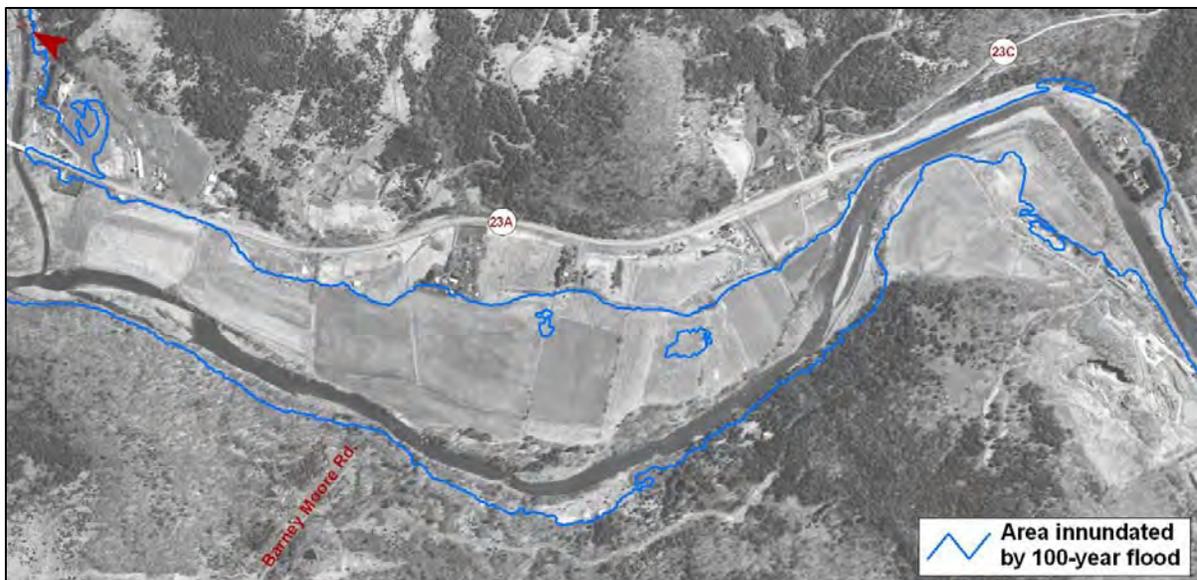
100-year floodplain boundary map

According to the current floodplain maps (below), fourteen existing structures in this management unit appeared to be situated within the estimated 100-year floodplain. The 100-

year floodplain is that area predicted to be inundated by floods of a magnitude that is expected to occur once in any 100-year period, on the basis of a statistical analysis of local flood record. Most communities regulate the type of development that can occur in areas subject to these flood risks.
